# Stillwater Creek 2015 Summary Report

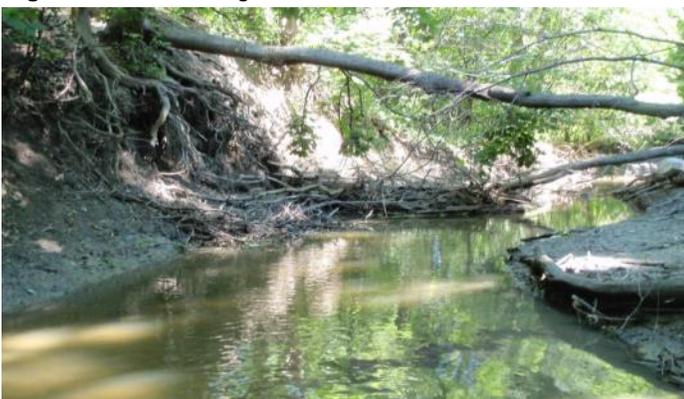
Erosion is a normal, important stream process and may not affect actual bank stability; however, excessive erosion and deposition of sediment within a stream can have a detrimental effect on important fish and wildlife habitat. Poor bank stability can greatly contribute to the amount of sediment carried in a waterbody as well as loss of bank vegetation due to bank failure, resulting in trees falling into the stream and the potential to impact instream migration. Figure 4 shows low to moderate levels of bank erosion were observed along many sections of Stillwater Creek. Most of the areas where erosion was observed were in the agricultural lands south of Highway 417 on the main channel of the creek and its tributary. Shoreline stability in this area could be improved by increasing the vegetated buffer width along the creek.

Stream bank erosion along Stillwater Creek

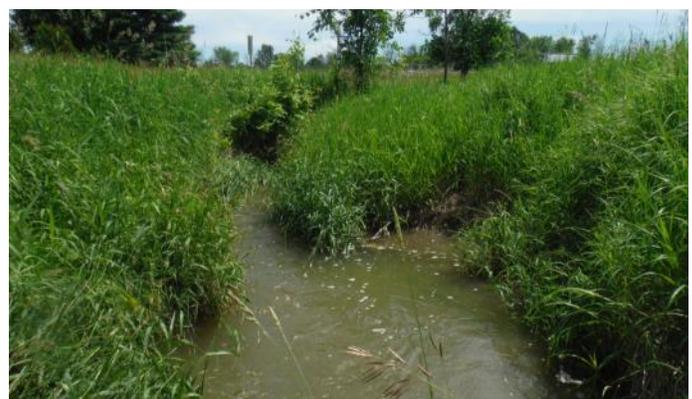
Undercut banks are a normal and natural part of stream function and can provide excellent refuge areas for fish. Figure 5 shows that the bank undercutting on Stillwater Creek varied considerably. Much of the creek had low levels of bank undercutting but these were interspersed with areas of moderate to high level undercutting. The highest levels of undercutting were observed where highway 417 crosses Stillwater Creek. The bank and substrate composition in this area is dominated by clay and the riparian vegetation is predominantly grasses so there is a possibility that the bank undercutting in section of the creek may lead to bank failure over time.

Section downstream of Hwy 417 with high levels of undercutting

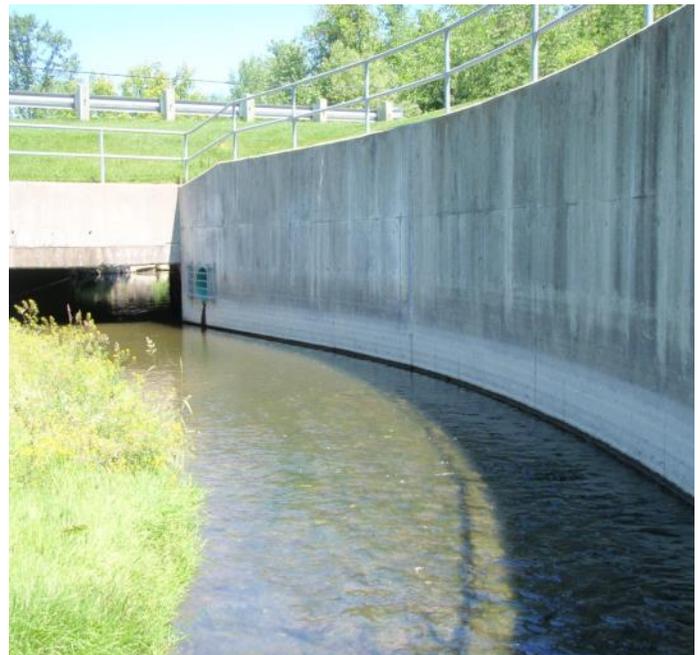
A highly altered section of Stillwater Creek at the Corkstown Road crossing

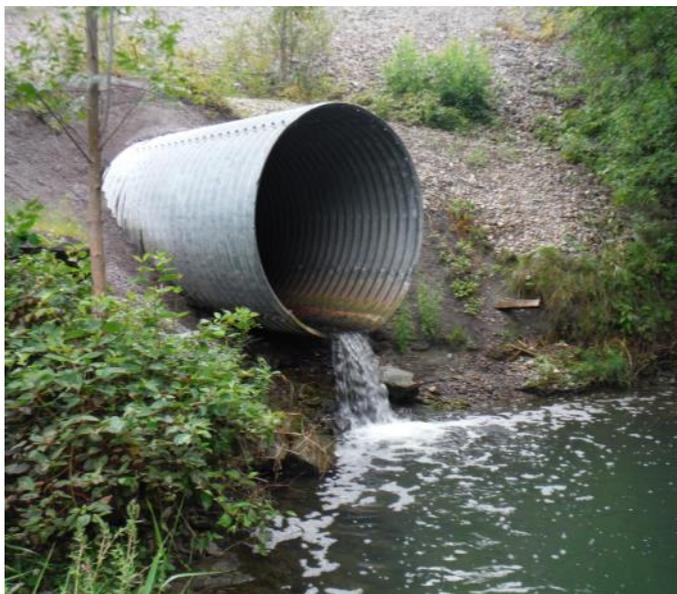
It is important to know locations of migratory obstructions because these can prevent fish from accessing important spawning and rearing habitat. Migratory obstructions can be natural or manmade, and they can be permanent or seasonal. Figure 29 shows that along Stillwater Creek, two perched culverts, two debris dams, one grade barrier and one weir were observed. Fish migration is currently being impacted by the weir near Moodie Drive and the perched culverts identified on the main channel of the creek at Timm Drive and the tributary east of Moodie Drive at the old railway line.

A perched culvert observed along a tributary of Stillwater Creek

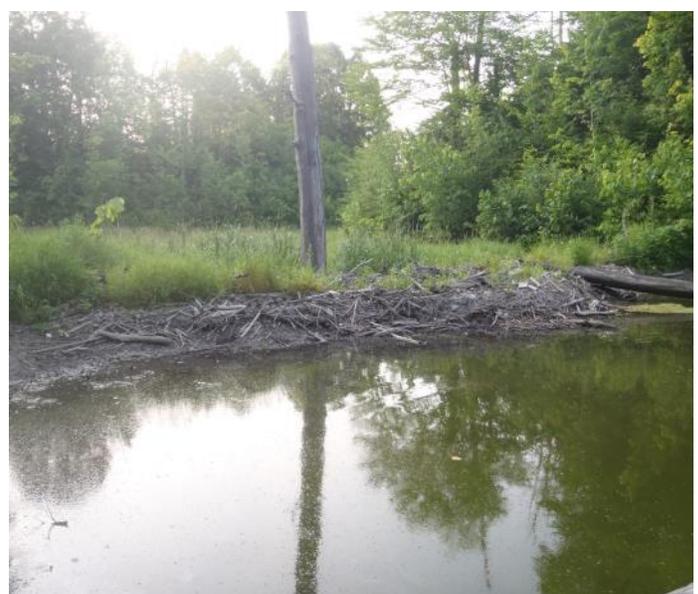
Beaver dams can also act as obstructions to fish migration. Figure 30 shows that a number of active, abandoned and breached beaver dams were observed on Stillwater Creek. Most of the beaver activity was observed between Highway 417 and Robertson Road as well as on the tributary east of Moodie Drive. The head, or difference between the water level up and down stream, of the beaver dams ranged from 0 cm to 60 cm.

A large beaver dam observed on Stillwater Creek

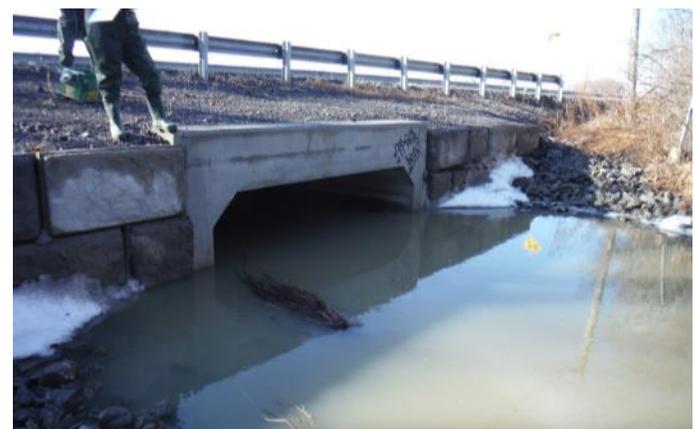
Channel hardening at an HDF site along Corkstown Road

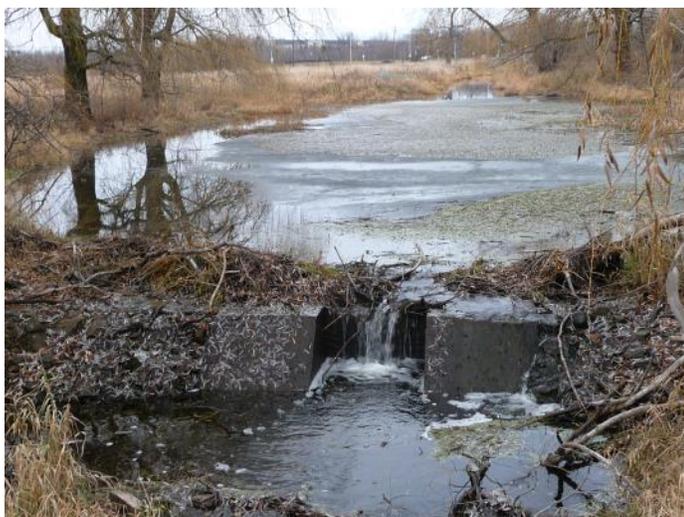
A weir constructed along Stillwater Creek downstream of Moodie Drive that was observed in 2009 and 2015

Three areas were identified for stream cleanups, all near road crossings in the developed areas of Stillwater Creek. In addition, two locations where stream channelization had occurred were identified for channel modifications. An additional opportunity exists to remove the weir located downstream of Moodie Drive.

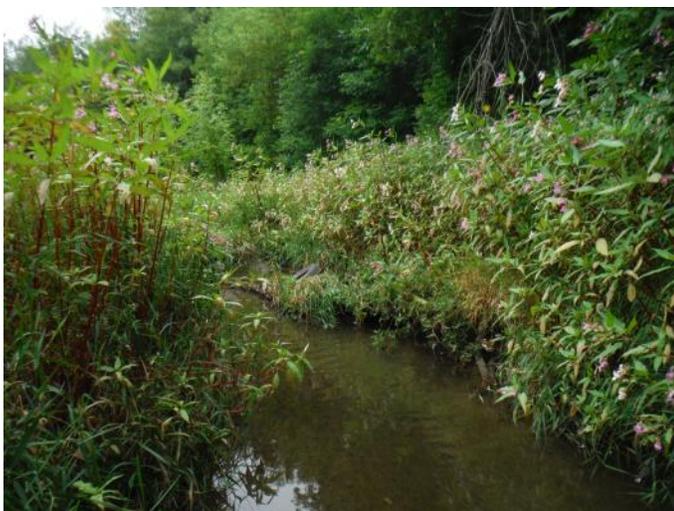
The majority of the opportunities listed were riparian planting and invasive species control. Himalayan balsam is prolific along the tributary east of Moodie Drive and numerous riparian planting opportunities were observed along the main channel of the creek and the tributaries surveyed.

Dense stands of Himalayan balsam observed on the tributary east of Moodie Drive

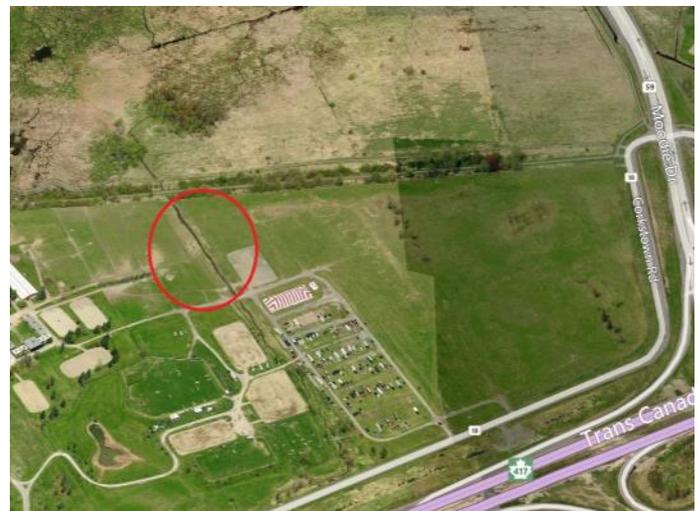
Location where channel modification opportunity was identified on Stillwater Creek
