Sustainable Drainage Project – Rideau Lakes Township

Monitoring Report/Summary

December 2022

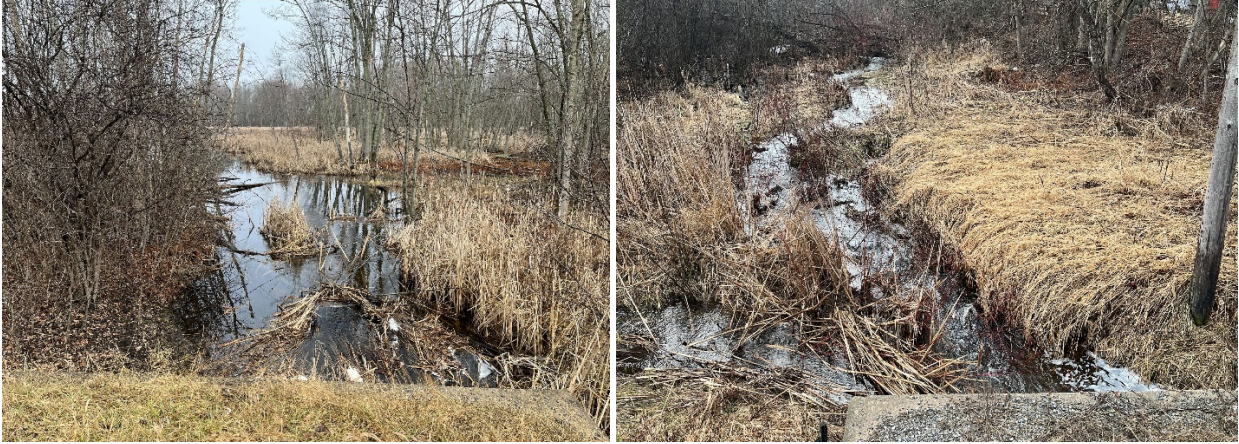
Figure 2 2. Downstream (right) and upstream (left) views at the HWY 15 crossing of an unnamed drainage feature located adjacent to the Portland Bay Conservation Area. Photos were taken in April 2022.

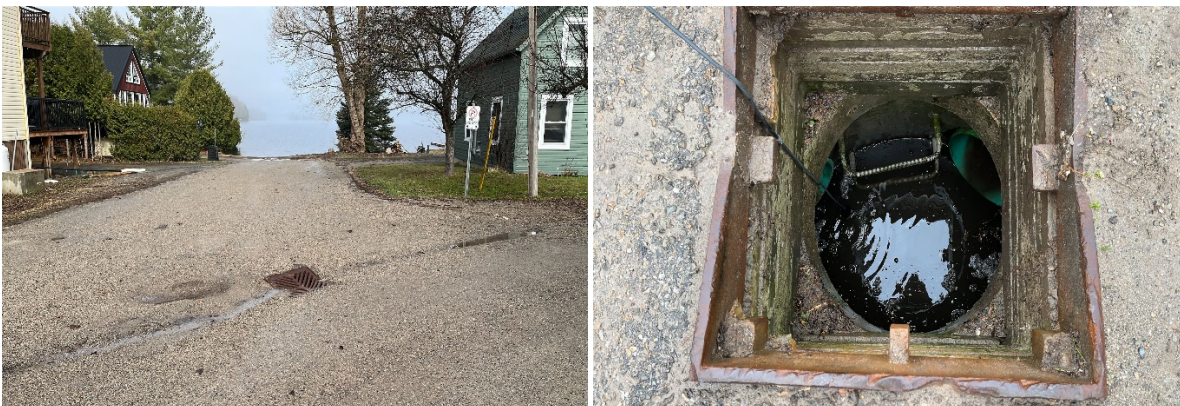
Figure 44. Exterior (left) and interior (right) view of the downstream Main & Water St. Catch Basin.

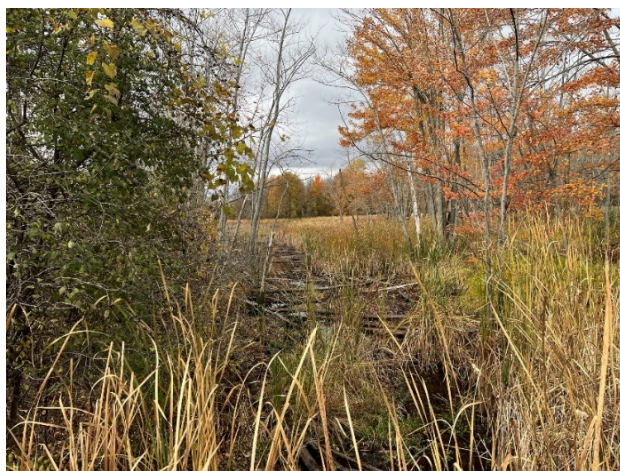
Figure 55. Water level observations collected on October 18th during baseline sampling event at the unnamed drainage feature located adjacent to the Portland Bay Conservation Area.

It should be noted, that as the monitoring season progressed, conditions within the unnamed drainage feature began to closely resemble a wetland system (Figure 5). As water levels also began to decline, the system became increasingly fragmented, resulting in shallow pools of standing water. The sampling done under these conditions (i.e., August to November) were not representative of regular flow conditions. These results likely skewed values from this system towards higher values demonstrating a

When evaluating total phosphorous (TP) results, the Provincial Water Quality Objective (PWQO) was exceeded in all samples in both baseline and precipitation event sampling within the catch basin system (Table 3). In the natural drain, TP exceeded the guideline 75% of the time during baseline sampling, and 83.3% of the time during precipitation events (Table 4). When comparing the two systems, average collected results from the catch basin were lower than the unnamed drainage feature when comparing the whole monitoring period on record. When results were separated based on water level conditions (i.e., May - July, and August-November) results collected from the catch basin during higher water level conditions (i.e., May - July) were about 4.75 times greater during baseline sampling, and about 8 times greater during precipitation events compared to the unnamed natural drainage feature. During lower water level conditions (i.e., stagnant flow), the catch basin did produce higher nutrient concentrations, however as noted above, these concentrations are more representative of wetland like conditions (figure 5) and may not pose downstream risk to water quality as a result of limited water movement.

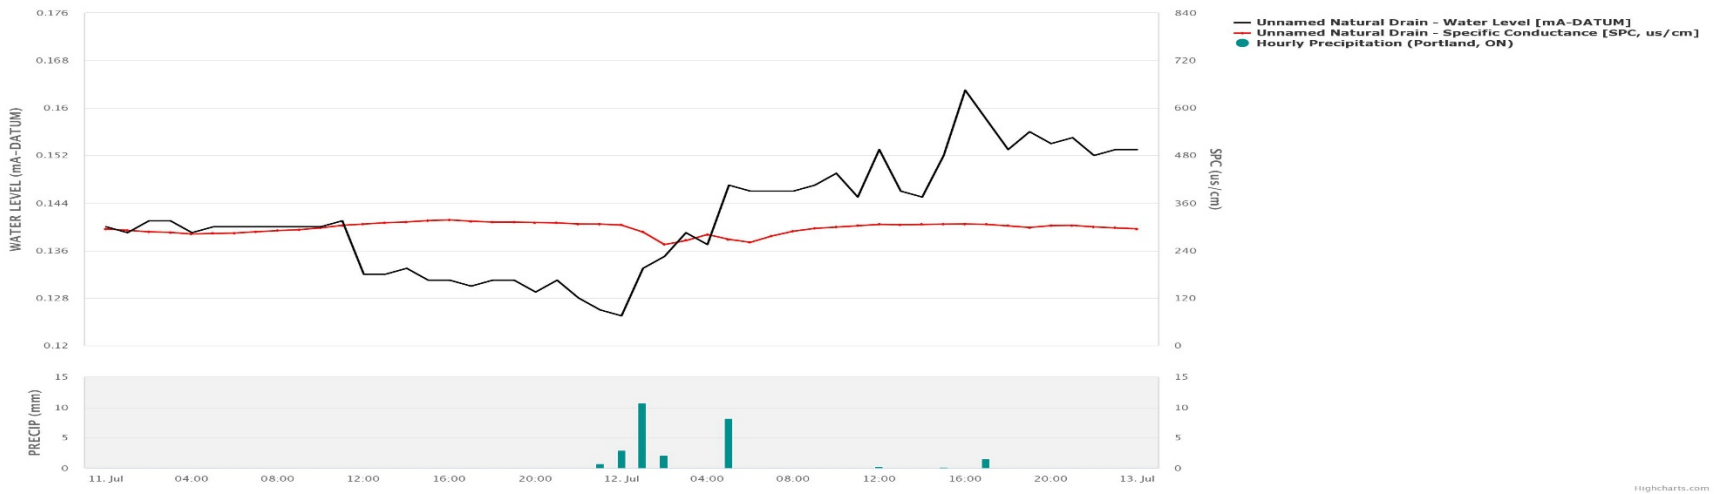
Figure 56. Analyzed specific conductance (SPC, uS/CM) and water level (m above datum) collected from a deployed solinst LTC logger deployed in an unnamed natural drainage feature located adjacent to the Portland Bay Conservation Area in Portland, ON compared to hourly precipitation data collected from RVCA's Portland Rain Gauge for the time period of July 11th to 13th, 2022.

When evaluating the event on July 12th, 2022, within the catch basin system, shortly after precipitation begins and as water level increases there is an observed decline in measured conductivity. This is likely a result of a dilution effect occurring with an influx of new water from upstream. As the precipitation continues, specific conductivity increases and continues to rise until a new equilibrium is met (Figure 5). In the case of the natural drain, this fluctuation was much less pronounced, and a new equilibrium was reached at a much quicker rate (Figure 6).

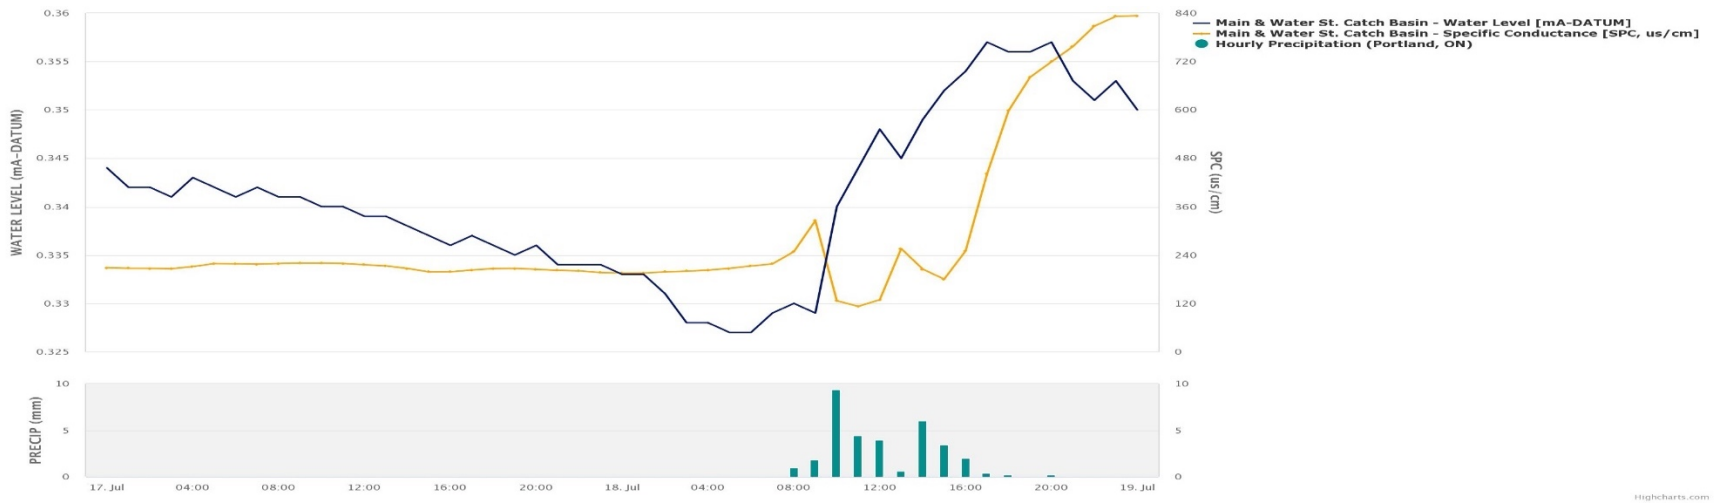
Figure 8. Analyzed specific conductance (SPC, uS/cm) and water level (m above datum) collected from a deployed solinst LTC logger deployed within the Main St. & Water St. catch basin located in Portland, ON compared to hourly precipitation data collected from the RVCA Portland rain gauge for the time period of July 11th, 2022, to July 13th, 2022

A similar event occurred on July 18th, 2022, that also produced similar results. In the case of the Main & Water St. Catch basin, a dilution effect was reached shortly after precipitation commences, however as the precipitation continues, SPC steadily increases and continues to rise as water levels begin to decline (Figure 7). The unnamed natural drainage feature presented similar results to the July 12th event, with a small dilution effect being indicated shortly after precipitation, with equilibrium being reached shortly after dilution (Figure 8).
