Nepean Creek 2012 Summary Report

Nepean Creek is approximately two kilometers long (excluding the stormwater ponds) and flows from Colonnade Business Park just east of Merivale Road to the Rideau River just south of the intersection of Prince of Wales Drive and Fisher Avenue. The headwater reaches of the creek are entombed, out letting just east of Howard Darwin Centennial Arena (formally Merivale). From that point, the creek flows along the southern edge of a highly developed residential area. A naturalized buffer has been maintained between the development and the stream, and well used recreational pathways wind their way through the area crossing the creek multiple times and connecting to residential streets. Nepean Creek has an one online stormwater pond and one offline stormwater settling pond located close to the Rideau River. The stormwater ponds were not included as part of the stream survey as they fall outside the guidelines of the stream assessment protocol.

As part of the City Stream Watch monitoring activities in 2012, twenty 100 meter sections of Nepean Creek were surveyed. The following is a summary of the 20 macro-stream assessment forms completed by staff and vol

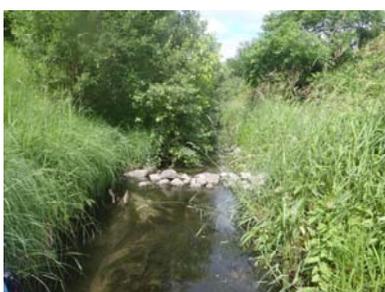
Photo 2. Filamentous algae on Nepean Creek downstream from the stormwater pond

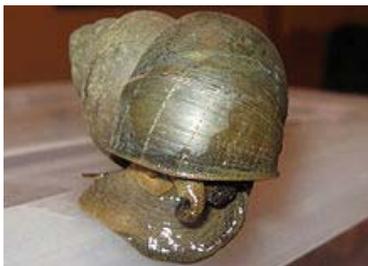
Photo 3. Chinese mystery snail (*Bellamya chinenses*). This invasive species is prolific on Nepean Creek downstream of the stormwater pond.

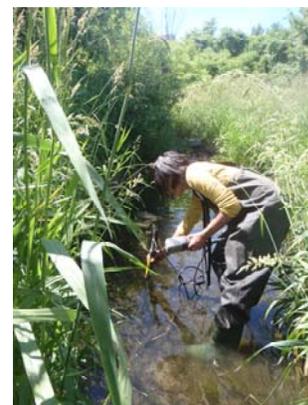
Photo 5. A volunteer using a YSI on Nepean Creek

Month	Range	DO (mg/L)	DO (%)	Conductivity (µs/cm)	pH
May	low	7	80.04	969	8.27
	high	9.04	103.37	1175	8.4
June	low	6.9	74.31	458	7.08
	high	14.13	152.18	2279	8.95
July	low	-	-	-	0
	high	-	-	-	0
August	low	4.34	48.42	385	7.43
	high	8.18	91.26	1595	7.77

Table 7. 2012 Water chemistry collected along Nepean Creek

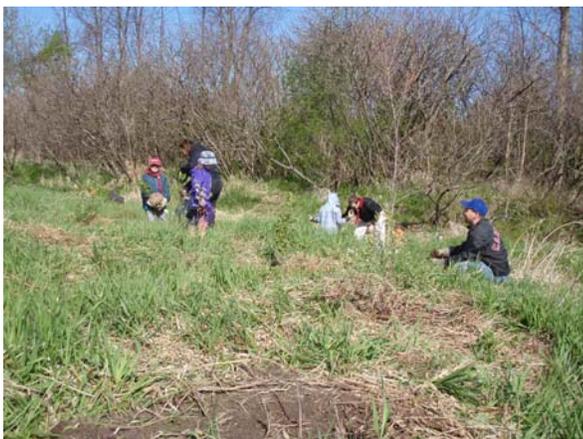
Photo 6. Volunteers planting trees along Nepean Creek

Approximately 150 volunteers from a number of Scout groups throughout the Ottawa area turned up to help 17 City Stream Watch volunteers and staff plant a section of Nepean Creek this spring. The 17 CSW volunteers spent 51 hours planting 1,500 trees and shrubs along a section of the creek in Nepean Creek Park/Charmaine Hooper Fields.

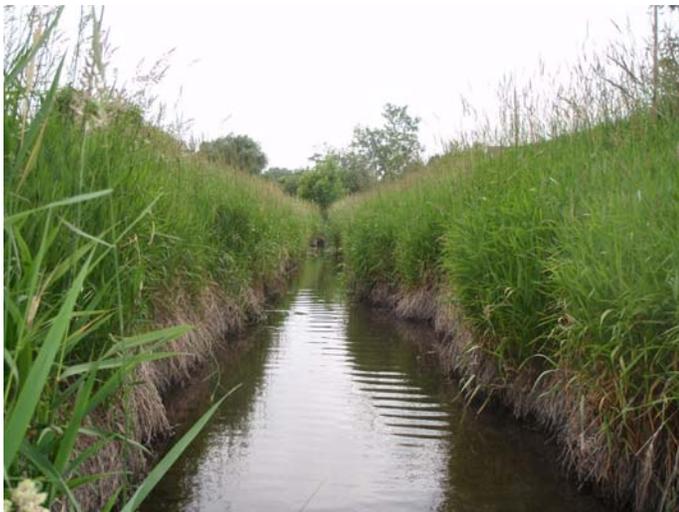
Photo 7. A section of Nepean Creek where riparian planting was identified as a potential restoration opportunity

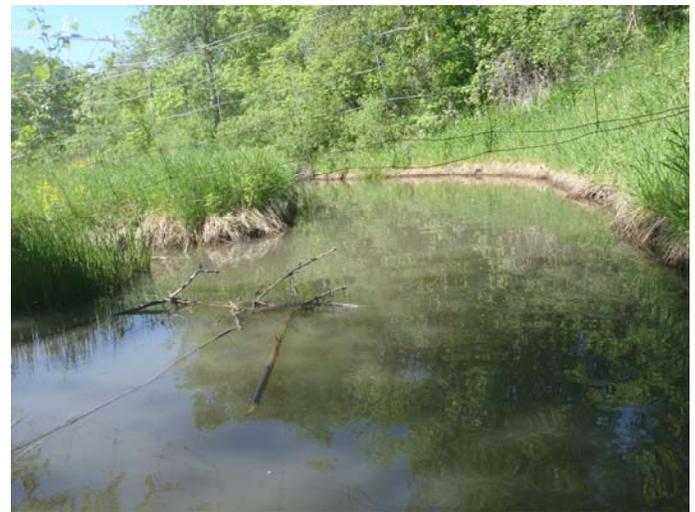
Photo 8. A section of Nepean Creek where fish habitat creation was identified as a potential instream restoration opportunity
