# Ottawa East Tributary 2012

## Summary Report

In 2012, Ottawa East Tributary was surveyed for the first time by the City Stream Watch Program. As part of the City Stream Watch monitoring activities, 16 sections along Ottawa East Tributary were surveyed by staff and volunteers in 2012. The following is a summary of the 16 macro stream assessments carried out on Ottawa East Tributary.

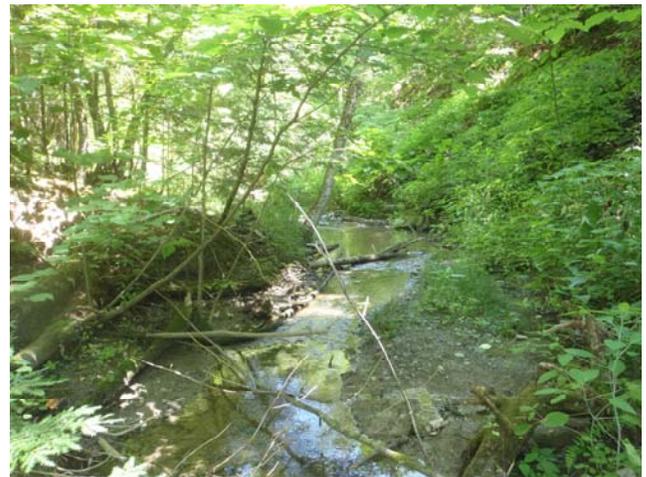
Photo 1. Overhanging trees and branches providing shade on Ottawa East Tributary

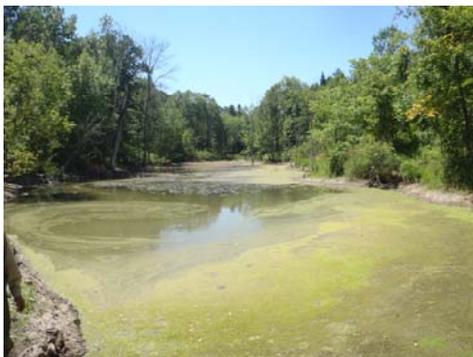
Photo 2. Extensive levels of algae on a section upstream of a beaver dam on Ottawa East Tributary

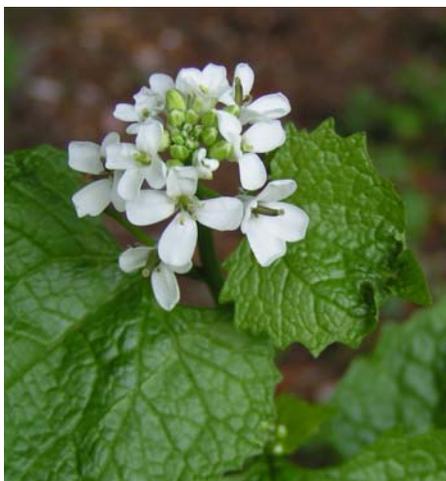
Photo 3. Garlic mustard, and invasive species found on Ottawa East Tributary

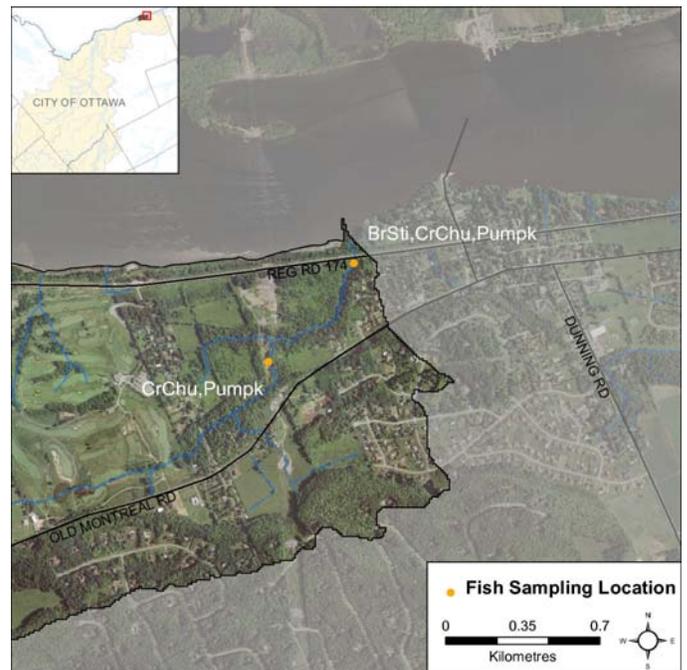
Fish sampling sites located along Ottawa East Tributary are shown in Figure 20, fish sampling occurred between May and July 2012. The provincial fish codes shown on the map are listed (in Table 6) beside the common name of those fish species identified in Ottawa East Tributary.

Figure 20. Fish species observed in Ottawa East Tributary

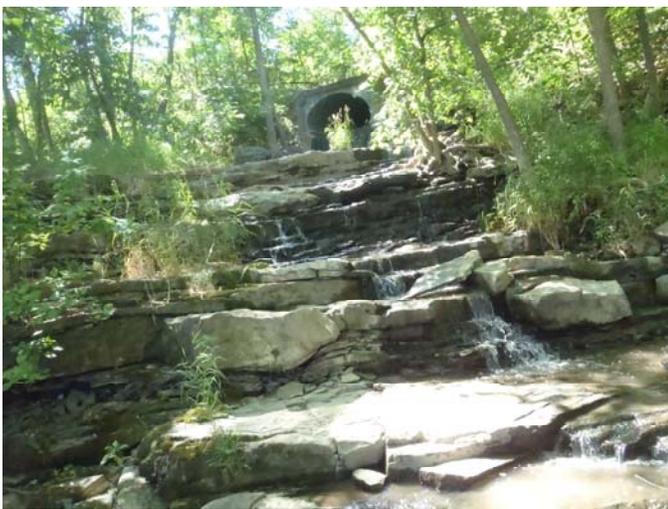
Photo 4. A grade barrier near the mouth of Ottawa East Tributary
