Barrhaven Creek 2009 Summary Report

City Stream Watch Report, 2009

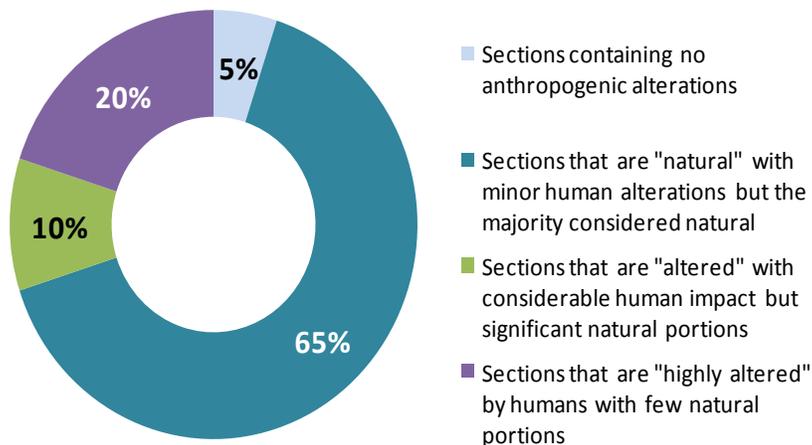
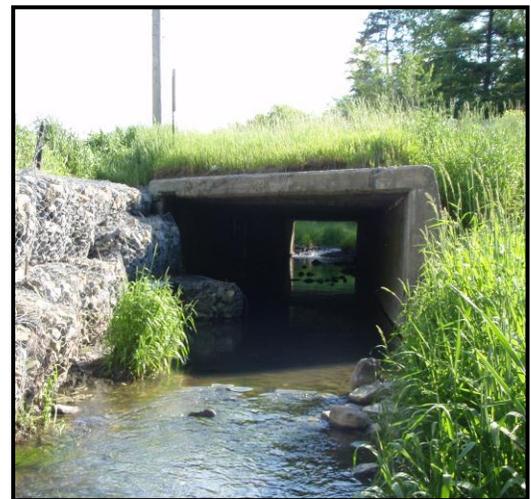
Anthropogenic Alterations to Barrhaven Creek

Of the 20 sections sampled, only five percent of the stream remained without any anthropogenic alterations. Sixty-five percent were considered natural, with some anthropogenic changes, ten percent were considered "altered" but still had natural features and twenty percent were considered "highly altered" with few natural portions. Areas that were listed as "altered" or "highly altered" were associated with road crossings, culverts, stormwater inputs, channelized sections or areas that had little or no buffer or little aquatic or wildlife habitat.

Figure 2. Channel and shoreline alterations along Barrhaven Creek

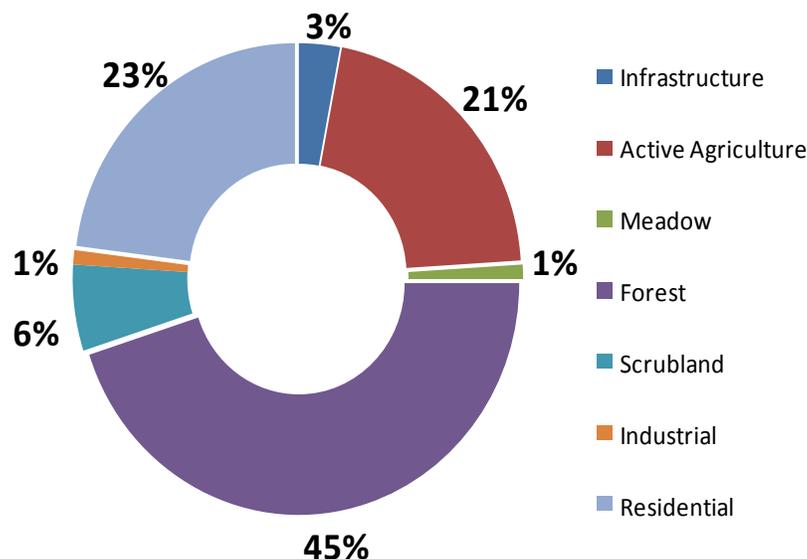
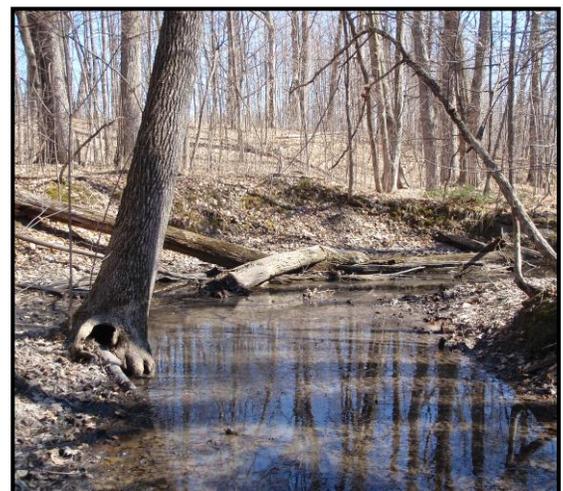
Land Use Adjacent to Barrhaven Creek

Fifty-two percent of Barrhaven Creek was considered natural, characterized by forest, scrubland and a bit of meadow. The two other major land uses were agricultural (21 percent) and residential (23 percent). The headwaters are mainly agricultural and residential areas run along the left bank, from the mouth to the headwaters. Four percent of the land use was infrastructure, which included road crossings, stormwater outlets and the stormwater treatment facility.

Figure 3. Landuse adjacent to Barrhaven Creek

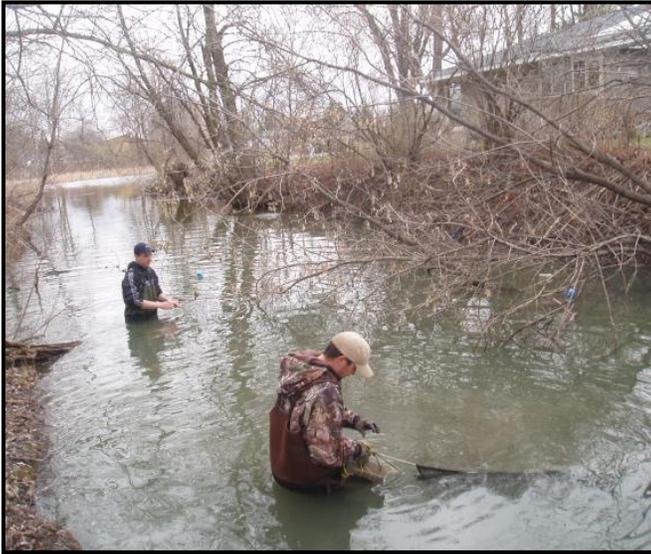
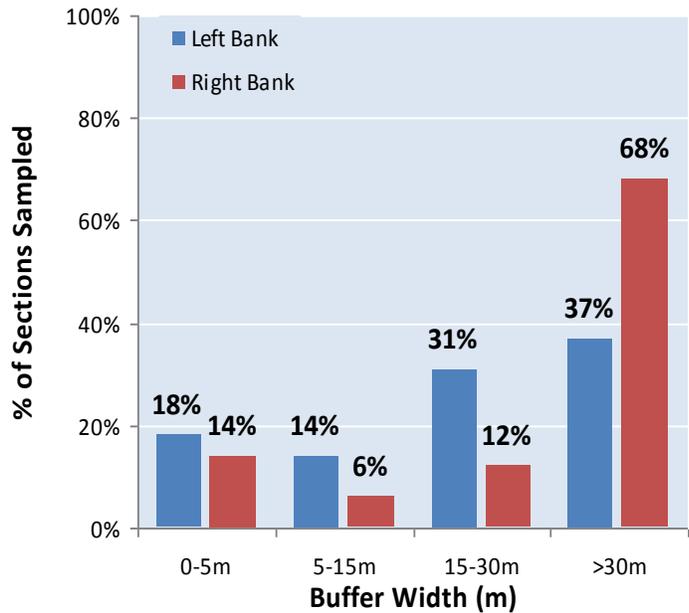
Buffer Evaluation of Barrhaven Creek

Natural buffers are extremely important for filtering excess nutrients running into the creek, infiltrating rainwater, maintaining bank stability, maintaining baseflow levels, keeping water temperatures cool and providing wildlife habitat. According to the document *How Much Habitat Is Enough*, a stream is recommended to have riparian areas of 30 metres minimum or more, depending on the site conditions. The right bank along Barrhaven Creek had a wider buffer for more stream length than the left bank.

Figure 4. Alterations to the natural buffer along Barrhaven Creek

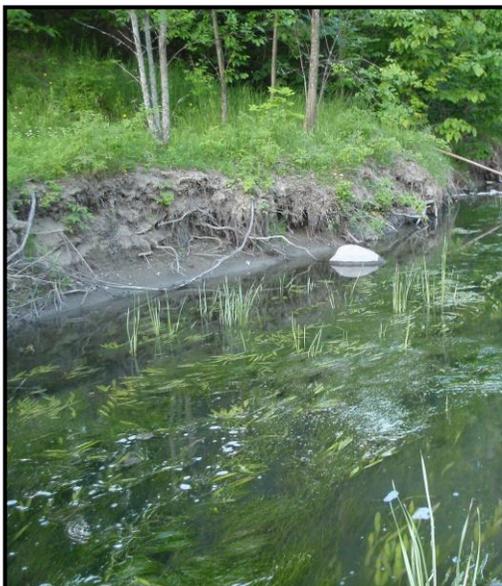
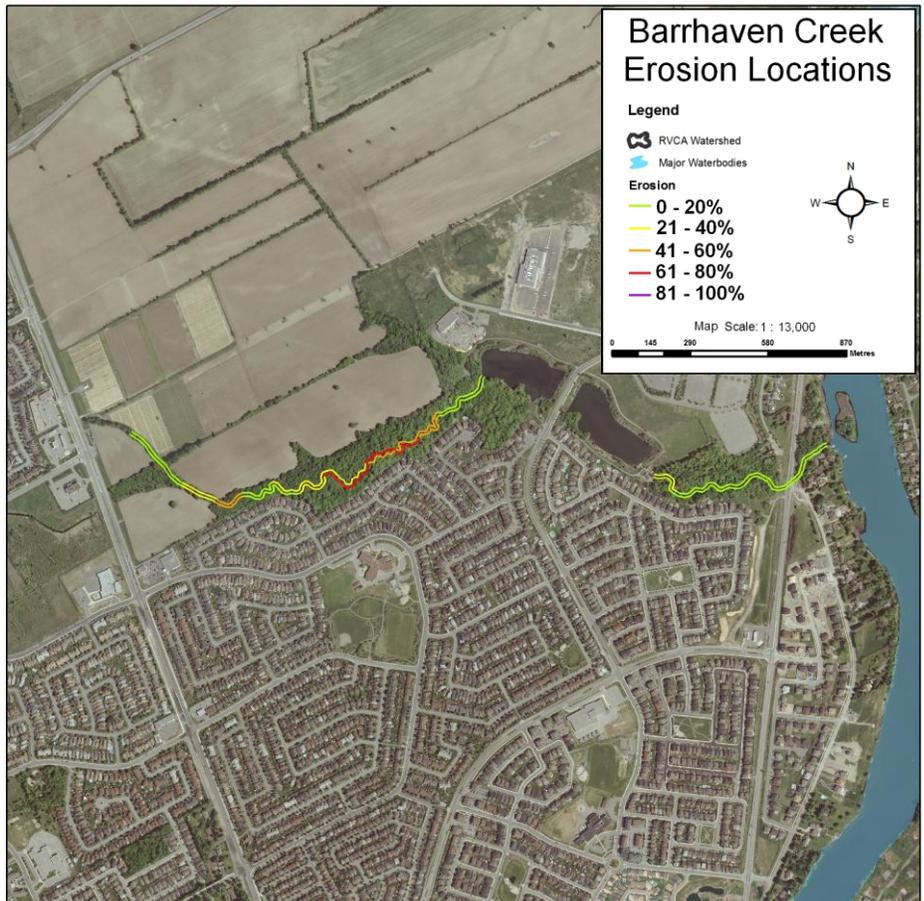
Erosion is a normal, important stream process and may not negatively affect bank stability; however, excessive erosion and deposition of sediment within a stream can have detrimental effects to important fish and wildlife habitat. Along Barrhaven Creek, 73 percent of the sections surveyed were considered stable and 27 percent unstable; results were the same for both the left and right banks.

Figure 5. Eroded shoreline along Barrhaven Creek

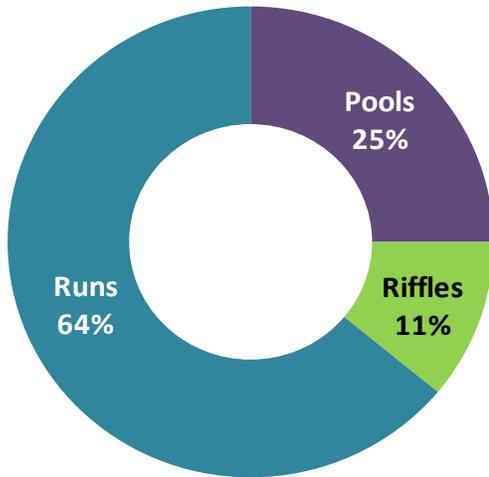
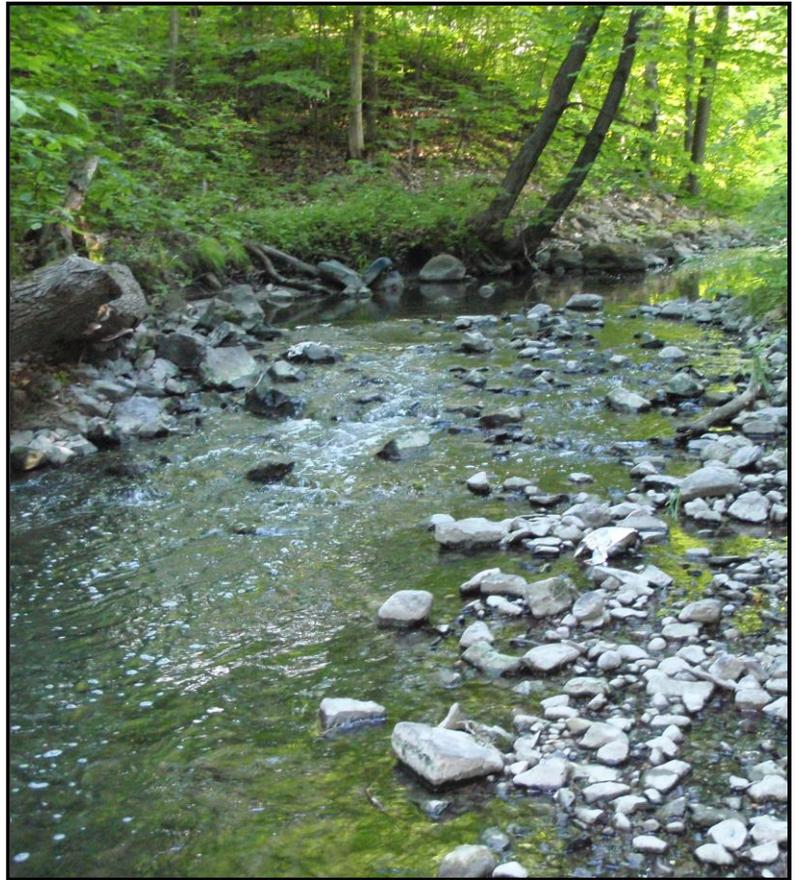
Instream Morphology of Barrhaven Creek

Pools and riffles are important features for fish habitat. Riffles contribute higher dissolved oxygen to the stream and act as spawning substrate for some species of fish and pools provide shelter for fish and can be refuge areas. Runs are usually moderately shallow, with unagitated surfaces of water, and areas where the thalweg (deepest part of the channel) is in the center of the channel. Barrhaven Creek consists of large runs with 25 percent pools and 11 percent riffles. Overall, stream conditions are quite diverse.

Figure 6. Instream morphology along Barrhaven Creek (riffle)

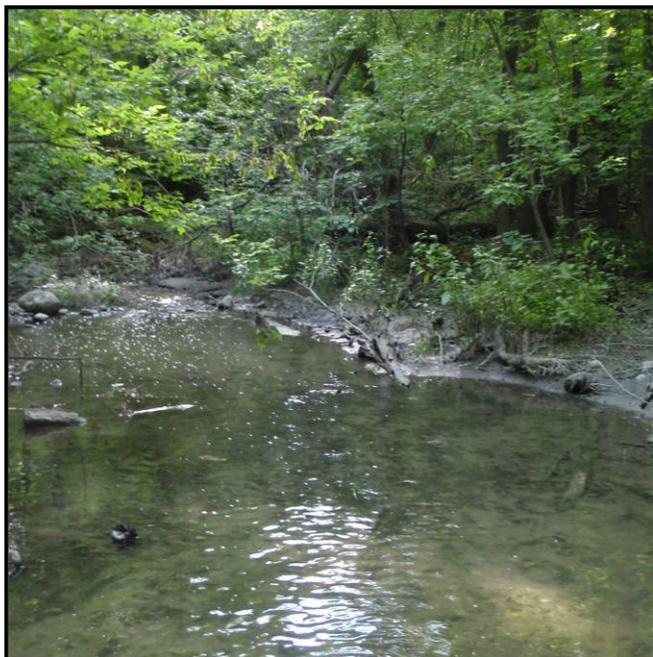
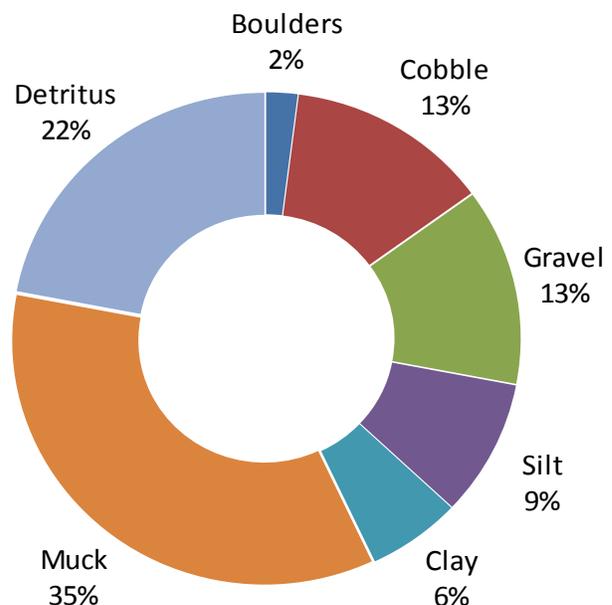
Types of Instream Substrate Along Barrhaven Creek

Diverse substrate is important for fish and benthic macroinvertebrate habitat for spawning, resting, over wintering and feeding. Over half of the substrate observed in Barrhaven Creek was muck (mixture of clay, silt and sand) and detritus, most of which was found upstream of the stormwater treatment facility. A variety of other substrates were observed in smaller percentages.

Figure 7. Clay/muck substrate along Barrhaven Creek

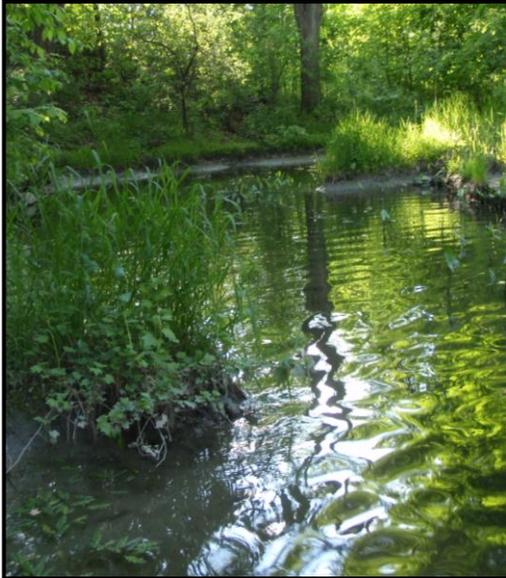
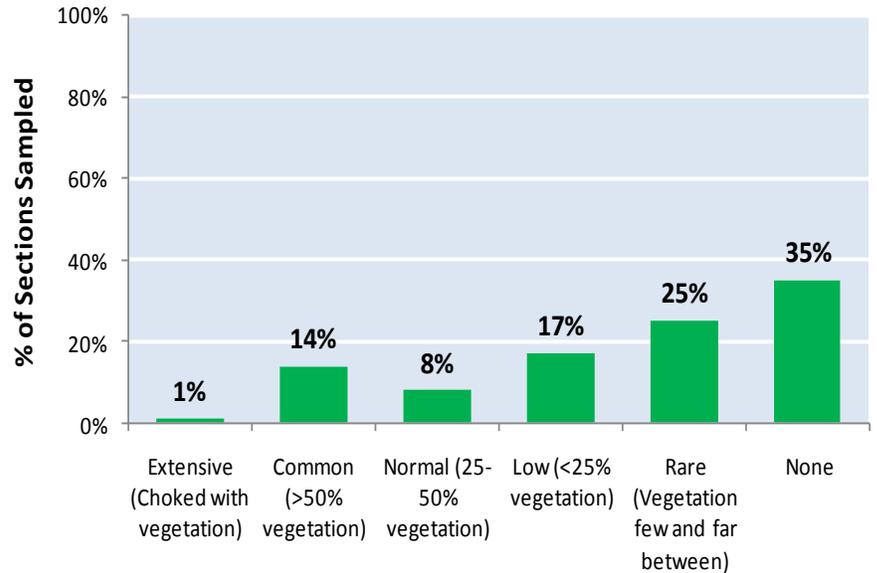
Instream Vegetation of Barrhaven Creek

Instream vegetation is an important factor for a healthy stream ecosystem; it helps to remove contaminants, contributes oxygen and provides habitat for fish and wildlife, although extensive vegetation can have negative impacts. A healthy level of vegetation was observed in only 22 percent of Barrhaven Creek; the majority of the stream had little to no vegetation. Areas upstream of the stormwater treatment facility were surveyed in April, before aquatic vegetation had a chance to grow. Extensive levels of vegetation were observed directly downstream of the stormwater treatment facility.

Figure 8. Instream emergent vegetation along Barrhaven Creek

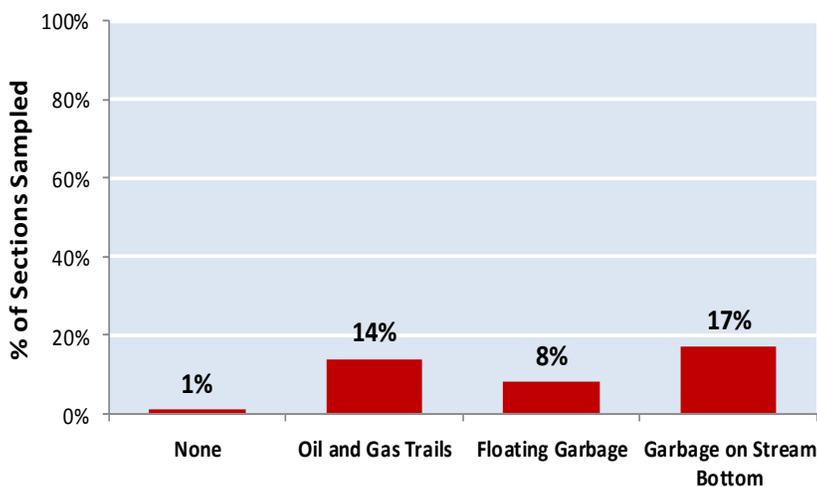
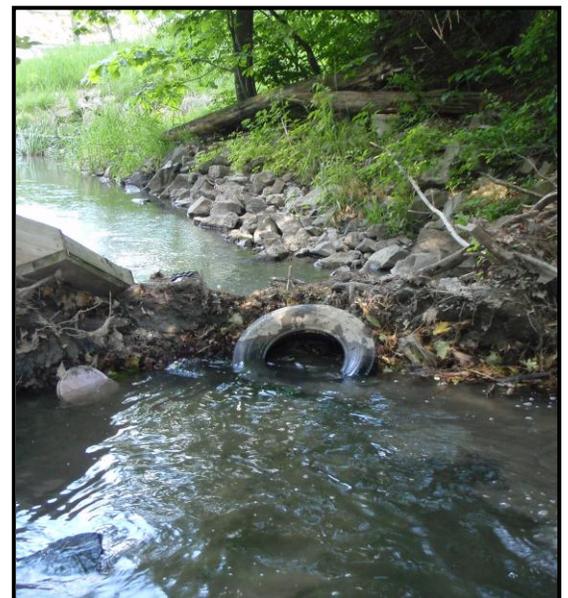
Pollution Observed in Barrhaven Creek

Pollution and garbage along Barrhaven Creek was assessed visually and noted for each section where it was observed. Only ten percent of the stream surveyed was free of pollution or garbage. Along the rest of the stream, 65% had floating garbage in the water and 40% had garbage on the stream bottom. In five percent of the sections, oil and gas trails were observed.

Figure 9. Pollution observed along Barrhaven Creek

Type of Project	Description
Stream Garbage Cleanups	Please see migratory obstruction removal.
Riparian Planting/Buffer Enhancements	Riparian plantings and buffer improvements with native species could be implemented to enhance wildlife habitat and help filter runoff from the surrounding area for approximately: -6km along the left bank -5km on the right bank -5km along the tributaries to Barrhaven -on the right bank of the stormwater treatment facility
Migratory Obstruction Removal	Two migratory obstructions could be removed. One obstruction has built up near Prince of Wales Drive. Game fish were caught downstream of the obstruction. The obstruction should be removed so that fish can access potential spawning and nursery habitat farther upstream.
Invasive Species Control	The only invasive species observed along Barrhaven Creek was rusty crayfish (<i>Orconectes rusticus</i>). Rusty crayfish are very difficult to control once introduced and can be spread via bait buckets. If you see a suspected rusty crayfish, you can report it to the Ontario Federation of Anglers and Hunters invading species hotline: 1-800-563-7711

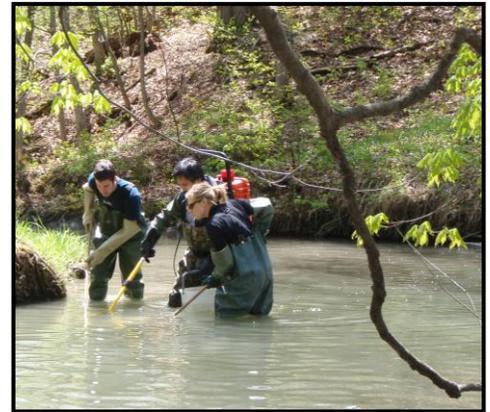
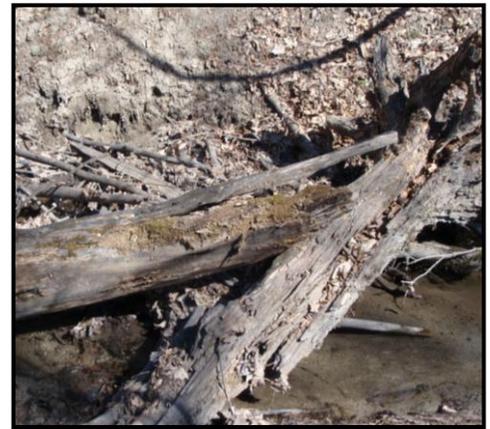
Figure 11. Fish collection using an electrofishing device in Barrhaven Creek (ABOVE); Migratory obstruction observed within Barrhaven Creek (BELOW)

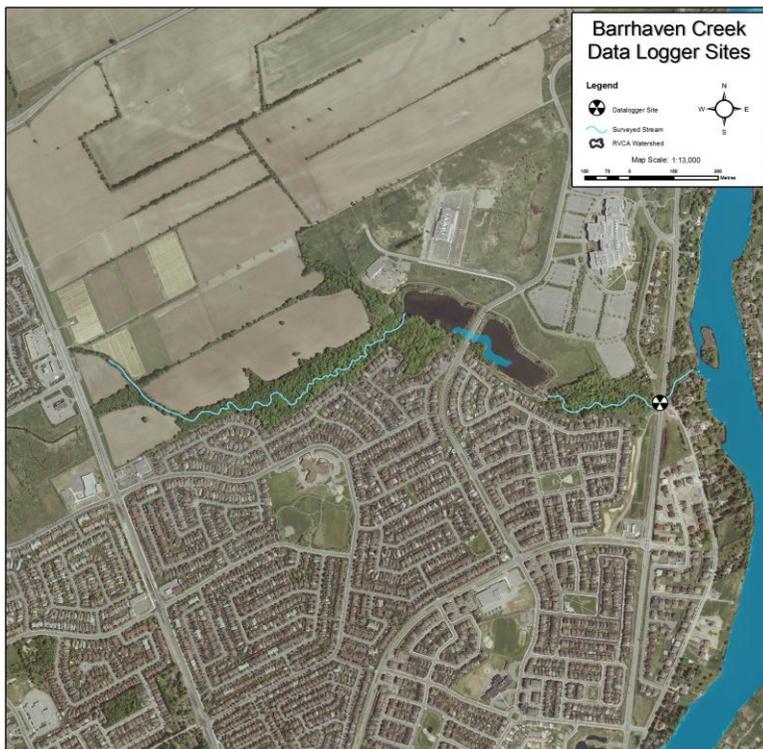
Temperature is an important parameter in streams as it influences many aspects of physical, chemical and biological health. One temperature datalogger was placed in Barrhaven Creek at Prince of Wales Drive. Water temperature values from July, August and September are colour coded for cold, cool and warm water classification and are listed in the chart under "class". Classification is based on the Ontario Stream Assessment Protocol. Based on the stream temperature classification and fish community structure, currently Barrhaven Creek can be classified as a cool water system with warm water reaches. The fish community results show a presence of mainly cool water species (11), three cool/warm water species and five warm water species. There may be stream temperature influences as the result of the upstream stormwater treatment facility which could result in a shift from a cool water system to a warm water system.

Blue values represent coldwater (<19°C), green values coolwater (19-25°C) and red values (>25°C) warm water temperatures none-there were no days meeting the OSAP temperature classification criteria during this month
September**-Temperature loggers were removed September 22, therefore temperatures recorded do not include the entire month
