Greens Creek 2016 Summary Report

Introduction

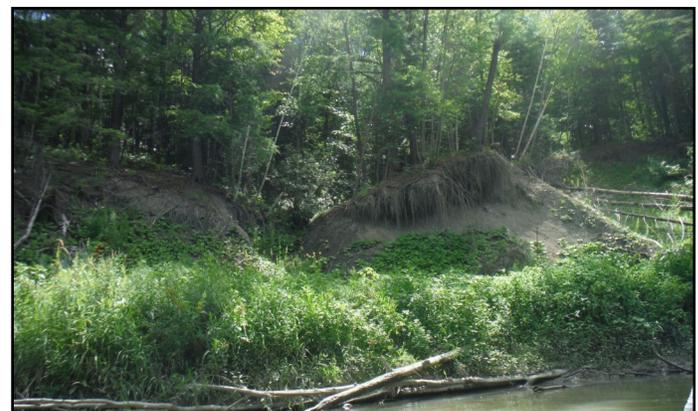
Bank destabilization and slumping along Greens Creek

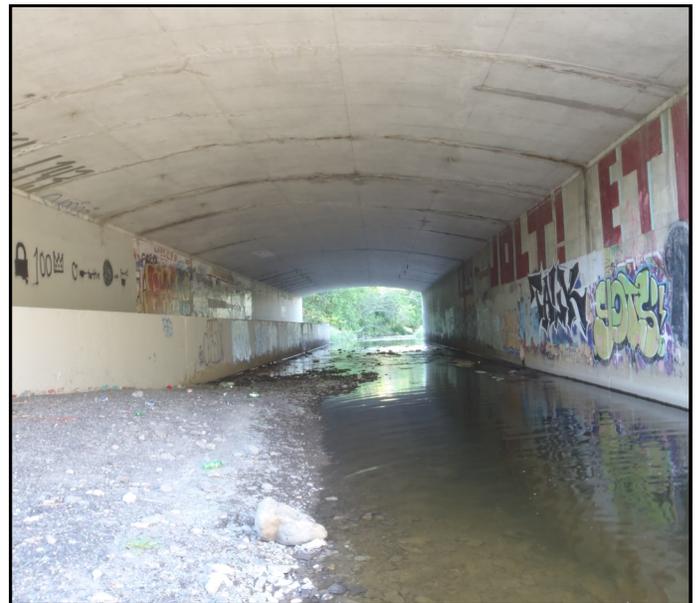
A highly altered section of Greens Creek (Innes Rd crossing)

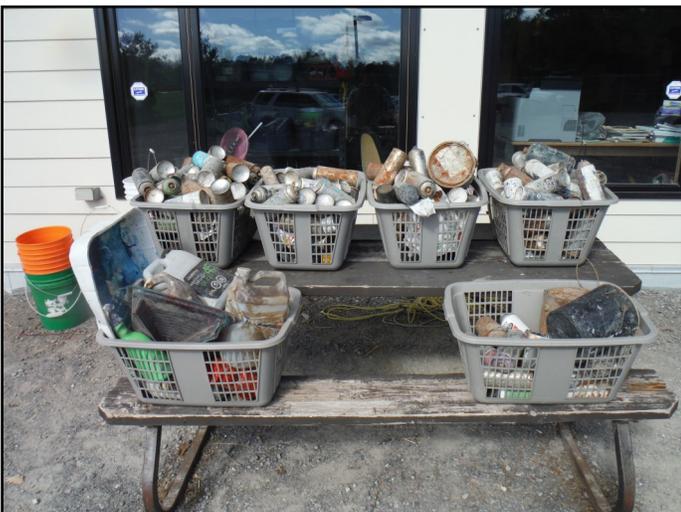
Hazardous waste products collected from Greens Creek

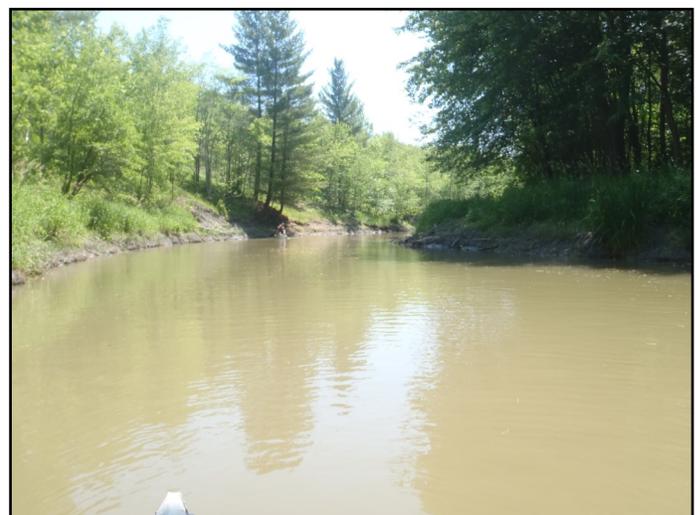
Site on Greens Creek with depleted oxygen conditions

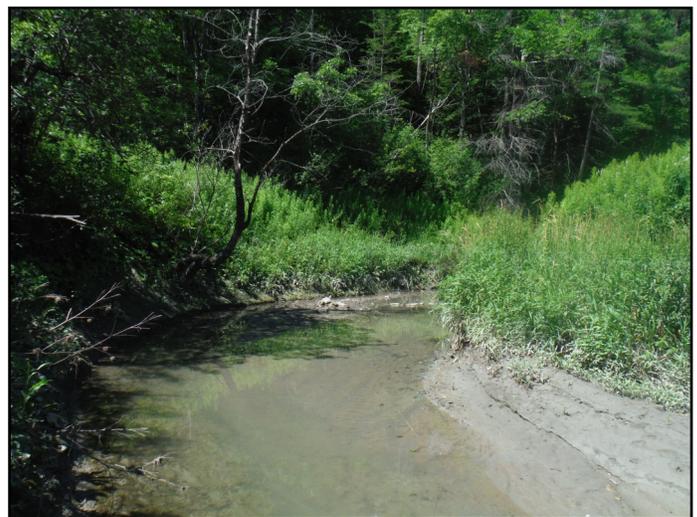
Tributary conveying storm water from an adjacent subdivision

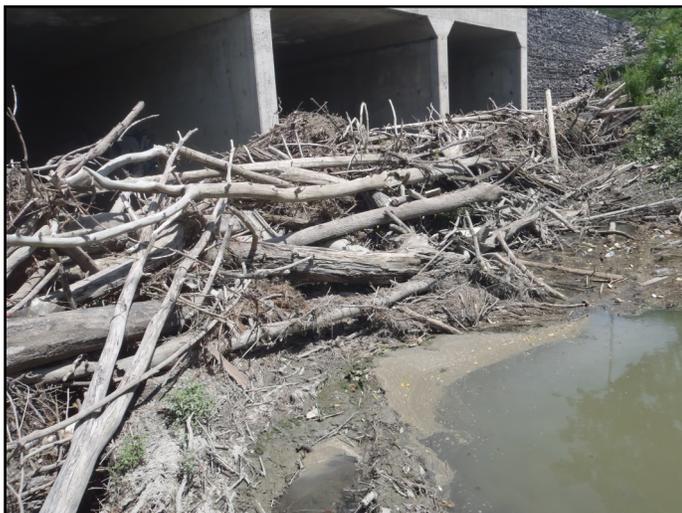
Debris dam located upstream of St Joseph blvd

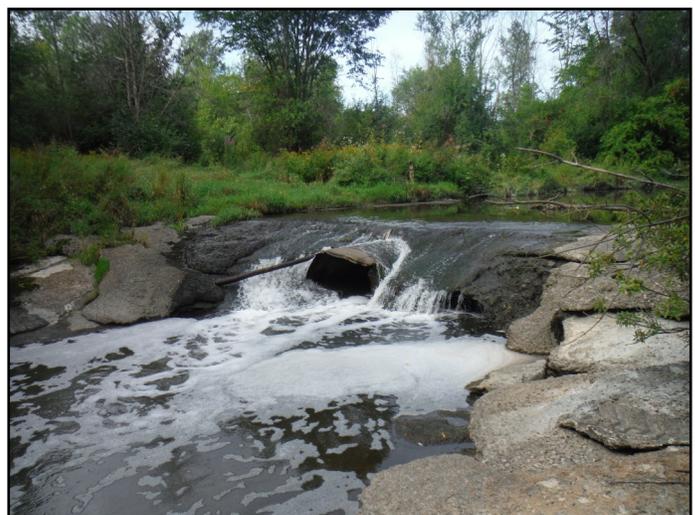
Concrete grade barrier identified upstream of Innes Rd

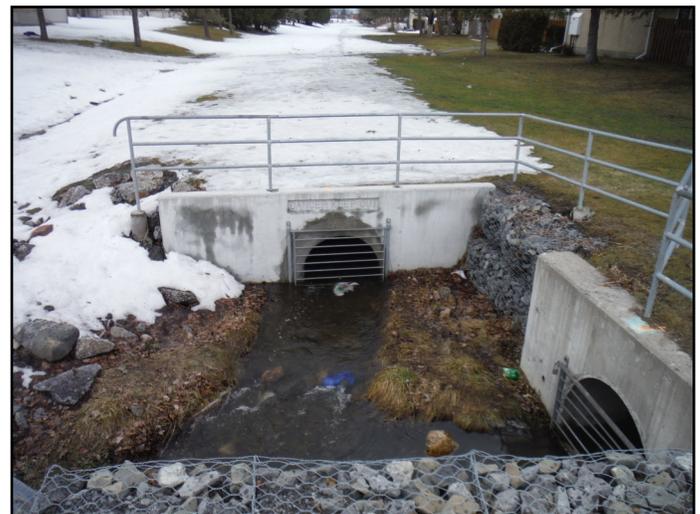
Piped outflow and channel hardening along Blair Rd

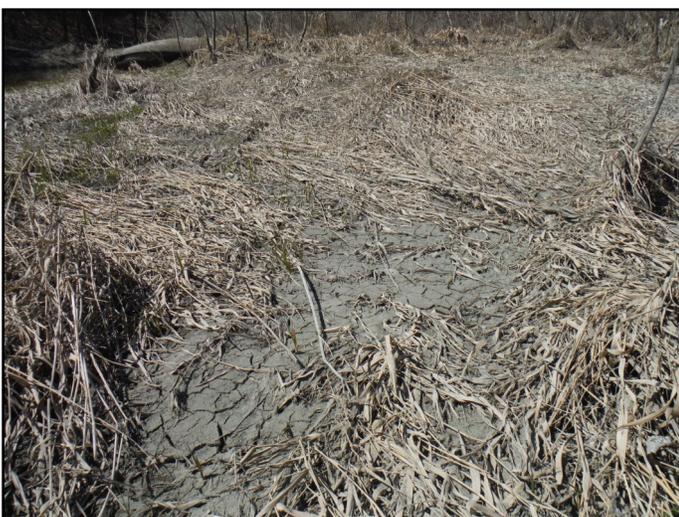
Sediment deposition along Greens Creek at St. Joseph Blvd

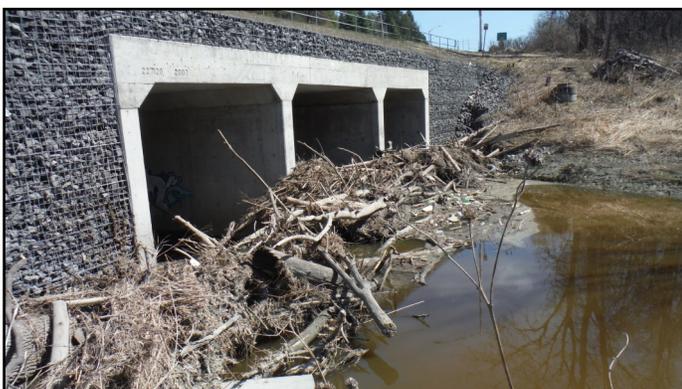
Significant debris accumulation was noted along St. Joseph Blvd and HWY 174 in the spring of 2016. Follow up monitoring confirmed that the accumulation was causing considerable backflow, with severely reduced water levels downstream. The City of Ottawa was consulted to assist in the removal of both debris dams. During the fall/winter of 2016, the City of Ottawa successfully removed the obstructions and re-stabilized flow conditions within the reach.

Debris accumulation along St. Joseph Blvd (Spring 2016)
