Black Creek 2018 Catchment Report

Introduction

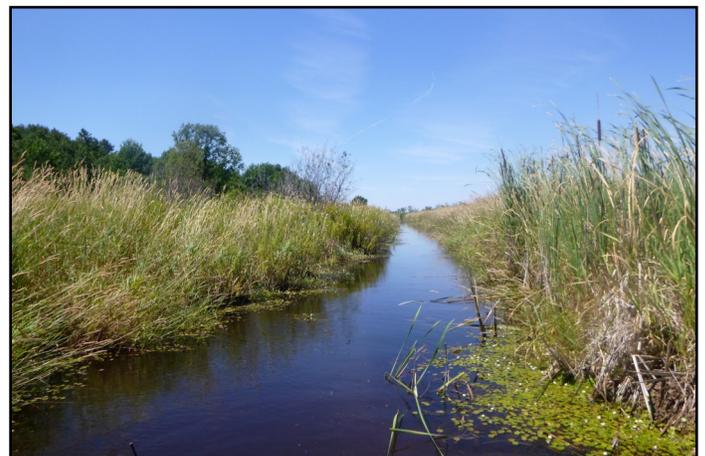
A highly altered straightened section along Black Creek

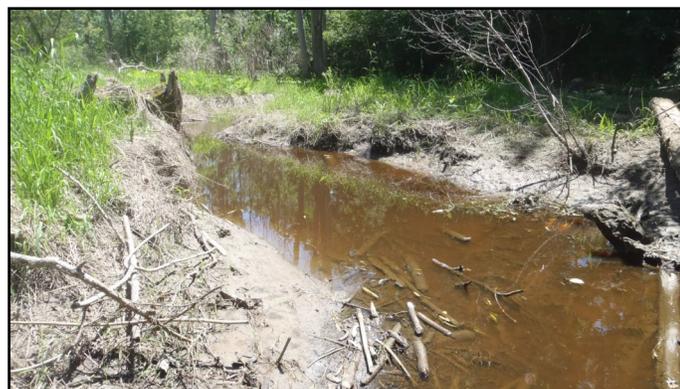
Erosion observed along Black Creek

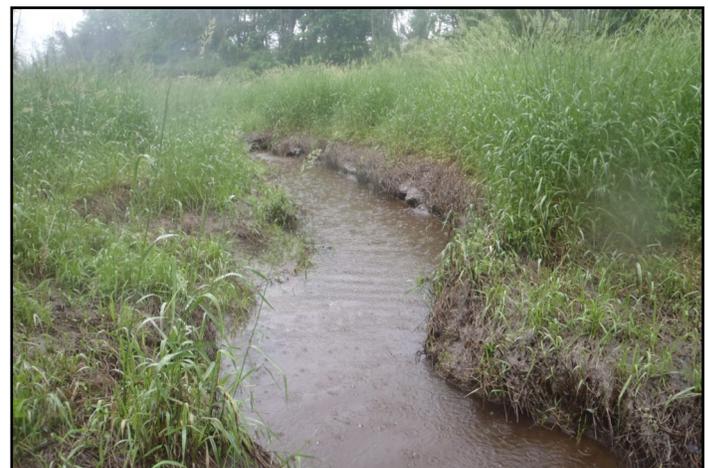
Bank undercutting along Black Creek

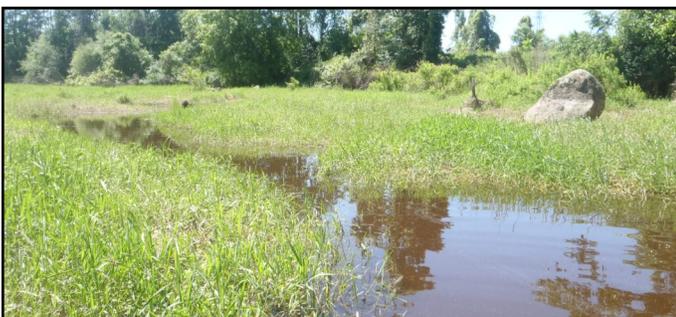
Site on Black Creek with **impaired** oxygen conditions
(Dissolved oxygen levels of 4.11 mg/L and 41.3% saturation)

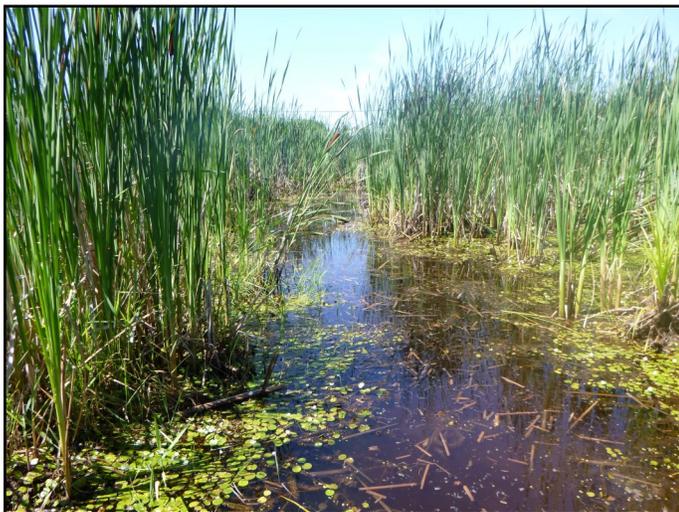
Section of Black Creek near Anderson Road with highly elevated levels of specific conductivity

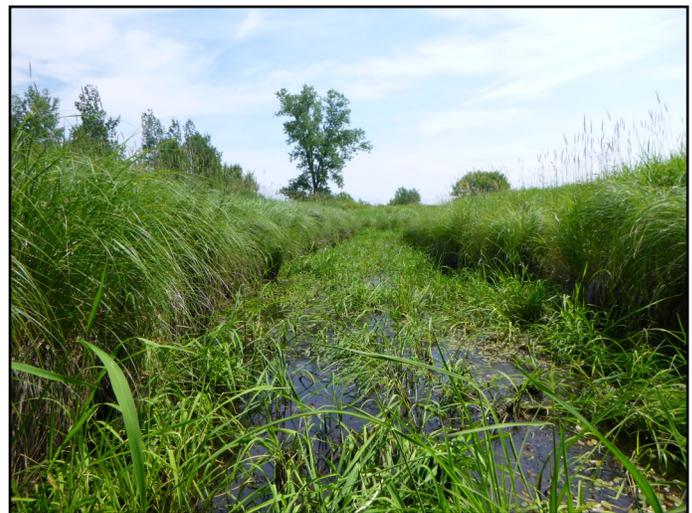
Section of Black Creek adjacent to agricultural fields with highly elevated levels of specific conductivity

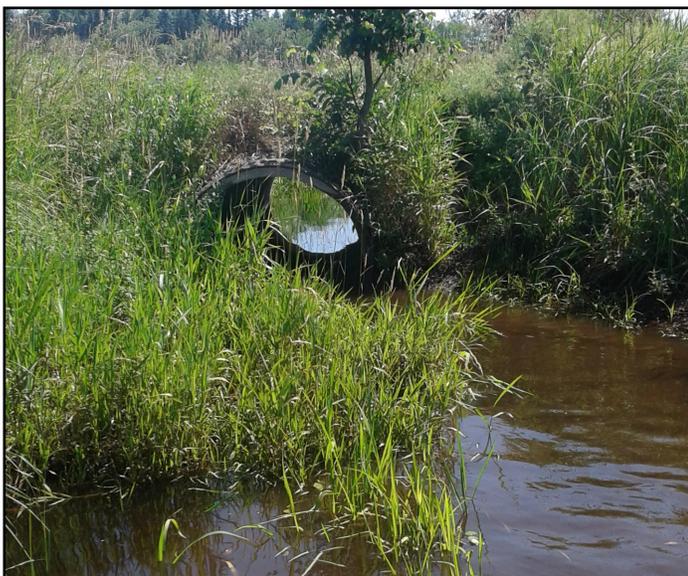
Perched culvert observed along Black Creek

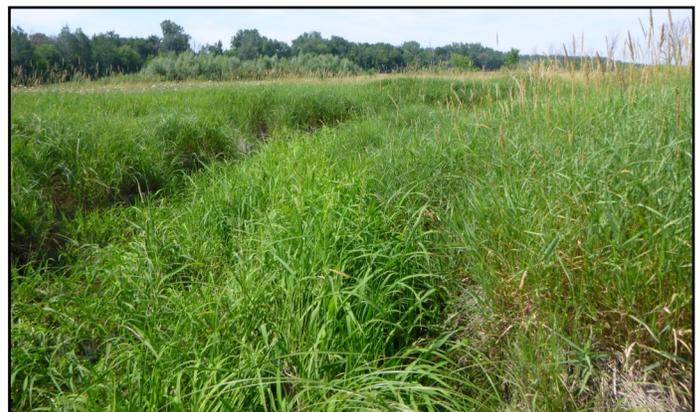
Area next to agricultural fields that could benefit from riparian planting along Black Creek.

Some sections of Black Creek riparian area can benefit from riparian planting. These sections run through an agricultural area, with minimal buffers between the stream and agricultural fields. Additional planting would increase shading, enhance wildlife habitat and reduce soil erosion.
