Cardinal Creek 2014 Summary Report

Introduction

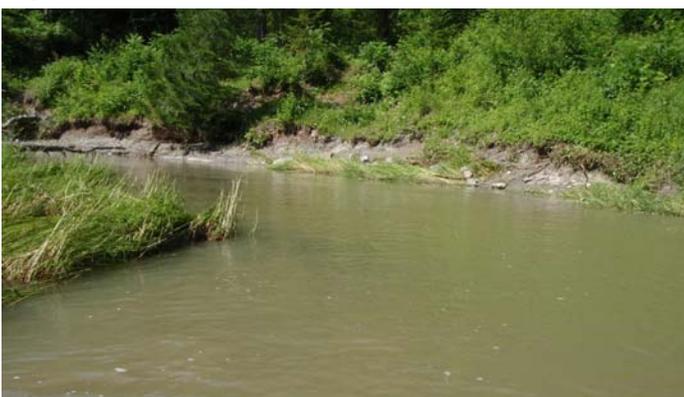
Stream bank erosion along Cardinal Creek

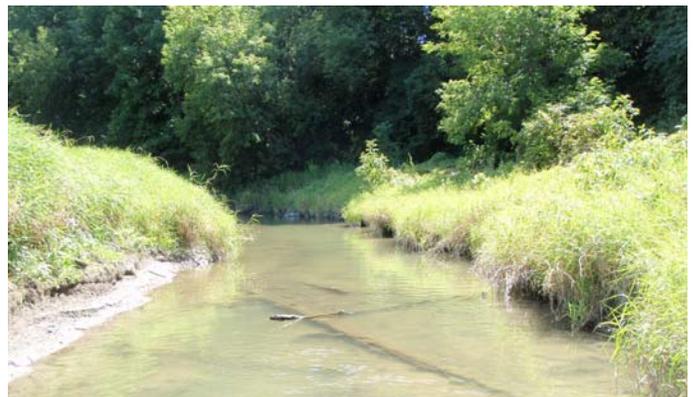
Bank undercutting along Cardinal Creek

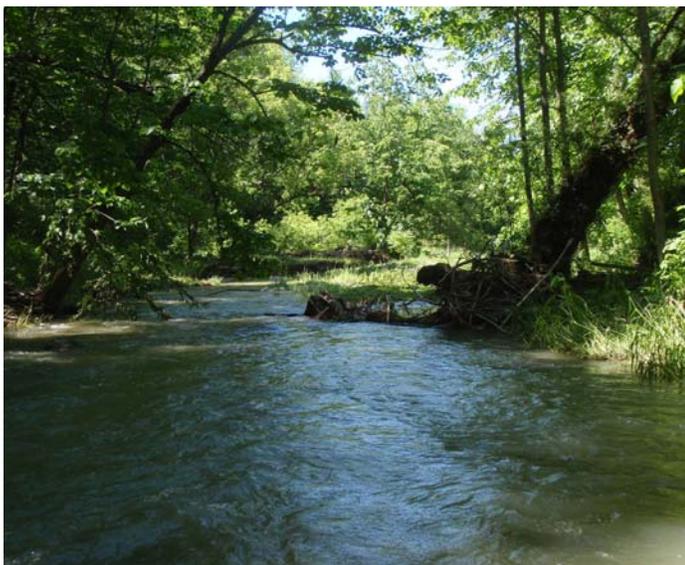
Stream shade along Cardinal Creek

Grasses, shrubs and trees all contribute towards shading a stream. Shade is important in moderating stream temperature, contributing to food supply and helping with nutrient reduction within a stream. Figure 6 shows stream shading along Cardinal Creek. Moderate levels of shading were seen along most of the creek. Some high levels of shading were observed in heavily forested areas near Old Montreal Road and in the upper reaches near O'Toole Road where the creek is shaded completely by overhanging grasses.

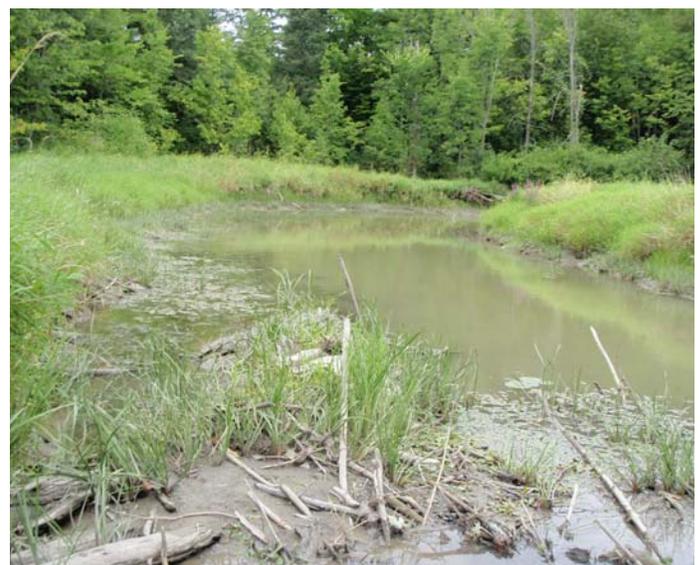
Instream woody debris along Cardinal Creek

Figure 7 shows that overall, the surveyed sections along Cardinal Creek had low to moderate levels of instream woody debris in the form of branches and trees. Instream woody debris is important for fish and benthic habitat, by providing refuge and feeding areas.

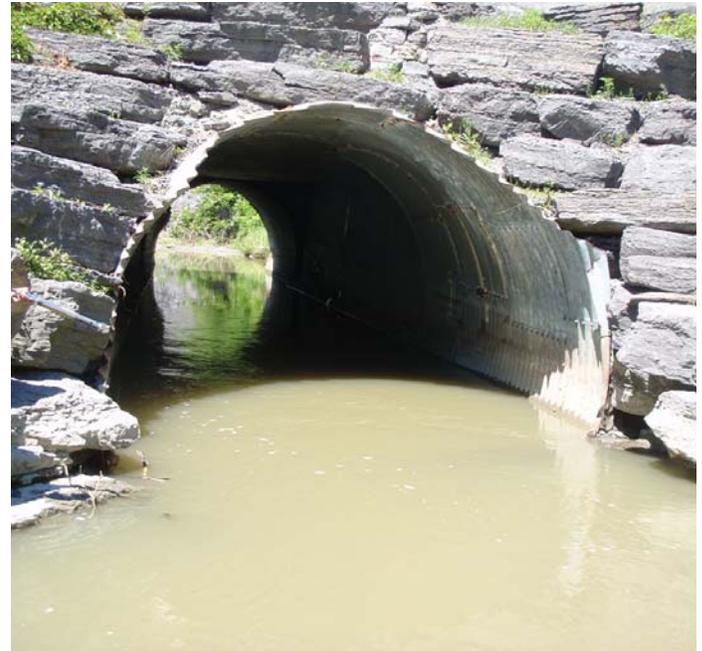
A highly altered section of CardinalCreek which runs through a culvert

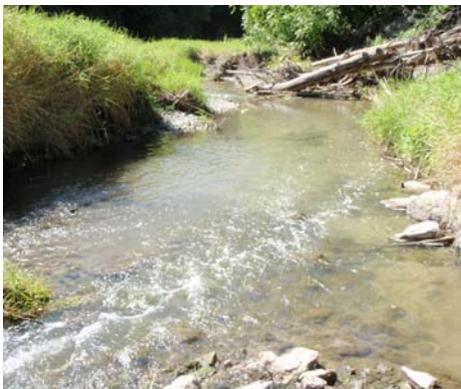
Habitat complexity on Cardinal Creek

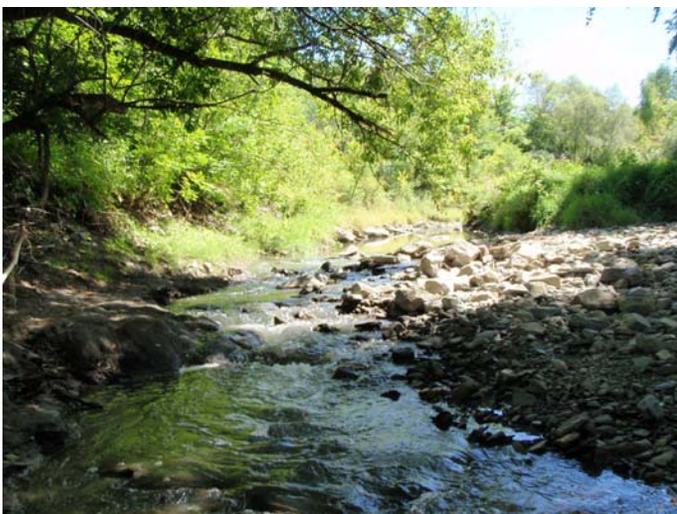
Cobble and boulder habitat observed along Cardinal Creek downstream of Old Montreal Road

Boulders create instream cover and back eddies for large fish to hide and/or rest out of the current. Cobble provides important over-wintering and/or spawning habitat for small or juvenile fish. Cobble can also provide habitat conditions for benthic invertebrates that are a key food source for many fish and wildlife species. Figure 13 shows the distribution of cobble and boulder habitat along Cardinal Creek. Areas of cobble and boulder habitat are concentrated around Old Montreal Road, Innes Road and in the upper reaches of the creek near O'Toole Road.

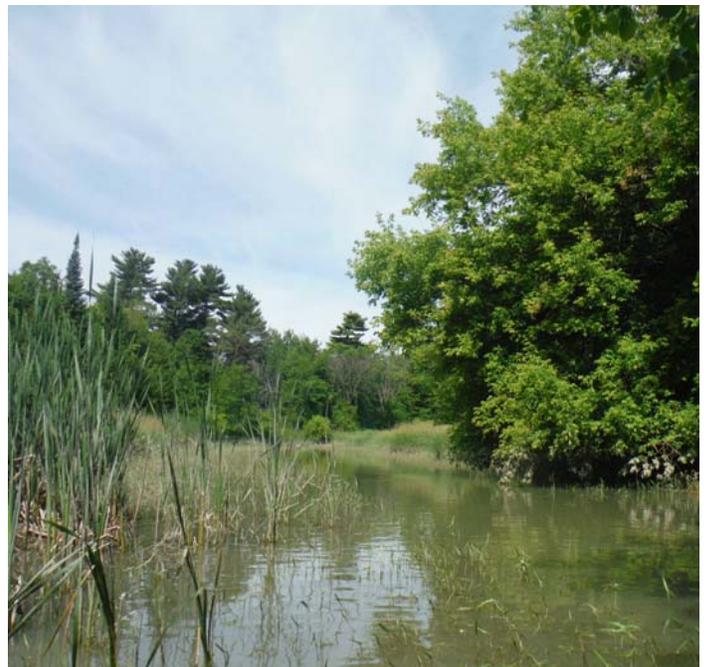
Narrow-leaved emergent vegetation observed on Cardinal Creek

Instream vegetation is an important factor for a healthy stream ecosystem. Vegetation helps to remove contaminants from the water, contributes oxygen to the stream, and provides habitat for fish and wildlife. Too much vegetation can also be detrimental. Figure 18 demonstrates that overall Cardinal Creek had low to normal levels of instream vegetation. Low levels accounted for 43 percent, normal levels accounted for 33 percent, common levels accounted for 12 percent and the remaining 11 percent were rare levels and no vegetation. The low levels of vegetation are the result of clay substrates and high flows in the system as most types of vegetation, other than algae, have trouble establishing root structure in these conditions.

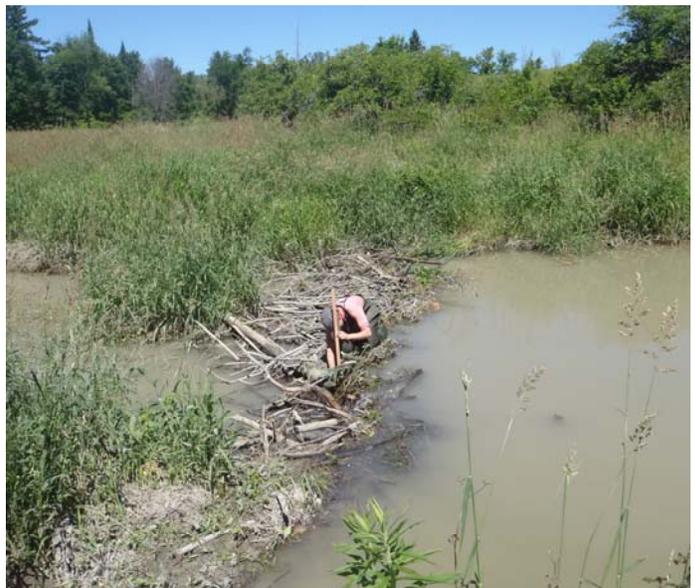
A volunteer measuring the head of a beaver dam

Beaver dams can also act as obstructions to fish migration. Figure 30 shows that three abandoned beaver dams were observed on Cardinal Creek downstream of Third Line Road. The head, or difference between the water level up and down stream, of the beaver dams ranged from 0 cm to 23 cm.

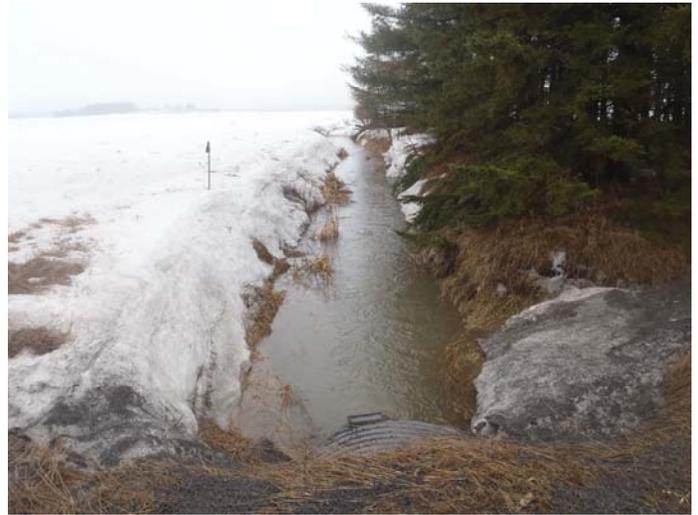
A headwaters site at French Hill Road during spring sampling in April

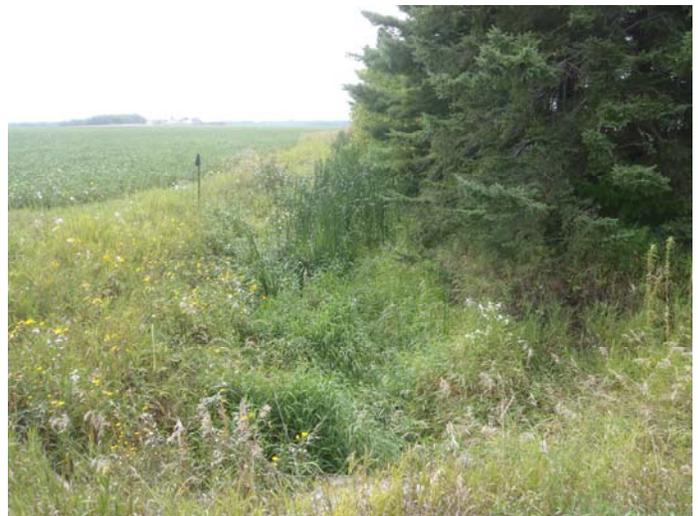
The same site at French Hill Road in August

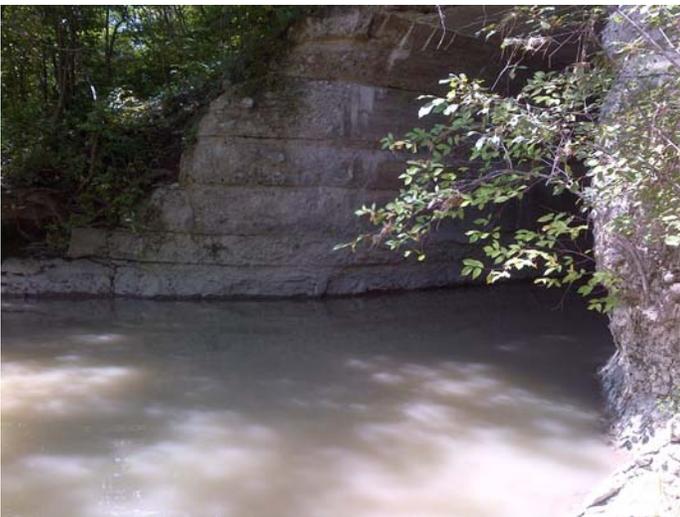
An anthropogenic alteration to Cardinal Creek that was observed in 2008 and 2014

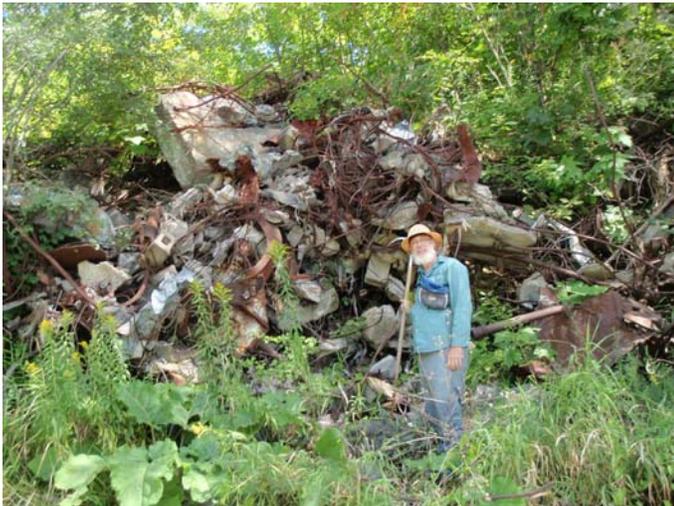
A debris pile found along Cardinal Creek

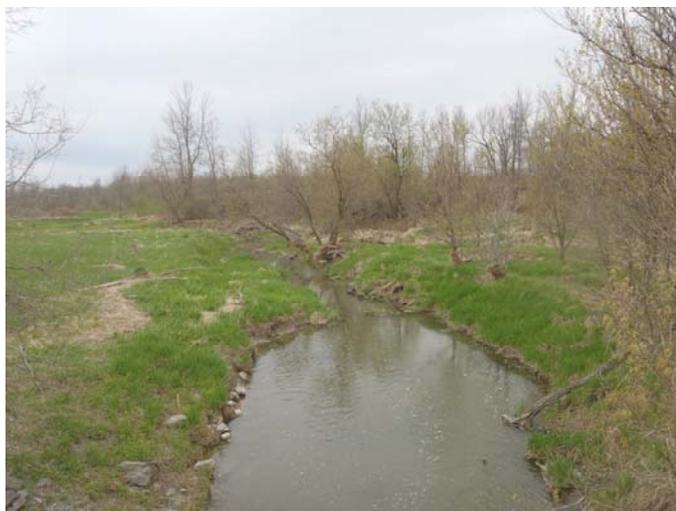
Riparian planting opportunity along Cardinal Creek downstream of Innes Road

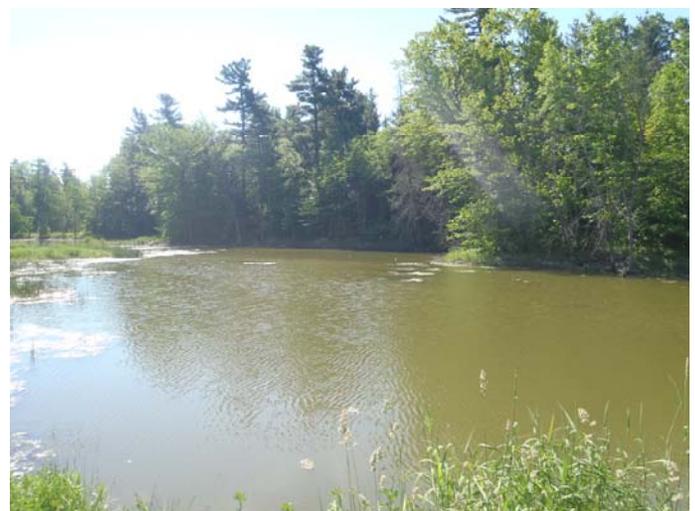
Retention pond upstream of Watters Road where garbage accumulates after rain events
