McEwan Creek 2016 Summary Report

Introduction

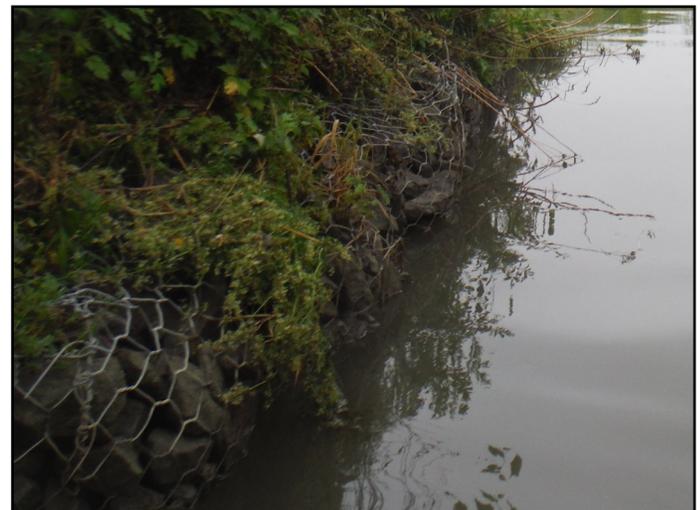
Erosion control measures (ie. gabion baskets) along McEwan Creek

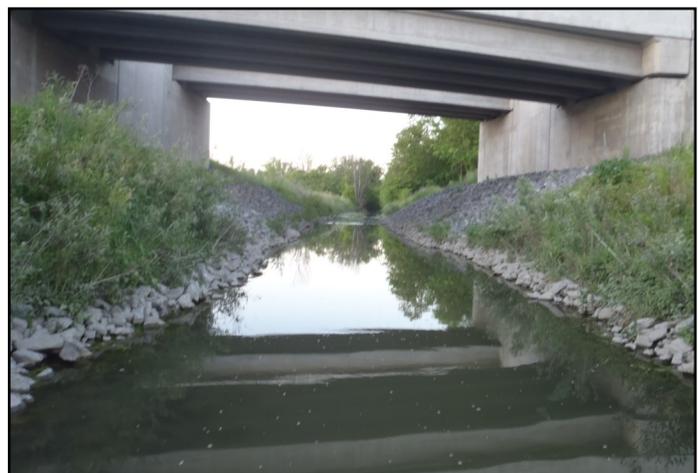
Heavily modified stream section along McEwan Creek

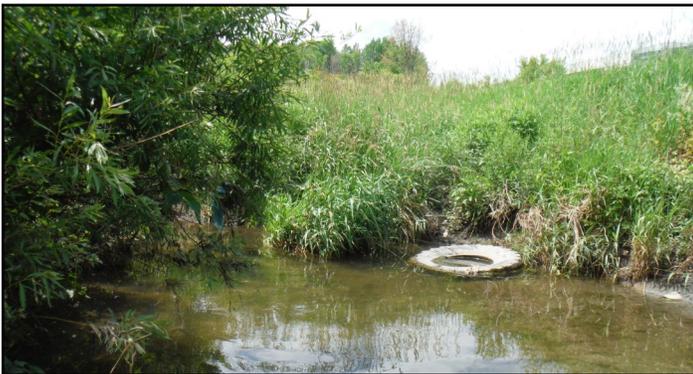
Pollution observed along McEwan Creek

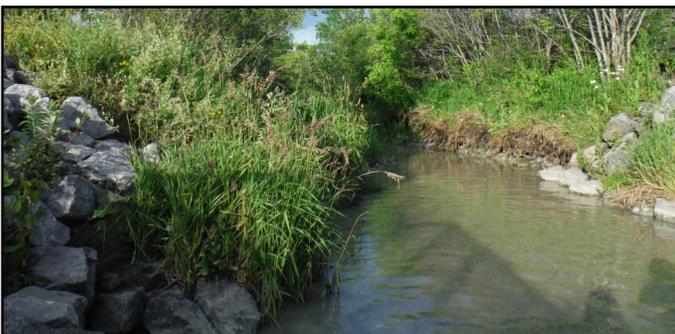
Site on McEwan Creek with poor oxygen conditions (Upstream of Hunt Club Rd)

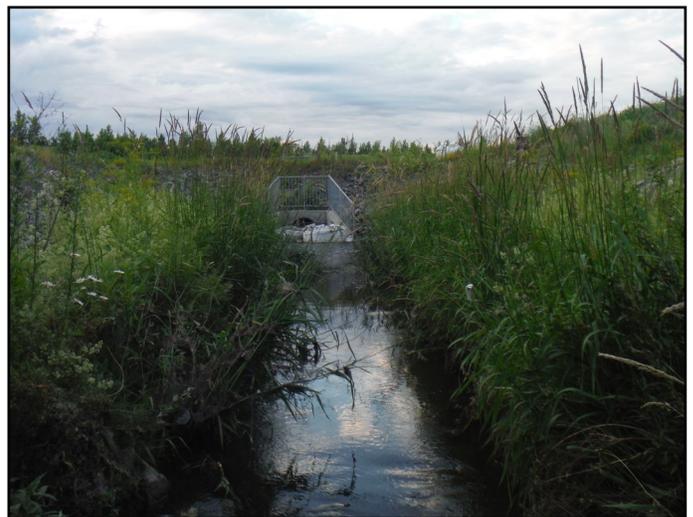
Storm water outflow with elevated conductivity and reduced oxygen conditions

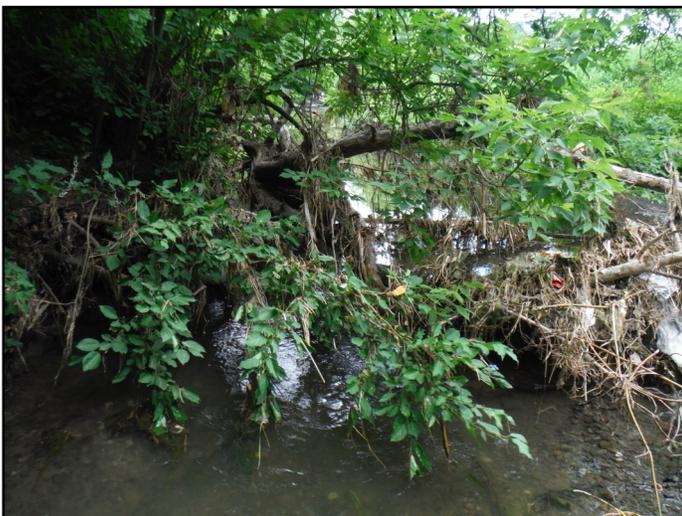
Debris dam observed in McEwan Creek

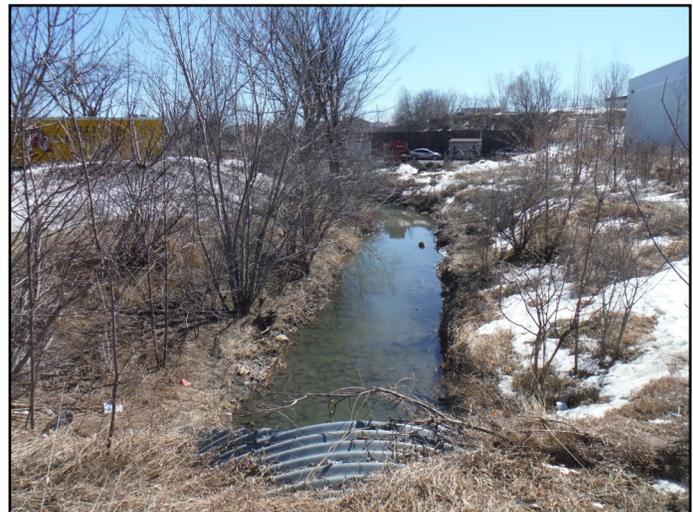
Channel straightening along the Mather Award drain (Ages Dr)

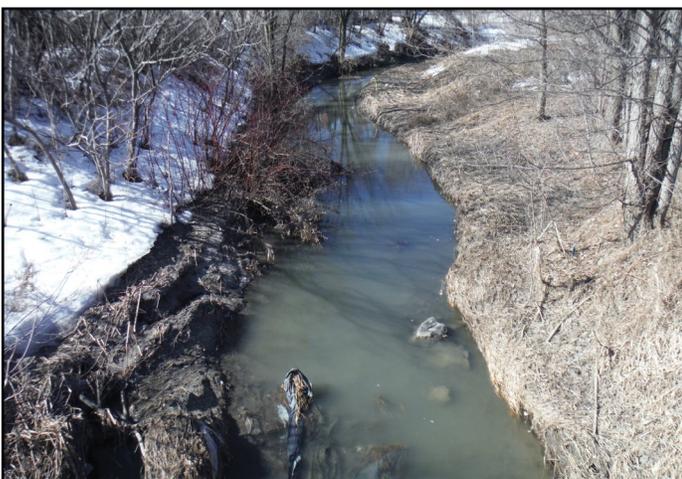
Extensive sediment deposition observed along the Mather Award drain (Overton Dr)
