# Graham Creek 2016 Summary Report

Graham Creek is located in the west Nepean region, and outflows directly into the Ottawa River at Andrew Haydon Park. The stream conveys flows from the Stony Swamp wetland, with active influences from agriculture and urban development. Graham Creek flows through multiple urban communities including, Trend-Arlington, Briar-Green Leslie Park, Qualicum and Bayshore neighbourhoods. The majority of Graham Creek has been modified to control flooding and erosion, with several piped sections and extensive channel hardening/straightening throughout. In an evaluation conducted by *Niblett Environmental Associations, Inc* (1991), it was estimated that only 500m of stream has remained unaltered.

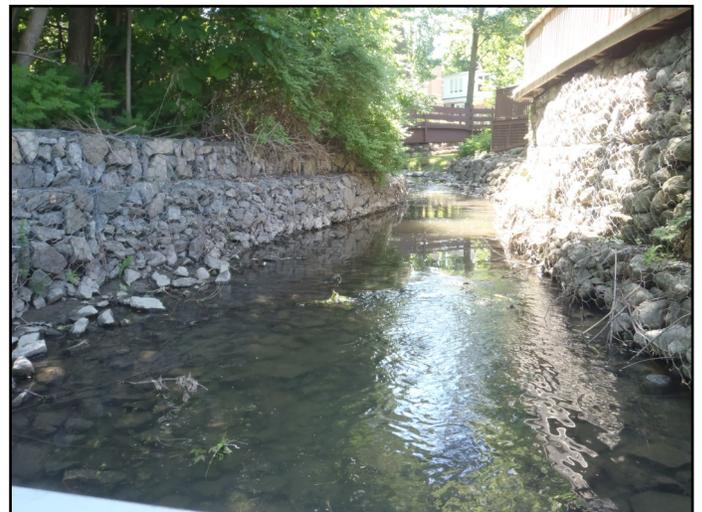
Erosion control measures (ie. gabion baskets) along Graham Creek

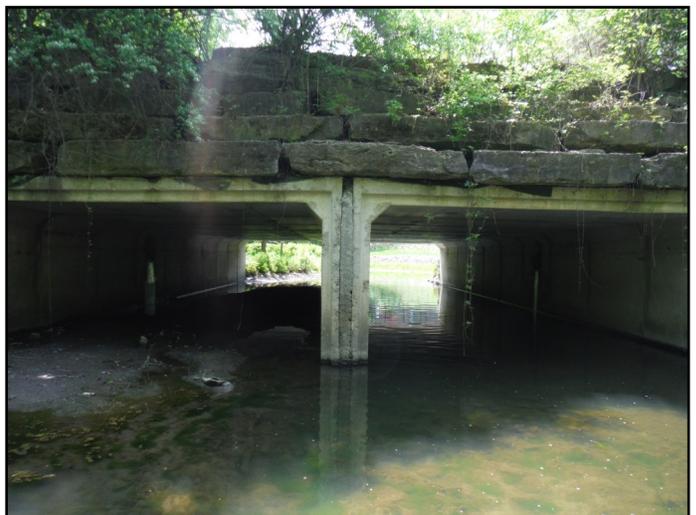
Heavily modified stream section along Graham Creek

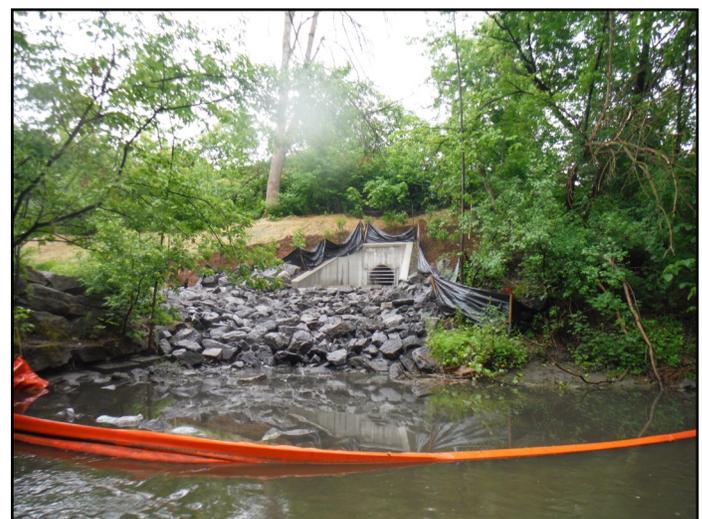
Storm water outlet with elevated conductivity and reduced dissolved oxygen conditions

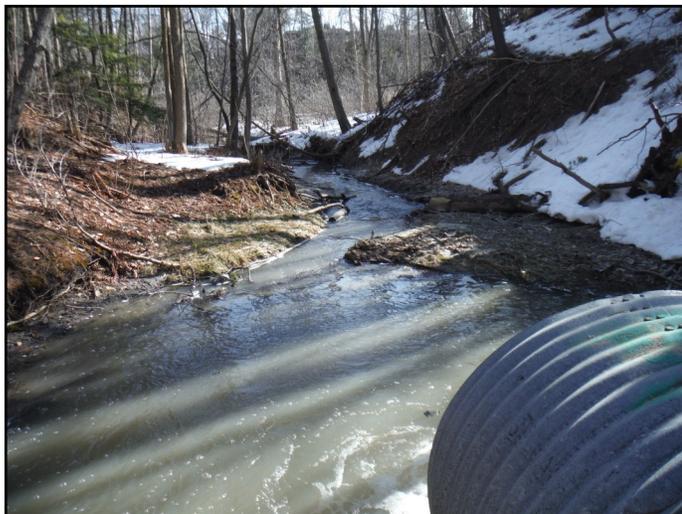
A perched culvert observed along a tributary of Graham Creek

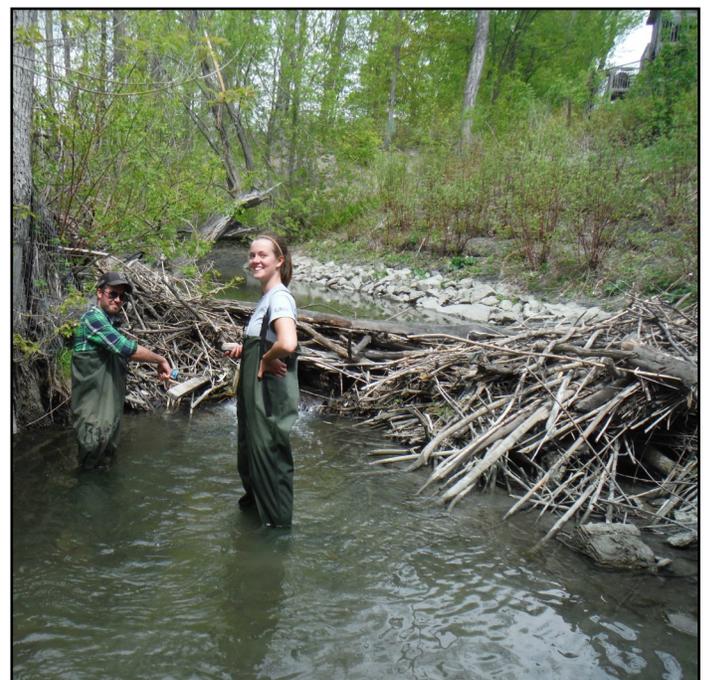
Active beaver dam observed on Graham Creek

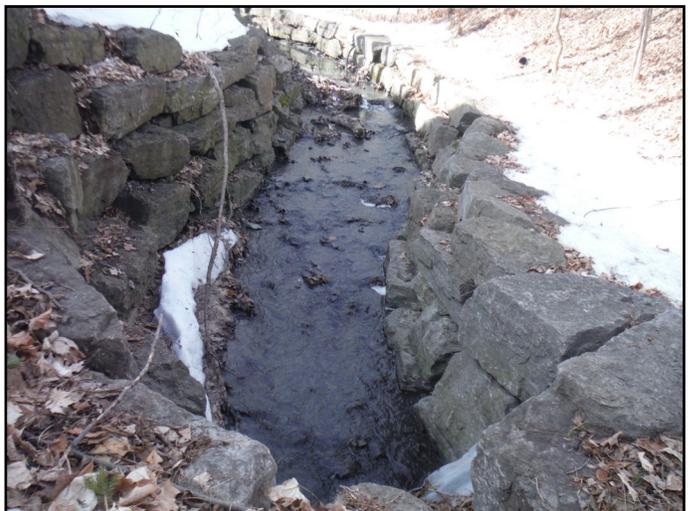
Highly modified headwater feature along Cowitchan Way

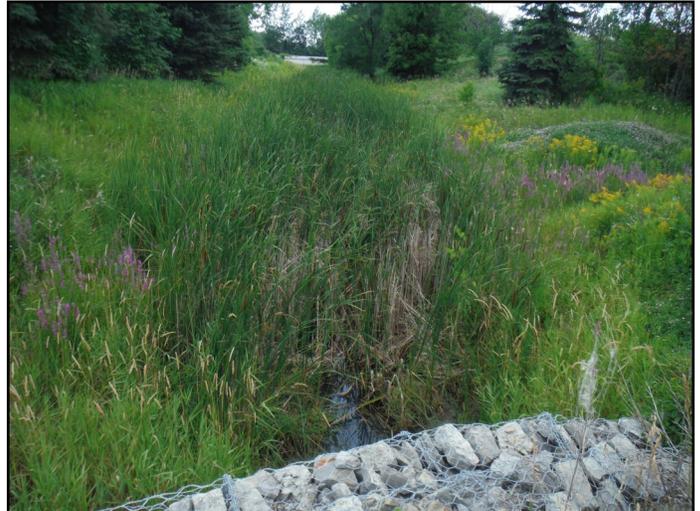
Headwater feature with extreme roughness conditions along Cedarview Rd

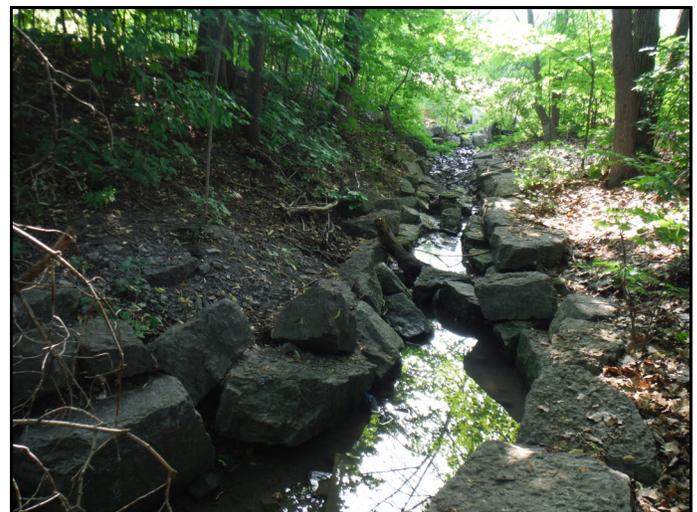
Unstable flow conditions and failed gabions were noted upstream of Banner Rd and may be due to regular debris accumulation within the culverts.

Bank wall failure along a tributary to Graham Creek
