Brassils Creek 2016 Summary Report

Introduction

In 2016, the City Stream Watch conducted surveys on 54 sections (5.4 km) of Brassils Creek. The following is a summary of our observations and assessment within this region.

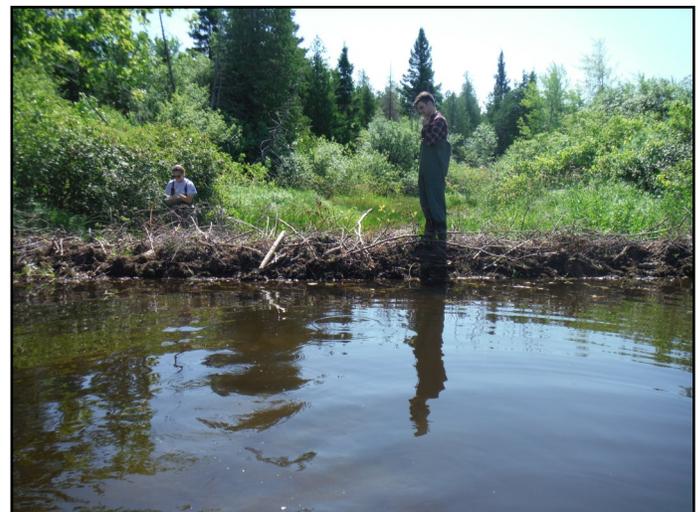
Beaver dam on Brassils Creek with depleted oxygen conditions

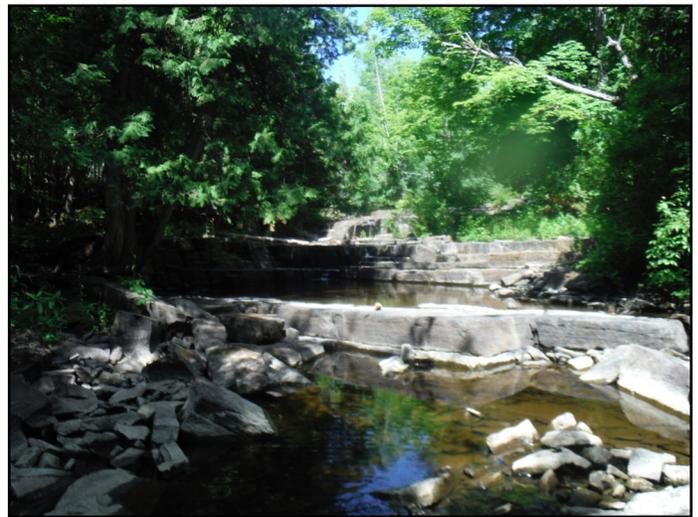
Stepping-stone falls (Brassils Creek—Summer 2016)

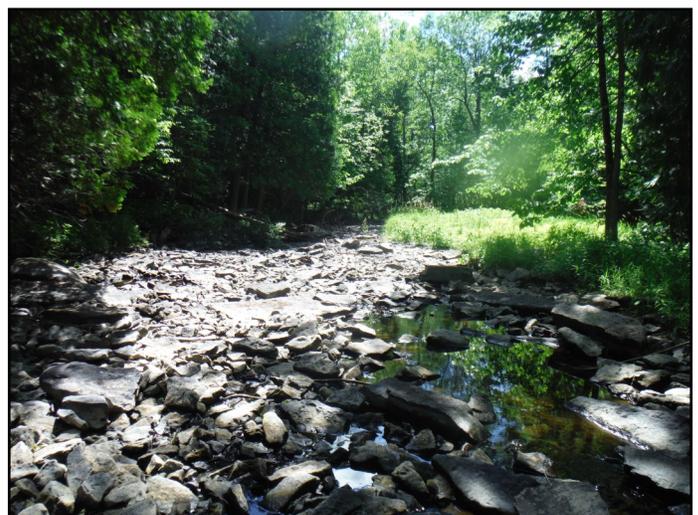
Upstream of Dwyer Hill Rd (Brassils Creek—Summer 2016)
