# Watershed Conditions Report

January 2024

# **The Rideau Valley:**

An Ever-Changing Watershed

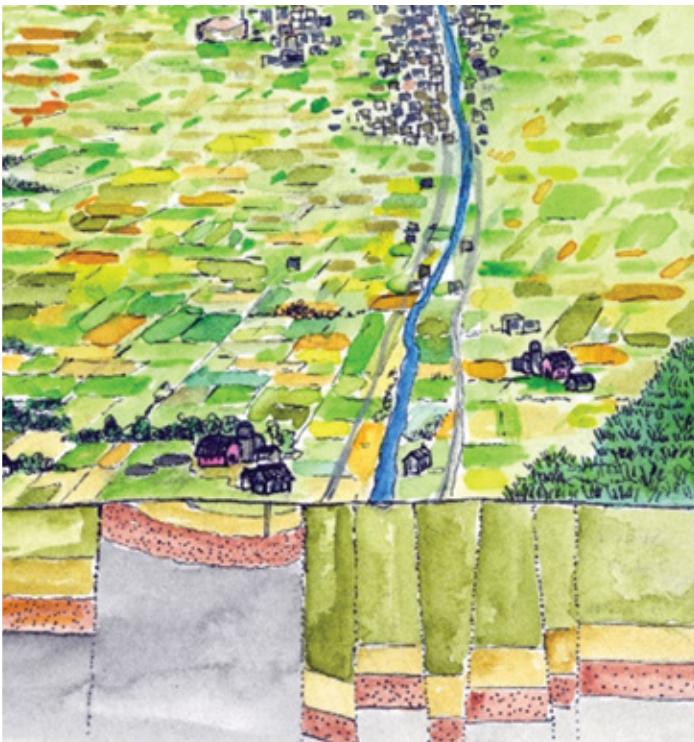
**FIGURE 1.5** Artist's interpretation of the faulted sedimentary rock layers that underly the Smiths Falls Limestone Plain above Ottawa.

The Middle Rideau rests atop the flat Smiths Falls Limestone Plain. It is a broad, wet, and scrubby expanse made up of layered sedimentary rock aquifers that include sandstones, limestone-like rocks, and some shale. These thick rock layers rest upon the Precambrian Shield, which forms the basement. Across the plain, soils are of various types and depth but generally thin or,

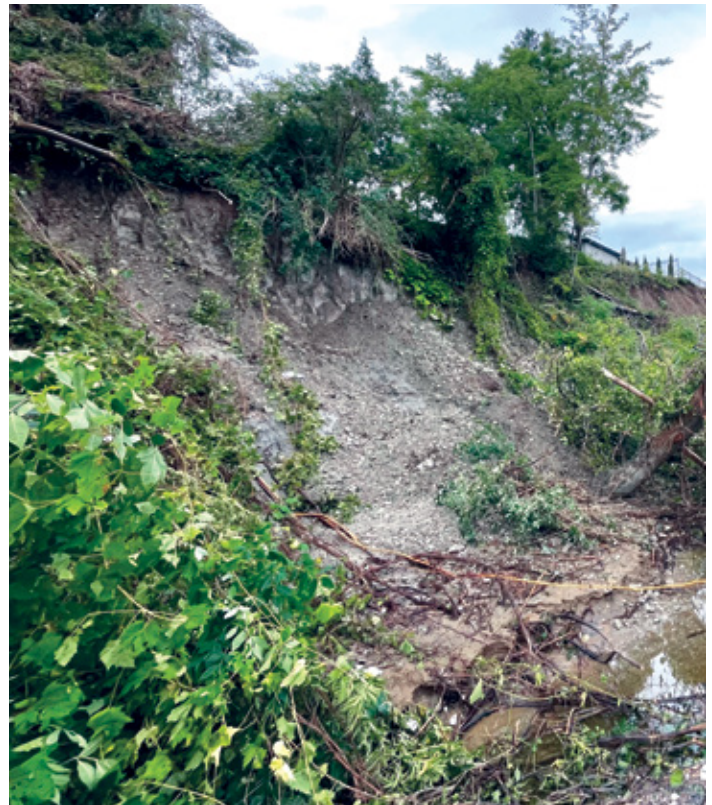
▲ An erosion event along the Rideau River shoreline in Ottawa in 2021. Erosion often looks like undercut banks with the soil exposed. A recent issue of major concern occurred in 2017 along Bilberry Creek, where three homes had to be temporarily evacuated until emergency slope stabilization efforts were completed.

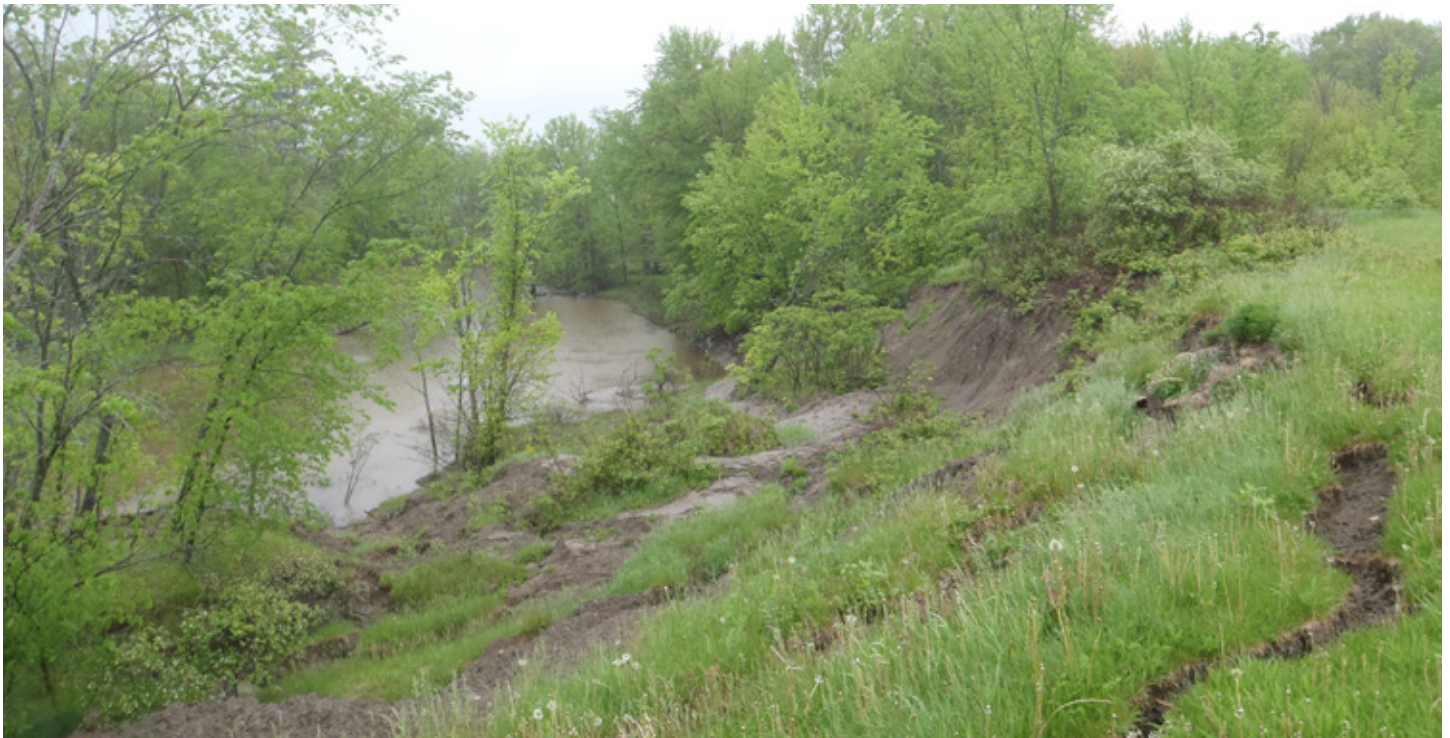
▲ A recent landslide scar can be seen along Becketts Creek in Orleans, City of Ottawa.

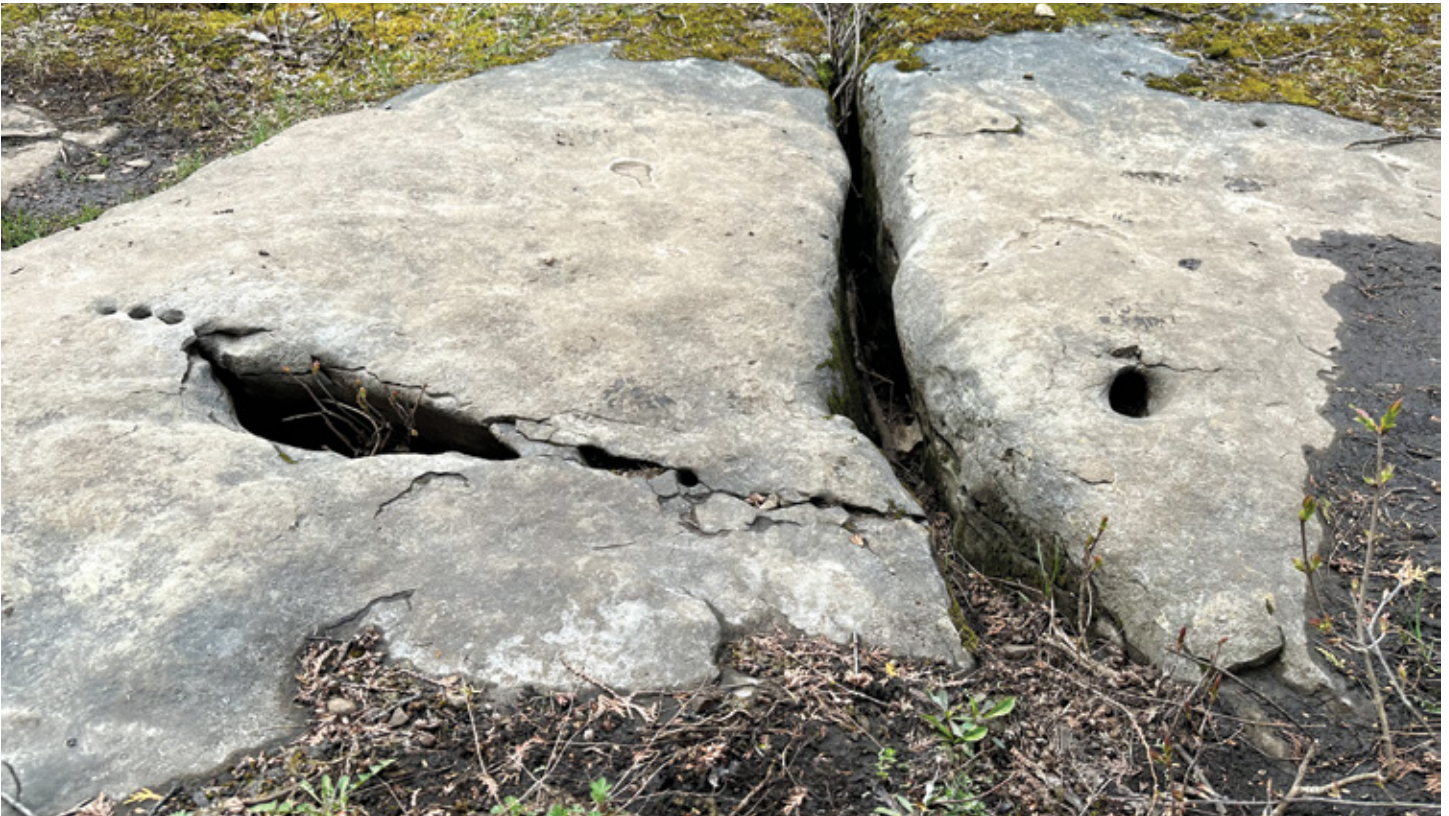
▲ Karst along the National Capital Commission's Lime Kiln Trail off Moodie Drive in Ottawa.

Karstic limestone has the potential to become hazardous land since well-developed karst can cause the bedrock to fail and therefore be unable to support structures. Fortunately, the direct risk from the collapse of karstic limestone is almost absent across our watershed. The Cardinal Creek watershed has exhibited the most significant issue, where “breakdown collapse” features have formed along Watters Road in Orleans, which is unique in the province.
