# City Stream Watch

## 2005 Annual Report

Grant Nichol  
City Stream Watch Coordinator  
Rideau Valley Conservation Authority

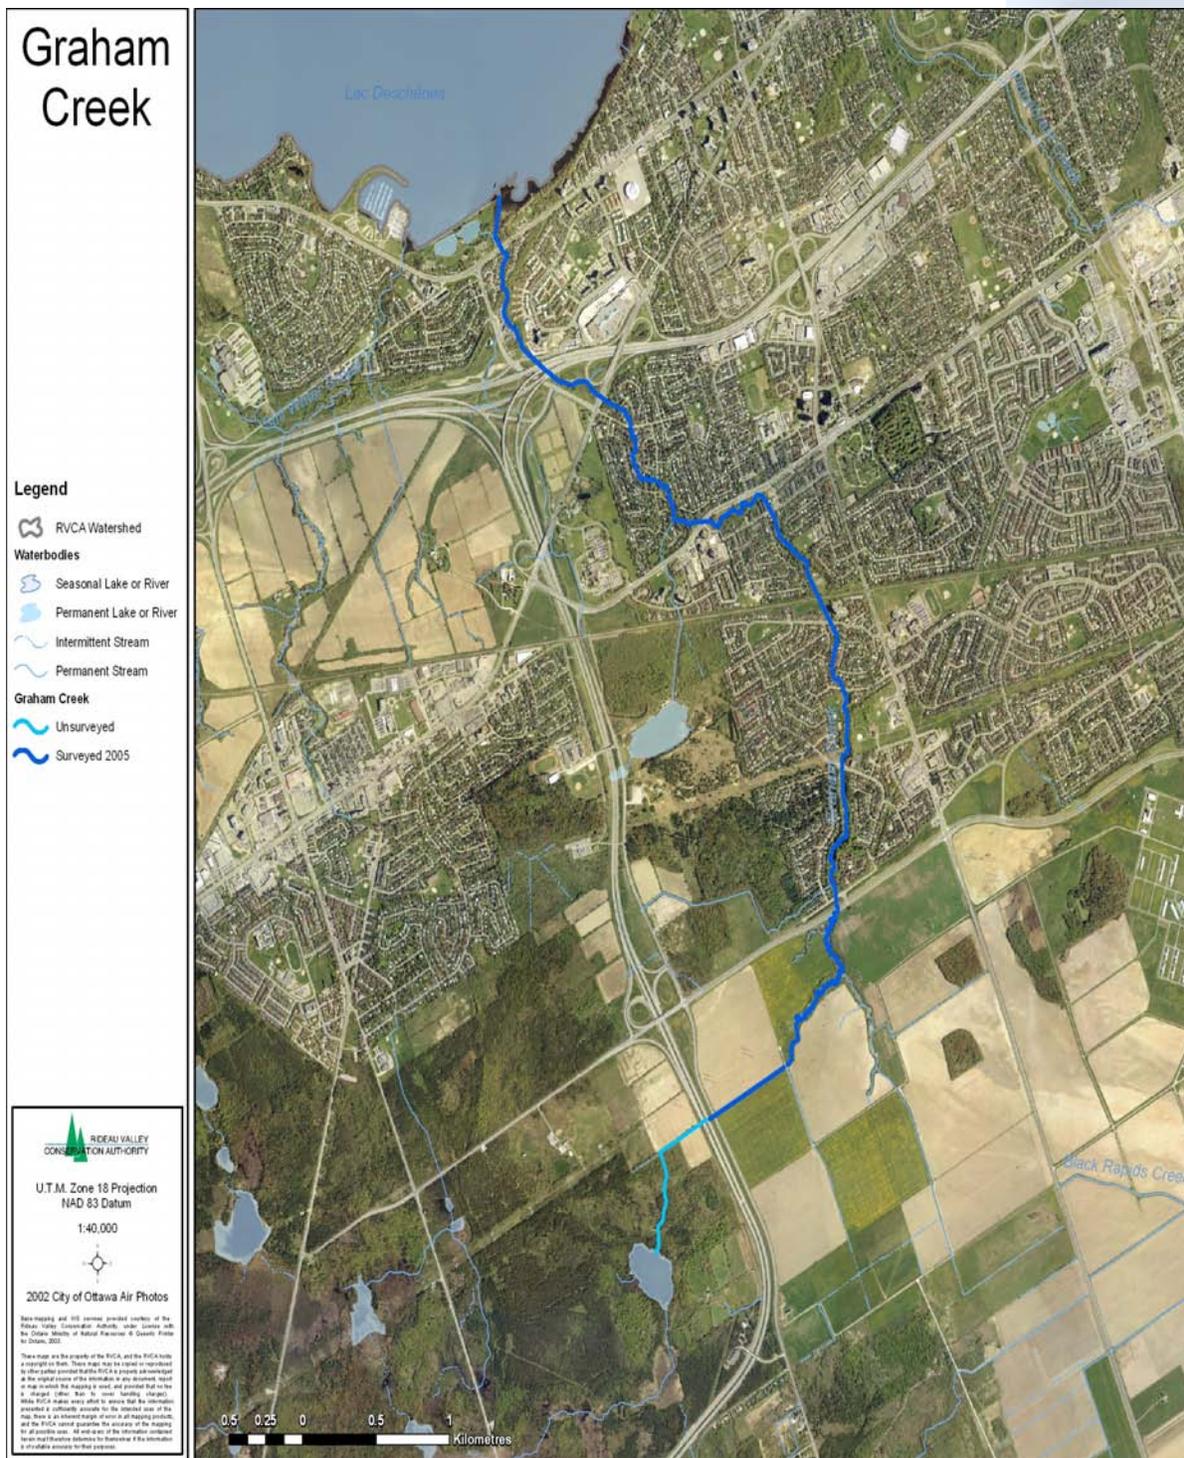
Figure 2. Air photo of Graham Creek and surrounding area.

Graham Creek is approximately nine kilometres long, and flows from Highway 416, just south of Hunt Club Road through the Canadian Food Inspection Agency farm and works its way through residential areas before entering the Ottawa River at Andrew Haydon Park. Figure 2 shows air photos taken of the Graham Creek area in 2002.

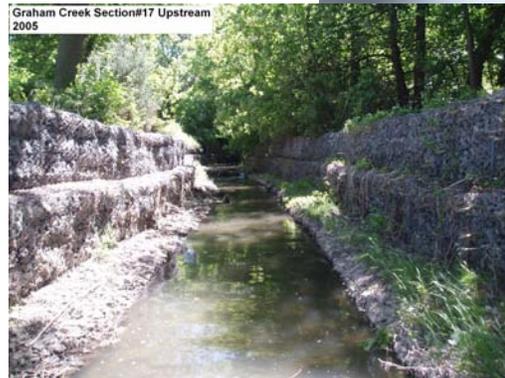
Figure 8. Bank stability of Graham Creek.

The level of bank stability indicates the occurrence of the removal of soil from the bank into the stream. High levels of bank instability can greatly contribute to the amount of sediment carried in a waterbody as well as the loss of bank vegetation in the form of bank failure, resulting in trees falling into the stream. Excessive erosion and deposition of sediment within a stream can have detrimental affects on fish and wildlife habitat. Figure 8 shows the overall bank stability of Graham Creek. Evidence of erosion on the stream bank was observed along 29% of the shoreline, coinciding with areas of little or no vegetation. The high percentage of stable banks can be attributed to the floodwater prevention system of gabion cage lining the banks of the stream in most residential areas. Though gabion cage secures the bank structure they have a tendency to fail and require repair. Gabion structures also create a steep vertical interface between the terrestrial and aquatic ecosystems along a stream, which can negatively impact fish and wildlife. Natural shoreline bioengineering projects such as brush bundles, fascines, live cribwalls and live cuttings are now the preferred option as they require little maintenance and promote the regeneration of vegetation to further stabilize the bank.

Areas of erosion have been identified on an aerial photo of Graham Creek and can be found in Appendix H. This information includes a percentage of the 100m site which is eroded.

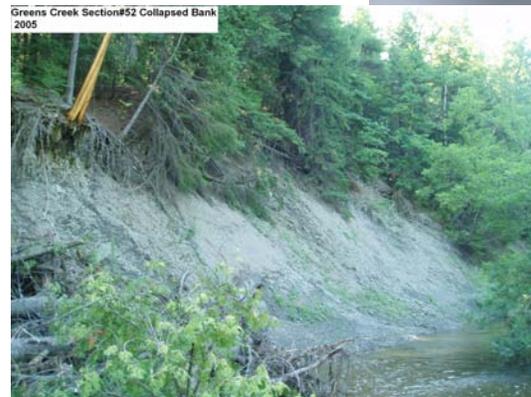
**Figure 16. Bank stability of Greens Creek.**

Figure 16 demonstrates the overall bank stability of Greens Creek. Evidence of erosion from the stream bank was observed along 51% of the shoreline, coinciding with areas of little or no vegetation. Many failed banks where trees have fallen into the stream were observed. Greens Creek is a natural flowing stream, with little urban/commercial disturbance, so it can be said that most of this erosion is natural. Spring high flows and extended rain events can account for this natural erosion.

Areas of erosion have been identified on an aerial photo of Greens Creek and can be found in Appendix H. This information includes a percentage of the 100m sites, which are eroded and will prove useful for rehabilitation opportunities.

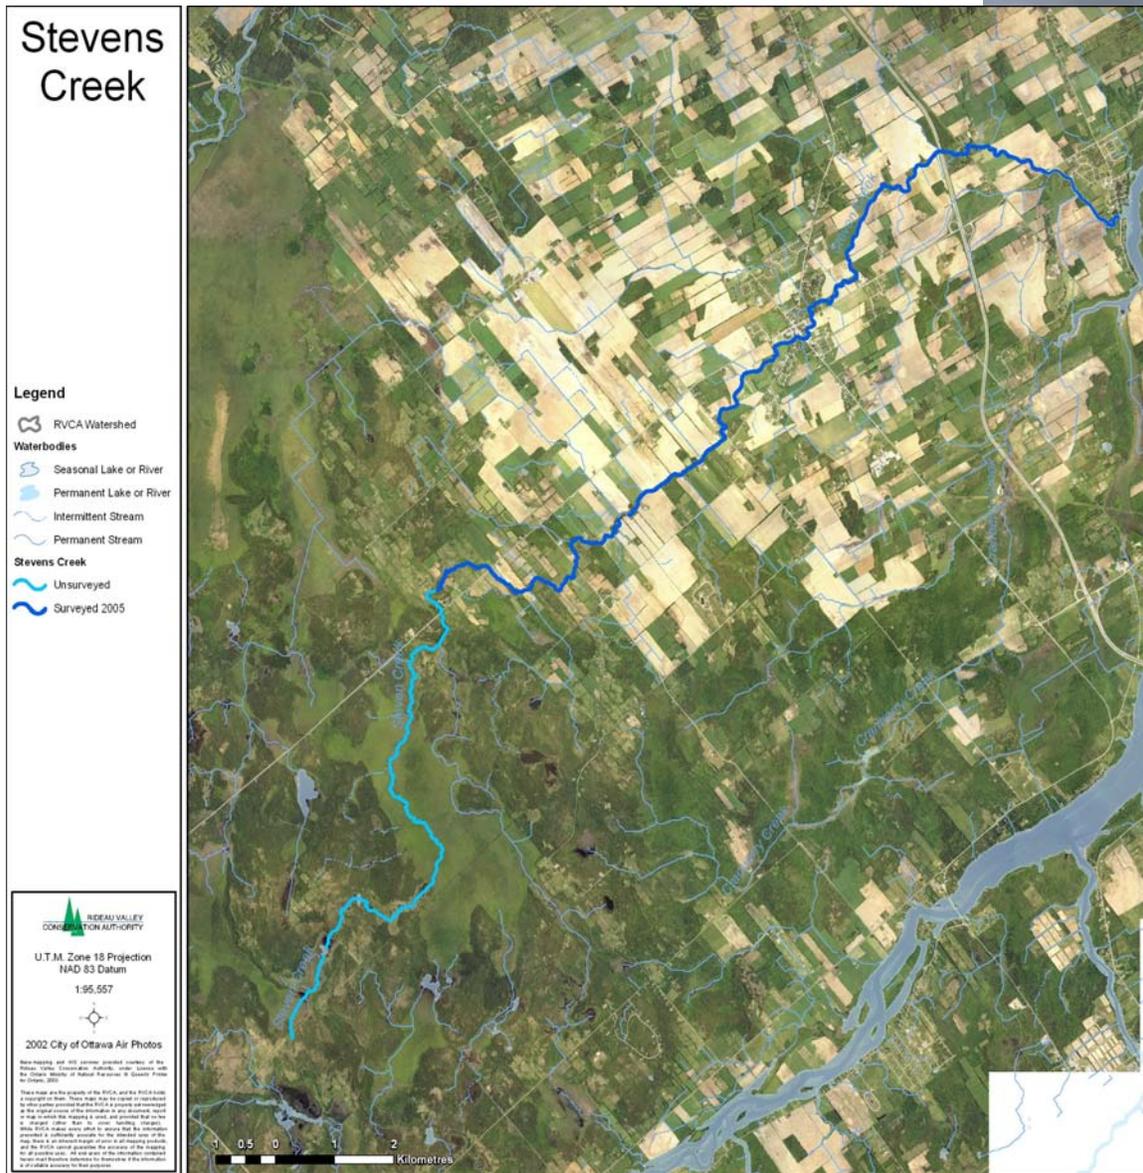
**Figure 26. Air photo of Stevens Creek and surrounding area.**

Stevens Creek is approximately 25 kilometres long, flowing through mainly agricultural land and the town of North Gower before entering the Rideau River in Kars. Figure 26 shows air photos taken of the Stevens Creek area in 2002.

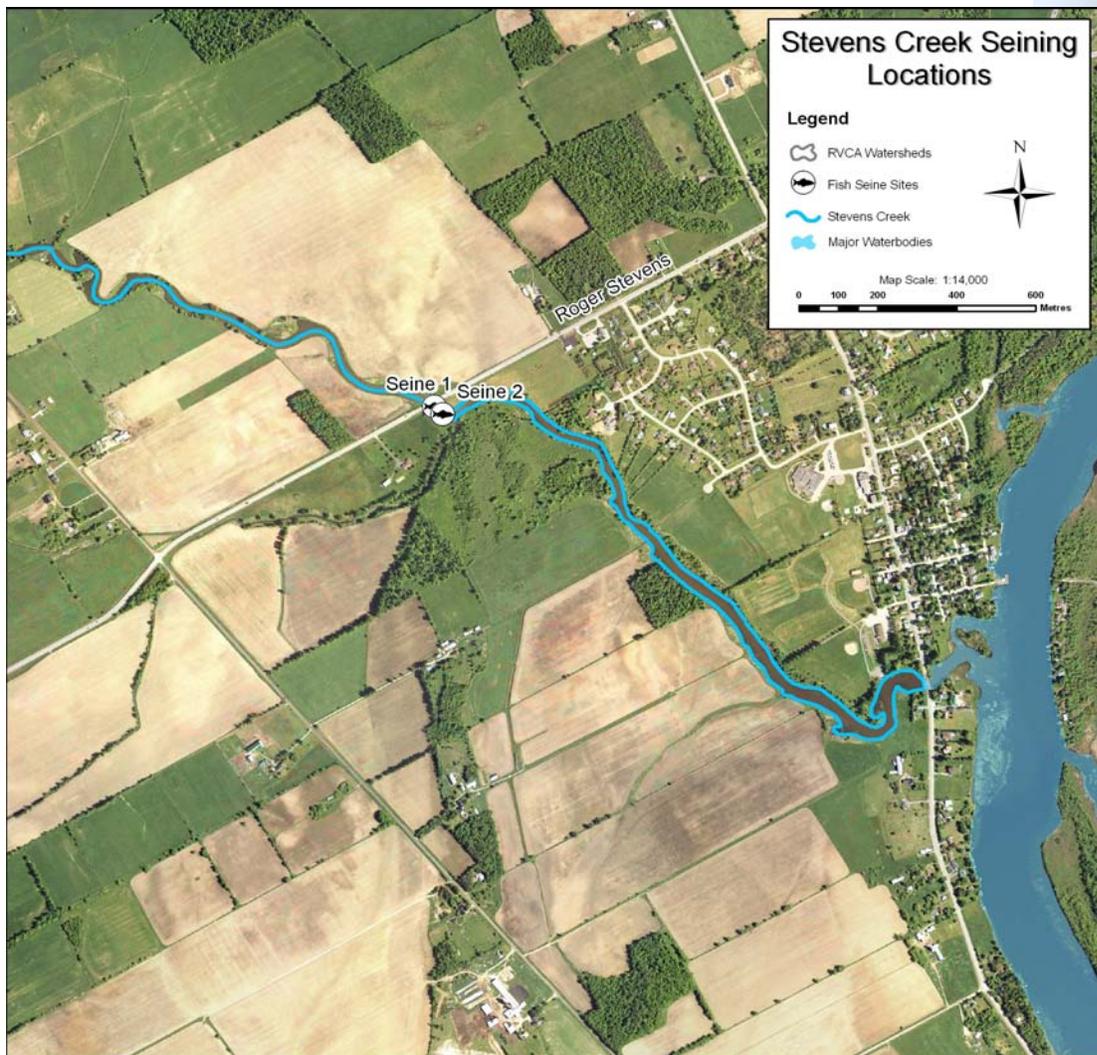
Figure 36 – Seine Net sites on Stevens Creek

Two seining events were held on Stevens Creek in July. This creek proved difficult to net due to its steep banks and dense aquatic vegetation. Figure 36 shows the location of the sampling sites, and Table 12 is a summary of the fish caught in Stevens Creek.

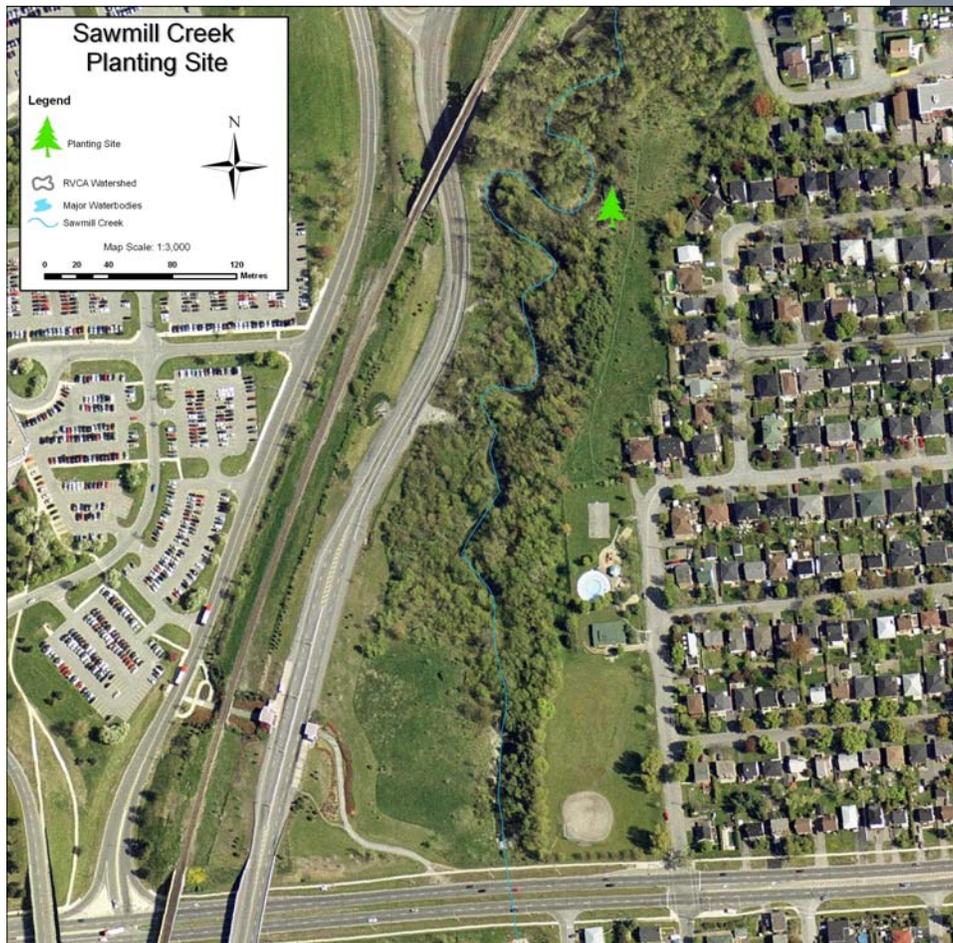
Figure 39- Sawmill Creek Planting Site in Heron Park

Based on recommendations of the 2004 annual report, a spring tree plant was carried out on a failed bank in the Heron park area. Figure 39 shows the area which was planted, just north of Heron Rd.

The riparian tree plant on Sawmill Creek at Heron Park was a successful event. Two collaborative members, City Councillor Clive Doucette and 4 volunteers from the Heron Park area, successfully planted 200 Red Osier, 100 White Spruce and 50 Red Elderberry along the failed bank on the east side of Sawmill Creek. A mulch trail was also re-routed past the site to help steer foot traffic around the bank to help the top of the bank colonize with vegetation once again.

The section was reevaluated in the summer to observe how well the trees took to the soil. The planted trees did well although few trees were planted on the top ridgeline of the bank. Therefore, proposed for the spring of 2006, is Phase II of the Sawmill Creek plant which will focus on the upper portion of

the bank. Two other failed banks have been identified just downstream and will be planted in the spring of 2006.

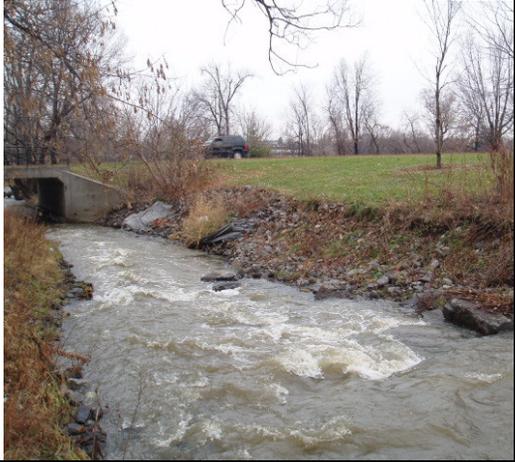
Location	Issue	Picture	Remediation Strategy	Expected Results
<p>The mouth of Sawmill Creek where it empties into the Rideau River near Billings Estate just east of the corner of Bank Street and Riverside Drive. Approximately 150m section of creek not including infrastructure.</p>	<p>The rock rubble that was used to armour the banks has failed at this site. The banks have failed, and much of the geotextile has been left exposed. The resulting erosion and deposition of the silty clay material from the banks is causing the deterioration of walleye spawning habitat at the mouth of the creek.</p>

<p>Utilize existing volunteer base of the City Stream Watch program to participate in this rehabilitation effort. A combination of several bio-engineering systems (live staking, live fascines, and bare root shrubs) should be applied along the slope. The toe of the slope requires protection against undermining and resultant slumping with appropriate sized rock rubble due to flashy flows.</p>	<ul style="list-style-type: none"> <li>• Effective stream bank protection;</li> <li>• Community involvement</li> <li>• Reduce siltation of existing walleye spawning habitat;</li> <li>• The enhancement of conditions for natural colonization of existing plant community;</li> <li>• Produce streamside fish and wildlife habitat.</li> </ul>

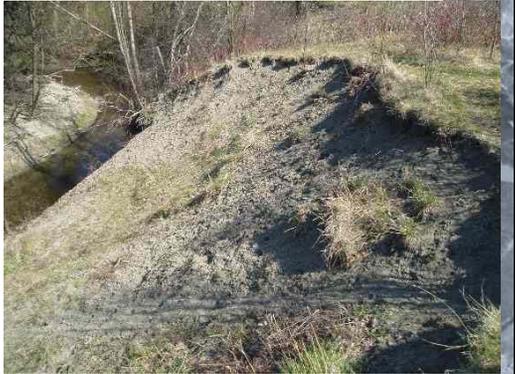
Location	Issue	Picture	Remediation Strategy	Expected Results
<p>Sawmill Creek just North of Heron Park Community Centre (Heron Rd.). One failed bank as well as three bank slumps upstream.</p>	<p>PHASE II The planting site on Sawmill creek hopes to further rehabilitate a failed bank on the east side of the stream just north of Heron Rd. Phase I was carried out in May of 2005 in hopes to stabilize bank. The lower sections of bank, close to the stream did well throughout the growing season although the higher portions did not due dry conditions. In May of 2006 we will plant more vegetation on the top section of the bank failure as well as fill in necessary sections in the lower section that may have been wiped out due to spring flows. Three additional bank slumps have been identified upstream and will be planted in the Phase II rehabilitation project.</p>

<p>Utilize existing volunteer base of the City Stream Watch program and residents from the Heron Park area to participate in this rehabilitation effort. Interested members can monitor progress of areas planted and report back to the coordinator with updates.</p>	<ul style="list-style-type: none"> <li>• Promote community involvement in rehabilitation projects</li> <li>• Enhancement of fish and wildlife habitat;</li> <li>• Enhancement of the creek’s aesthetic qualities.</li> <li>• Erosion control</li> </ul>

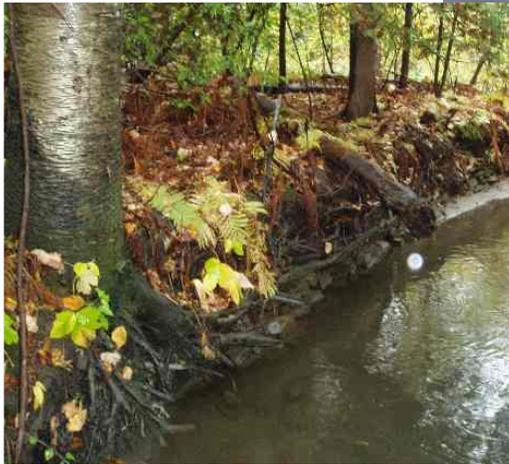
Location	Issue	Picture	Remediation Strategy	Expected Results
<p>Graham Creek shoreline in between Acres Rd and Carling Ave.</p>	<p>High water is eroding banks causing them to fail resulting in trees falling into stream. Landowners are worried that stream erosion may encroach on their land.</p>

<p>Utilize existing volunteer base of the City Stream Watch program to participate in this rehabilitation effort. Plant shrubs and trees to stabilize banks to help stop erosion.</p>	<ul style="list-style-type: none"> <li>• Community involvement</li> <li>• Enhancement of fish and wildlife habitat</li> <li>• Reduce erosion of banks</li> <li>• Eliminate possibility of bank failure causing tree collapse into stream</li> </ul>
Location	Issue	Picture	Remediation Strategy	Expected Results
<p>Many sections of Sawmill Creek (South Keys Shopping Area of primary concern)</p>	<p>The accumulation of garbage and refuse along various stretches of Sawmill Creek is a ongoing problem. Not only does man made pollution take away from the aesthetic quality of the stream but it limits and degrades fish and wildlife habitat.</p>

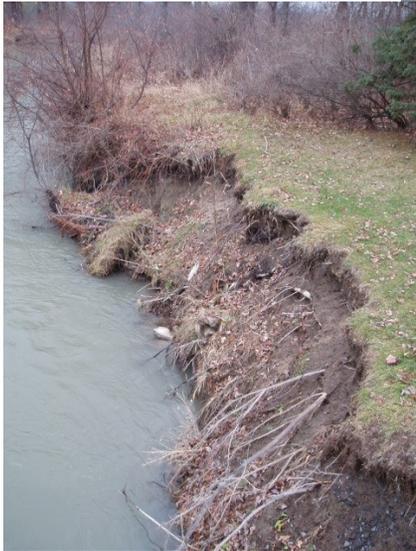
Location	Issue	Picture	Remediation Strategy	Expected Results
<p>Graham Creek at Andrew Haydon Park. On right bank just downstream from bridge.</p>	<p>High water is eroding banks causing banks to fail and trees to fall into stream. Siltation can be affecting fish spawning and nursery habitat.</p>

<p>Utilize existing volunteer base of the City Stream Watch program and recruit volunteers from neighbouring communities to participate in this rehabilitation effort.</p>	<ul style="list-style-type: none"> <li>• Community involvement</li> <li>• Effective stream bank protection;</li> <li>• Reduce siltation of fish spawning habitat;</li> <li>• The enhancement of conditions for natural colonization of existing plant community;</li> <li>• Produce streamside wildlife habitat.</li> </ul>
Location	Issue	Picture	Remediation Strategy	Expected Results
<p>Greens and Graham Creek</p>	<p>Frequency of litter on these two systems is high. Though not a lot of pollution is present, many sections have plastic bags and other small items in them. Walk along cleanups involve members of the community walking certain stretches of stream with garbage bags and removing items such as bags, styrofoam, lumber, bottles etc. to rid the stream of human oriented debris.</p>

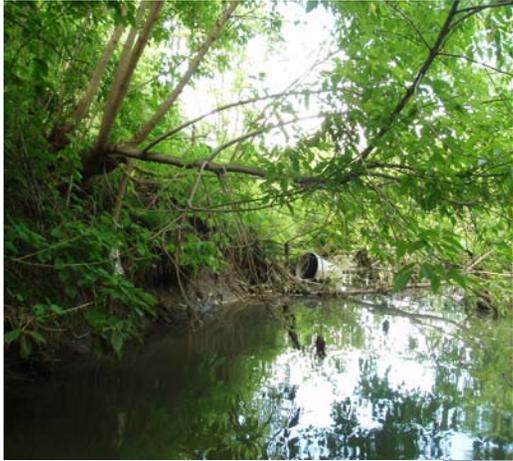
Location	Issue	Picture	Remediation Strategy	Expected Results
Stevens Creek at North Gower	Stevens creek is a natural flowing creek although some sections would benefit from a weekend cleanup. The stretches which contain pollution are in and downstream of North Gower. Items observed were tires, plastic bags and bottles, styrofoam and buckets.

Recruit volunteers from the communities around North Gower to participate in this cleanup effort. Stevens Creek cleanup could be completed on a weekend in the fall when water levels are low. The goal would be to facilitate the proper removal of garbage and to rid the stream and riparian areas of (man made) pollution.	<ul style="list-style-type: none"> <li>• Community involvement;</li> <li>• Enhancement of fish and wildlife habitat;</li> <li>• Enhancement of the creek's aesthetic qualities.</li> </ul>
