City Stream Watch

2008 Annual Report

Julia Sutton
City Stream Watch Coordinator
Rideau Valley Conservation Authority

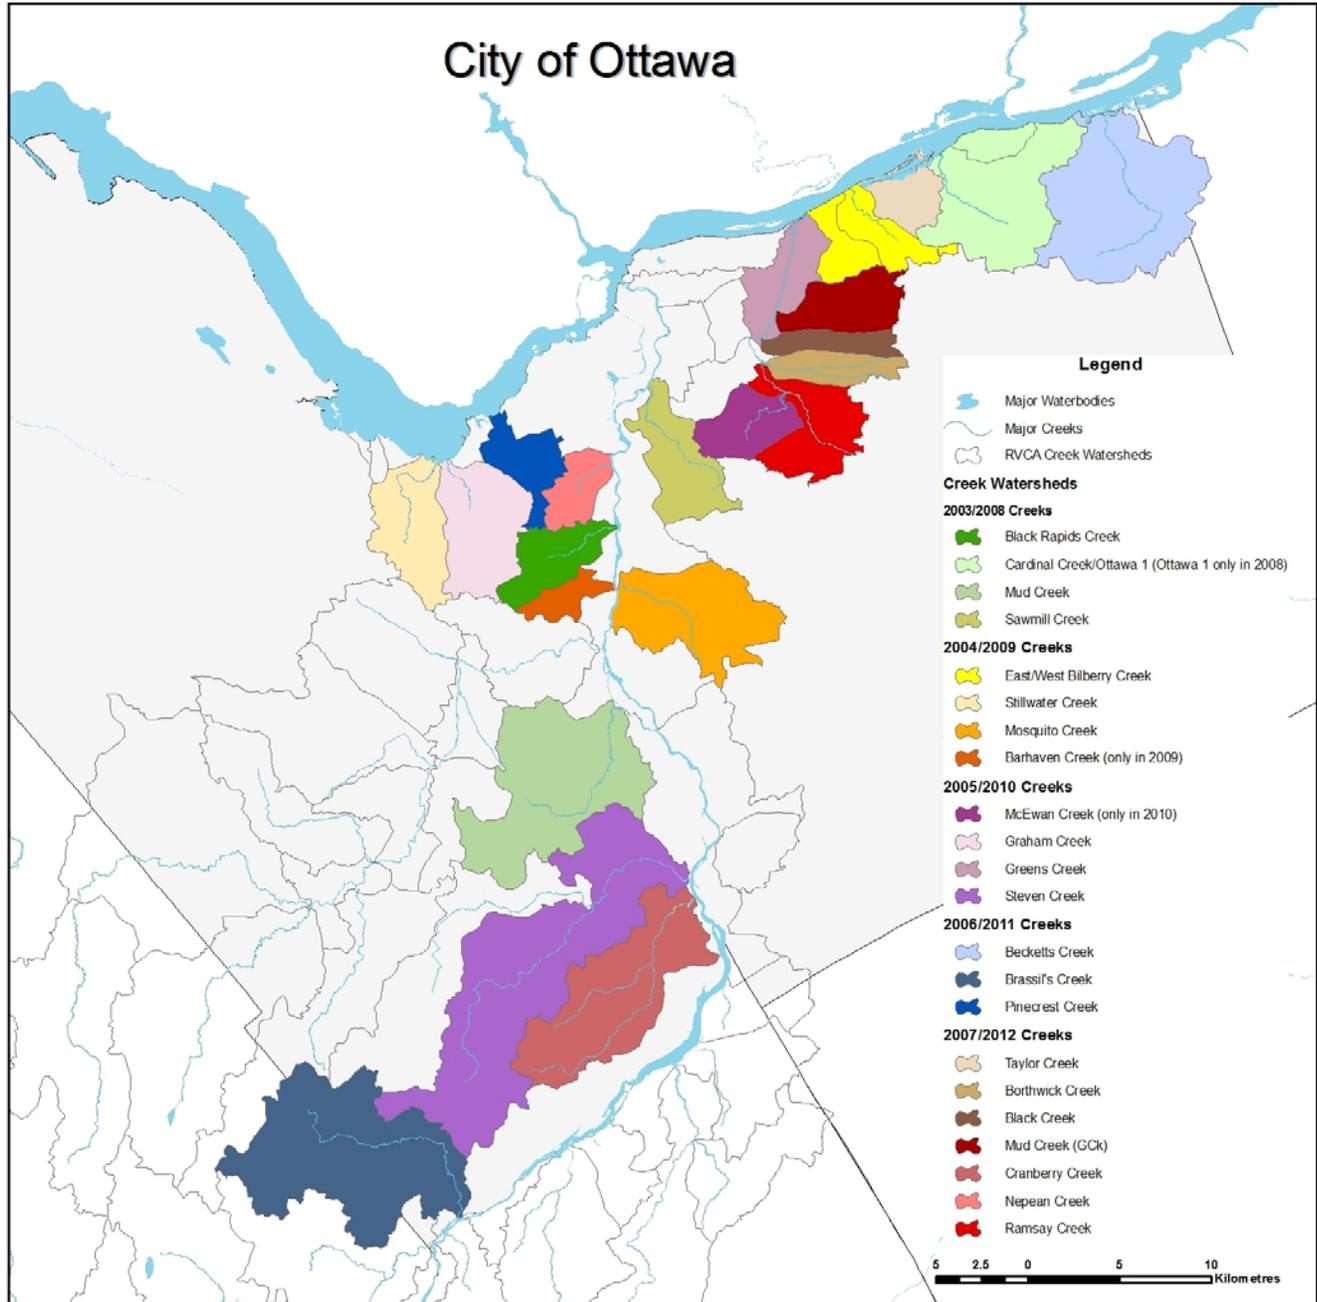
Figure 1. Locations of Streams and Their Watersheds on the 2003-2012 Sampling Schedule

In 2008 the original four streams from 2003 were re-surveyed. Those creeks were Black Rapids Creek, Cardinal Creek, Mud Creek and Sawmill Creek. Figure 1 shows the locations of the 2008 sample streams as well as all streams sampled from 2003 to 2007.

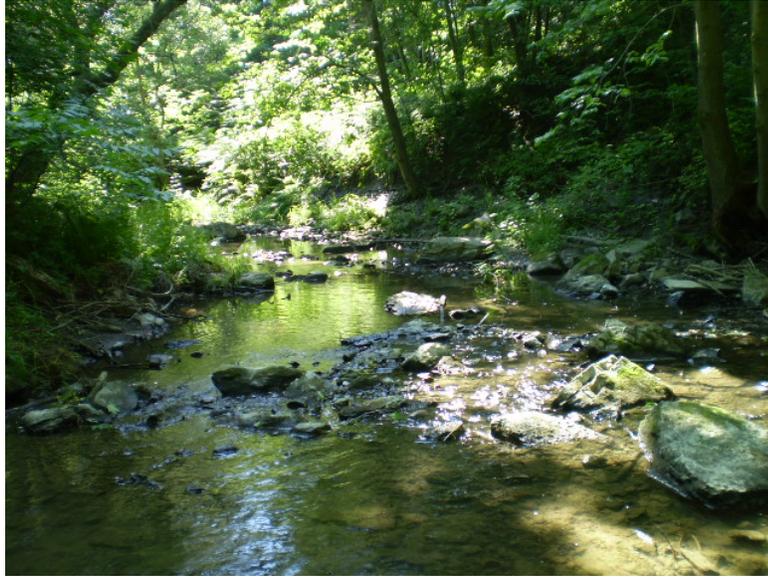
Figure 3 illustrates the classes of anthropogenic alterations observed by volunteers along Black Rapids Creek. Of the 56 sections of stream sampled, 52 percent of the stream remained without any anthropogenic alterations. Sections considered natural, but with some anthropogenic changes made up 34 percent of the sections sampled, and nine percent accounted for sections that were considered "altered" but still had natural features. Only five percent of the samples were "highly altered" with few natural portions.

Only five percent of the samples were "highly altered" with few natural portions. Areas that were listed as "altered" or "highly altered" were associated with road crossings, culverts, straightened areas of the creek or sections of the creek with little or no buffer and little aquatic or wildlife habitat. Most of these areas occurred in the headwaters, east of Greenbank, through Woodroffe where the creek is homogeneous. The area around Woodroffe is highly impacted with road crossings and drains from the road.

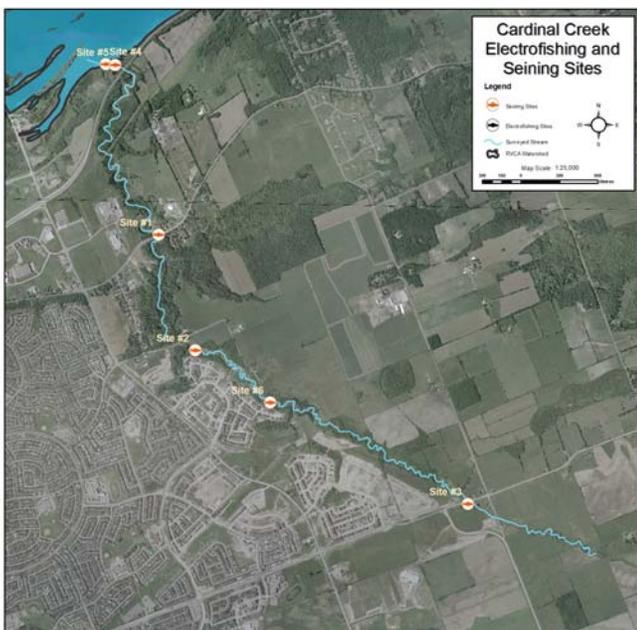
Figure 28. Air photo of Cardinal Creek showing Seining Sites

Figure 28 shows the seining locations for Cardinal Creek.

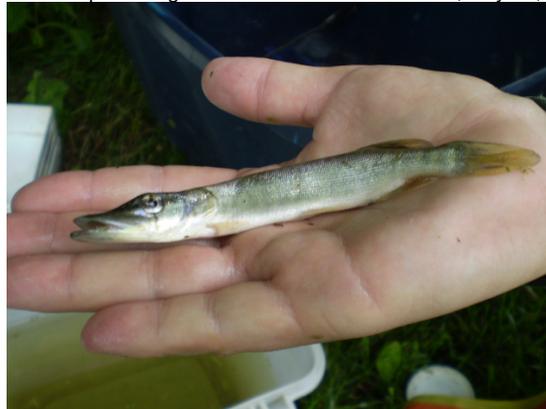
Juvenile pike caught at mouth of Cardinal Creek, July 30, 2008

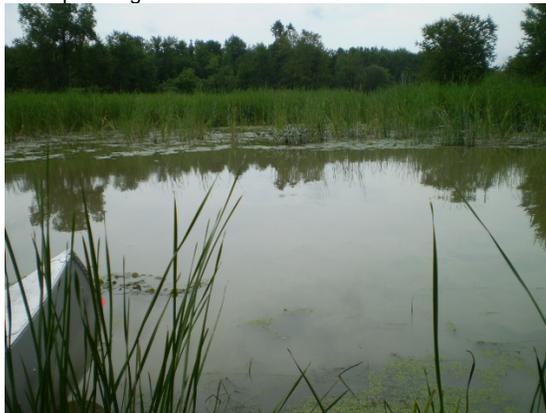
Pike spawning habitat at mouth of Cardinal Creek

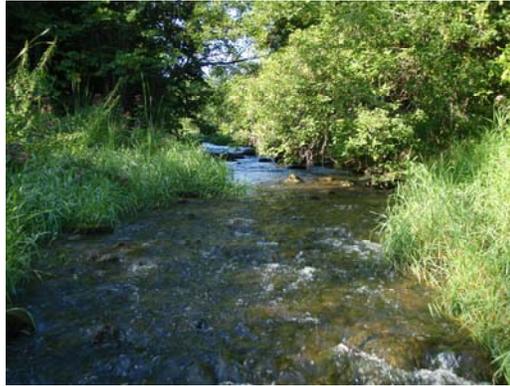
Electrofishing site on Mud Creek

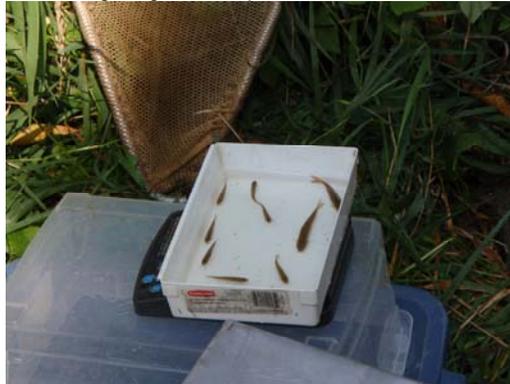
Calculating weight of sample

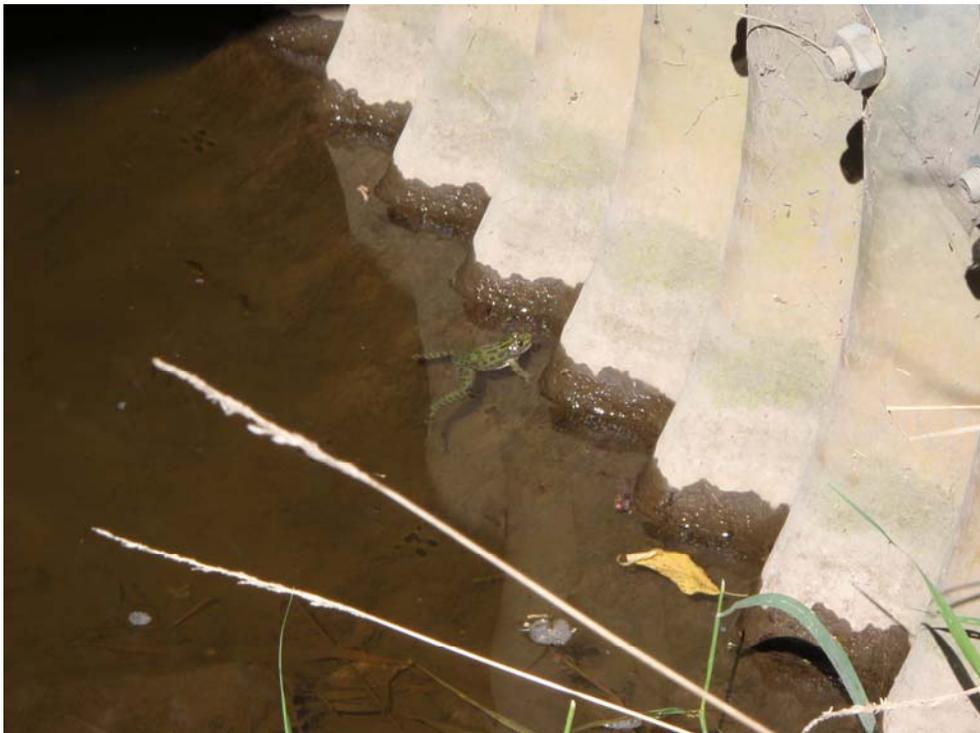
Figure 50. Air Photo of Sawmill Creek and Surrounding Area

Where Sawmill Creek is less impacted from development, the riparian areas continue to play an important role for wildlife and fish habitat (supplying nutrients through the addition of woody debris, shelter, creation of instream features for fish) and bank stabilization. The entire length of Sawmill Creek was sampled during the 2008 season for a total of 9.8 kilometres. Caution was needed when sampling the creek after periods of rain, as it experienced large, fast fluctuations in water levels. The dramatic fluctuation in water levels is characteristic of urban streams, as storm sewers shorten runoff travel time to stream channels while total runoff volume is increased with an increase in impervious surfaces. The following is a summary of the 98 macro stream assessment forms filled out by volunteers.

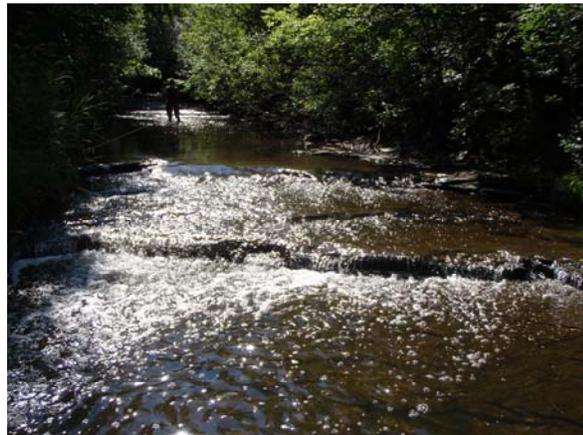
Figure 54. Types of Instream Substrate Along Sawmill Creek

A variety of substrate can be found instream along Sawmill Creek and is demonstrated in Figure 54. Diverse substrate is important for fish and benthic macroinvertebrate habitat because some species will only be found in certain types of substrate and will only reproduce on certain types of substrate. Boulders create instream cover and back eddies for large fish to hide and/or rest out of the current, and cobble provides important over wintering and/or spawning habitat for small or juvenile fish. Other substrates also provide instream habitat for fish and macroinvertebrates.

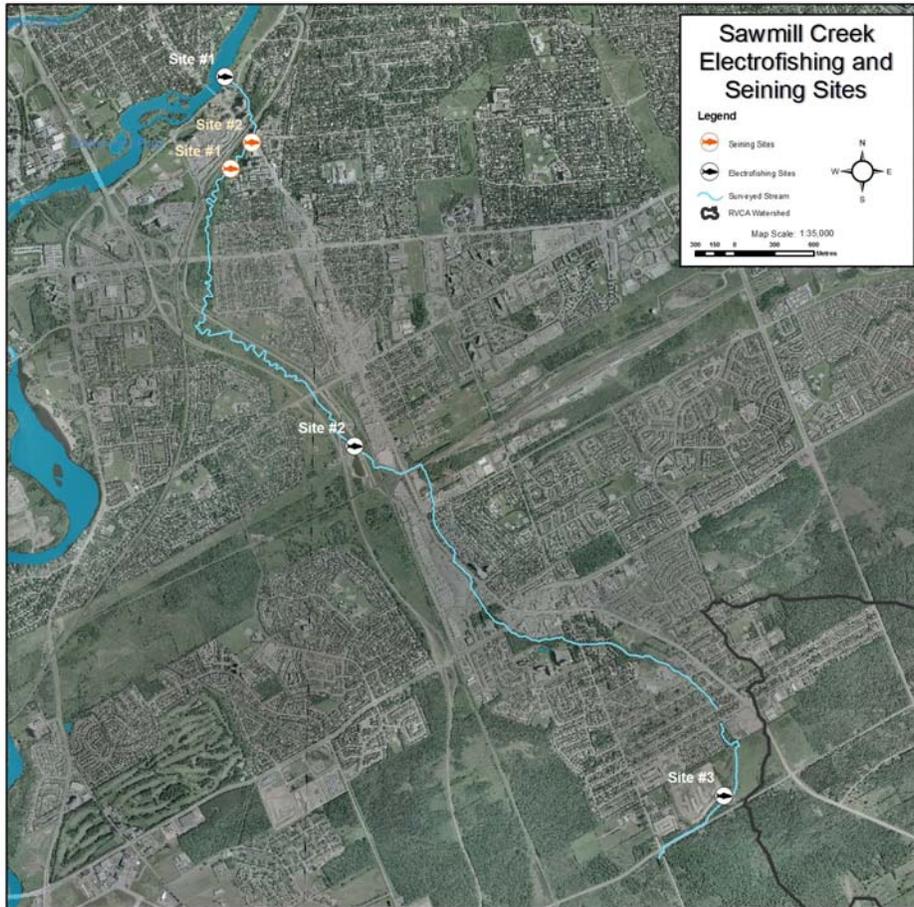
Figure 60. Air photo of Sawmill Creek Showing Sampling Sites

Sawmill Creek was electrofished by RVCA staff on July 2, 2008 and July 8, 2008. A total of three sites, each at a minimum of 70 metres, were sampled. (See discussion at 3.2.1 for a description of electrofishing). Figure 60 shows the locations of the electrofishing sites along Sawmill Creek. A total of fourteen different species were identified during sampling. Top predators are highlighted in bold and were caught at the mouth of the creek. A one metre long muskellunge was caught at the mouth, and it is clearly using the area for food and refuge.

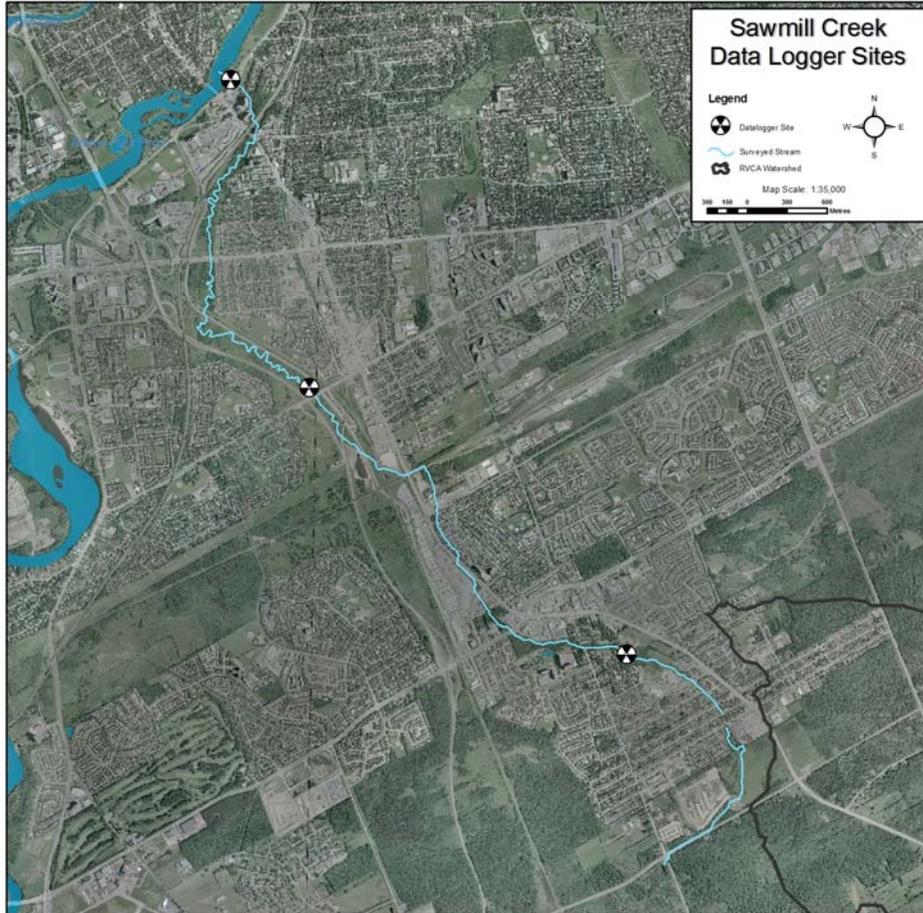
Figure 61. Datalogger Locations Along Sawmill Creek

Three temperature dataloggers were set in Sawmill Creek. Dataloggers 1 and 3 were set on May 15, 2008. Datalogger 2 was set on May 22, 2008. Dataloggers 1 and 2 were removed on September 19, 2008, and datalogger 3 was removed on September 15, 2008 during a survey. Figure 61 shows the locations of dataloggers in Sawmill Creek.

Dataloggers were set in three different locations along the stream to give a representative sample of how temperature fluctuates and differs throughout the course of the stream. Sites begin at the furthest downstream site and were placed in order upstream. Datalogger 1 was set just upstream of Riverside Drive East. Datalogger 2 was set just downstream of Walkley Road, and datalogger 3 was along a section upstream of Albion Road. Figures 62, 63 and 64 show the results from the three dataloggers.

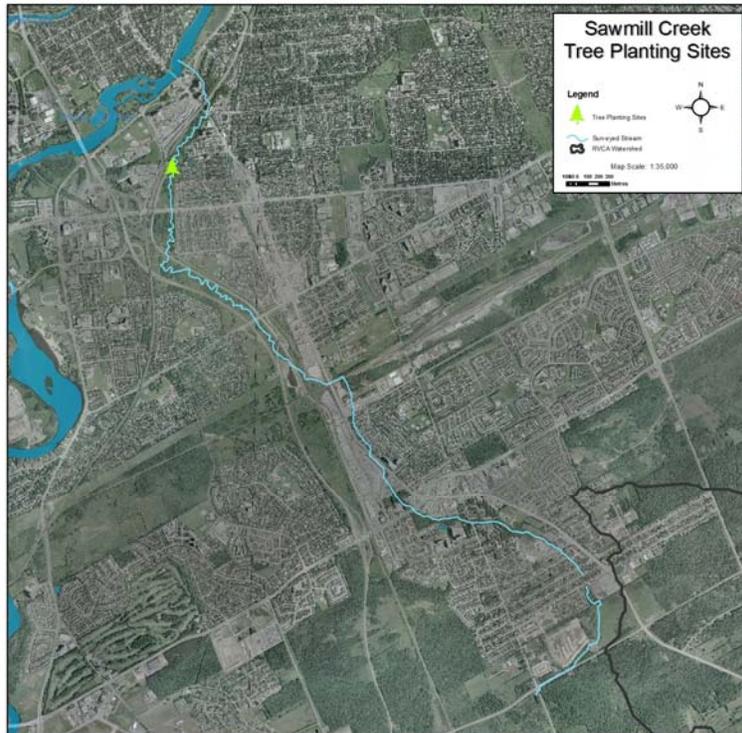
Figure 67. Air Photo of Sawmill Creek Showing Tree Planting Site

City Stream Watch, in cooperation with Heron Park Community Association has completed two phases of a shoreline rehabilitation project on Sawmill Creek. The goal of this project was to restore a failed bank on the east side of the stream just north of Heron Road. Phase I planting was done in 2005 where 350 small shrubs were planted along a failed bank to help re-vegetate the lower areas of the bank. A pathway was also relocated further away from the crest of the slope. Phase II was completed in the spring of 2006 at the same location where 600 more trees were planted along the upper sections of the bank failure and in areas where more planting was necessary. No planting was done in 2007 in order to give the plants a chance to grow for a year, but more planting was done in 2008. Figure 67 shows the location of the tree planting site.

Sumac and red osier dogwood were planted by six volunteers to help fill in some of the gaps. A total of 210 trees were planted in cool, rainy weather. The bank closest to the water is still experiencing a lot of erosion, and bioengineering is needed instead of tree planting to help vegetation hold against fluctuating water levels and higher velocities during storm events. Bioengineering uses plant material in different ways where trees planted would normally wash out. Cuttings from willows, dogwoods and other species can be used together in a number of ways to hold in the banks while the cuttings sprout. There are a number of different methods that can be used. The path that was relocated in 2005 is not being used, and people are still using the path on the crest of the slope. Signage and proper fencing would be needed to keep people from trampling the vegetation there. Later in the 2008 season, dog-strangling vine was found growing over much of the vegetation surrounding the site. Dog-strangling vine (*Cynanchum rossicum*) is an invasive species and wraps around trees

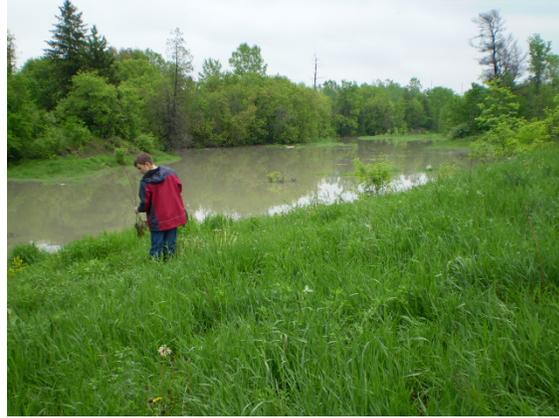
Figure 69. Air Photo of Cardinal Creek Showing Tree Planting Sites

The Cardinal Creek Community Association held a tree planting event on May 31, 2008 in the morning. In the afternoon, City Stream Watch joined up with some of those volunteers and provided 295 trees and shrubs to plant. The area of focus is where the trailhead comes down to Cardinal Creek in the Springridge subdivision. This is also where a stormwater retention pond holds water and releases it into Cardinal Creek. On each side of the pond is a grassy hill that comes down to the edge of the creek. Aside from leaving an area of access to the stormwater outlet, all of the grassy area should be planted with trees to help filter some of the runoff from the subdivision and the recreation path. Planting trees will also increase shading around the pond and will help thermally mitigate the potential that the stormwater facility is releasing warmer water to Cardinal Creek. Volunteers planted staghorn sumac, red osier dogwood, red pine, peachleaf willow, white spruce, silver maple and tamarack. This area is very large, and many more trees could be planted here. Some dogwoods were planted just south of Watters Road that is also open grass and experiencing some erosion. More trees and shrubs could be planted here in the future as well. Figure 69 shows the area planted.

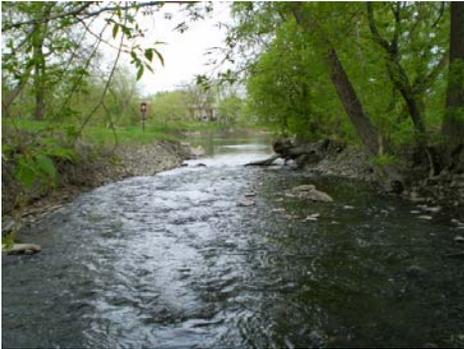
Location	Issue	Picture	Remediation Strategy	Expected Results
Sawmill Creek	At the mouth of Sawmill Creek, where it empties into the Rideau River, there is a very minimal buffer. Erosion along the shoreline needs to be mitigated. There is no buffer around the creek from Riverside Drive. This issue has also been mentioned in the subwatershed study update for Cardinal Creek. There is a park on either side of the creek, with lots of room for vegetation.

<ul style="list-style-type: none"> Discuss options with the NCC about developing a larger buffer and plant trees and shrubs along the bank in spring 2009. Plant shrubs where Riverside Drive crosses Sawmill Creek to help filter runoff. 	<ul style="list-style-type: none"> Increased collaboration with the NCC Enhancement of fish and wildlife habitat; Erosion control Enhancement of the creek's aesthetic qualities
Location	Issue	Picture	Remediation Strategy	Expected Results

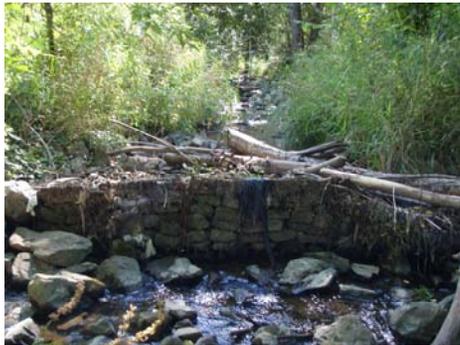
Black Rapids Creek, Cardinal Creek, Mud Creek (Manotick) and Sawmill Creek	There are a number of seasonal and year-round migratory obstructions along all of the creeks which inhibit fish passage. Some of these obstructions are old log jams, piles of rock, a structure and a gabion basket. Some of the obstructions also affect stream flow, causing the banks on either side of the obstruction to erode.

<p data-bbox="829 1247 1220 1271">Gabion basket across Sawmill Creek</p>	<ul style="list-style-type: none"> Determine land ownership Utilize existing volunteer base of the City Stream Watch to remove the obstruction. In some cases, the projects need landowner permission and involvement. Work with landowners to remove migration barriers along various systems 	<ul style="list-style-type: none"> Community involvement Improve stream flow Mitigate fish passage Restore natural stream flows

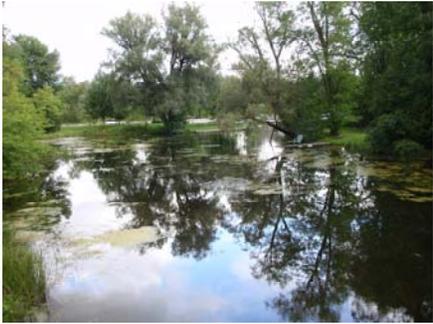
Location	Issue	Picture	Remediation Strategy	Expected Results
<p>Black Rapids Creek-at the mouth</p>	<p>The mouth of Black Rapids Creek is an important spawning area for fish. It is also the site of the Black Rapids Locks on the Rideau River, so there is a lot of traffic and the grounds need to be maintained for visitors. A minimal buffer exists adjacent to the creek. There is also Japanese Knotweed, and invasive species growing on the right bank near the walking bridge which should be removed before it spreads into the forested ravine.</p>

<ul style="list-style-type: none"> • Determine land ownership • Talk with Parks Canada/ NCC to see about the possibility of expanding the buffer around part of the mouth of the creek and removal of Japanese Knotweed. If the project goes forward, use existing volunteer base of the City Stream Watch to do the riparian planting and invasive species removal 	<ul style="list-style-type: none"> • Enhancement of fish and wildlife habitat • Collaboration with Parks Canada/NCC • Enhancement of the creek's aesthetic qualities • Protection of local, native species and biodiversity

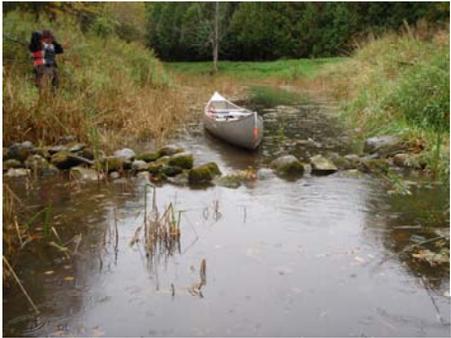
Location	Issue	Picture	Remediation Strategy	Expected Results
<p>Mud Creek</p>	<p>There is an old bridge across the creek that someone had made with large cobble. This cobble is a temporary barrier to fish migration in low flows.</p>

<ul style="list-style-type: none"> • Determine land ownership • Speak with landowners about footpath and possibility of removal. If landowners agree, take obstruction apart 	<ul style="list-style-type: none"> • Increase fish movement through this area of Sawmill Creek • Enhanced fish habitat

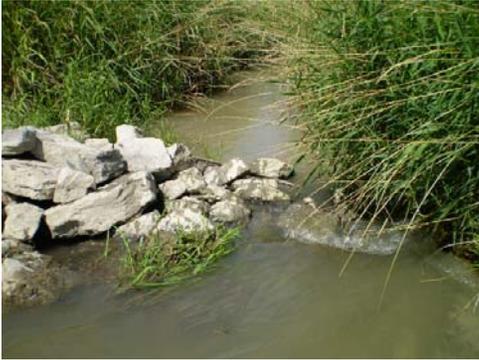
Location	Issue	Picture	Remediation Strategy	Expected Results
Cardinal Creek	Near the hydro lines between Springridge Road and Valin Street, there is a migratory obstruction across the creek. It is a pile of cobble, and in low water levels, fish cannot migrate upstream.

<ul style="list-style-type: none"> • Determine land ownership • Discuss best way to mitigate the obstruction • Cobble should not be removed from the creek because the morphology of this part of Cardinal Creek does not vary much • Place cobble strategically so that it does not result in a barrier but still provides important habitat 	<ul style="list-style-type: none"> • Increase fish movement through this area of Cardinal Creek • Fish and wildlife habitat enhancement
