City Stream Watch 2006 Annual Report

Grant Nichol
City Stream Watch Coordinator
Rideau Valley Conservation Authority

December 18, 2006

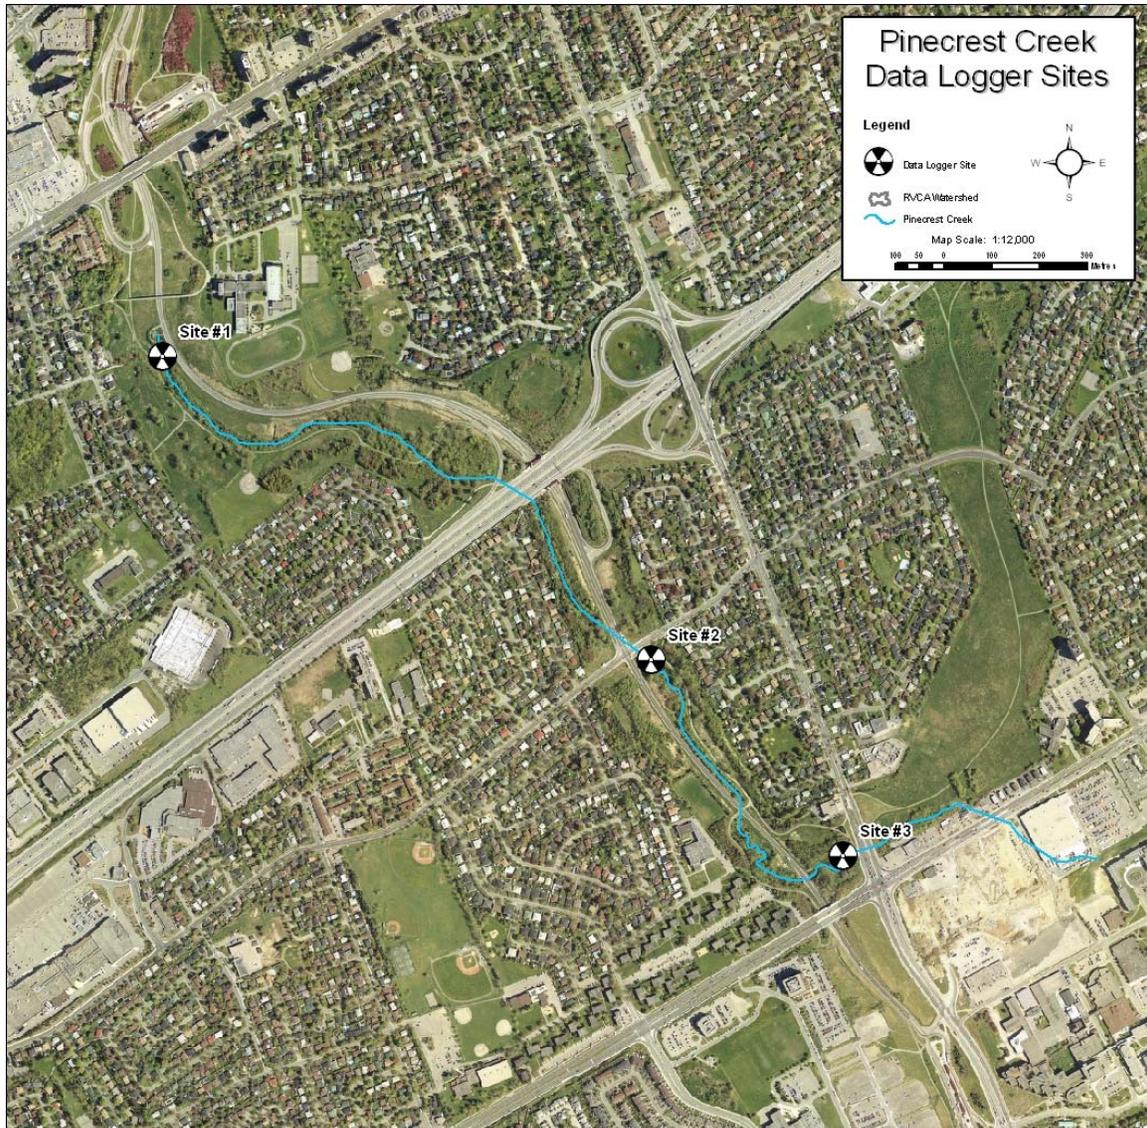
Figure 6. Datalogger Locations Along Pinecrest Creek

Three temperature dataloggers were set in Pinecrest Creek for a 90-day period beginning on June 12 and removed on September 9, 2006. Figure 6 shows the locations of dataloggers in Pinecrest Creek.

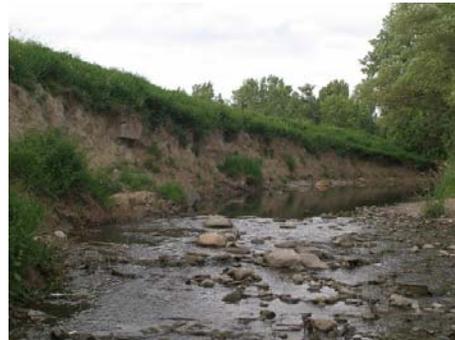
Figure 8. Bank Stability of Pinecrest Creek.

Figure 8 shows the overall bank stability of Pinecrest Creek. In 81% of sections sampled by volunteers, the stream banks along Pinecrest Creek were identified as being unstable or undercut. Many sections identified as being stable were due to artificial features. These included concrete bridge structures and entombed sections which offer no habitat or refuge for wildlife. A percentage of the stable banks along Pinecrest Creek can also be attributed to gabion cage reinforcement. Though gabion cage secures the bank structure they have a tendency to fail and require repair. Gabion structures also create a steep vertical interface between the terrestrial and aquatic ecosystems along a stream, which can negatively impact fish and wildlife. Natural shoreline bioengineering projects such as brush bundles, fascines, live cribwalls and live cuttings are now the preferred options as they require little maintenance and promote the regeneration of vegetation to further stabilize the bank. In addition they also help to dissipate energy from flow to reduce negative affects downstream. These bioengineering projects should be promoted along many of the eroded banks observed on Pinecrest Creek.

Areas of erosion have been identified on an aerial photo of Pinecrest Creek and can be found in Appendix G. This information includes a percentage of the 100-metre site that is eroded.

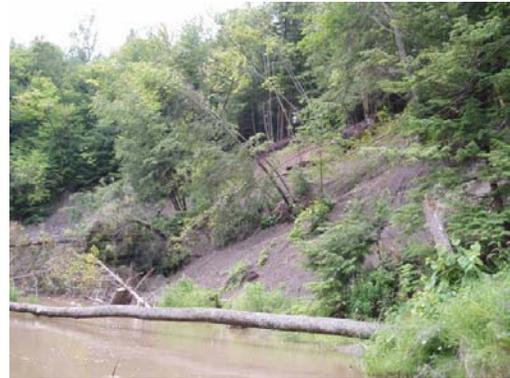
Figure 16. Bank Stability of BeckettsCreek.

Figure 16 demonstrates the overall bank stability of Becketts Creek. Evidence of erosion from the stream bank was observed along 57% of the shoreline, coinciding with areas of little or no vegetation. Many failed banks, where trees have fallen into the stream, were observed. Becketts Creek is a natural flowing stream, with little urban/commercial disturbance, so it is likely that most of this erosion is natural and possibly a result of a large drainage area and varying soil conditions.

Areas of erosion have been identified on an aerial photo of Becketts Creek and can be found in Appendix G. This map includes a percentage of the 100 m sites, which are eroded and will prove useful for rehabilitation opportunities.

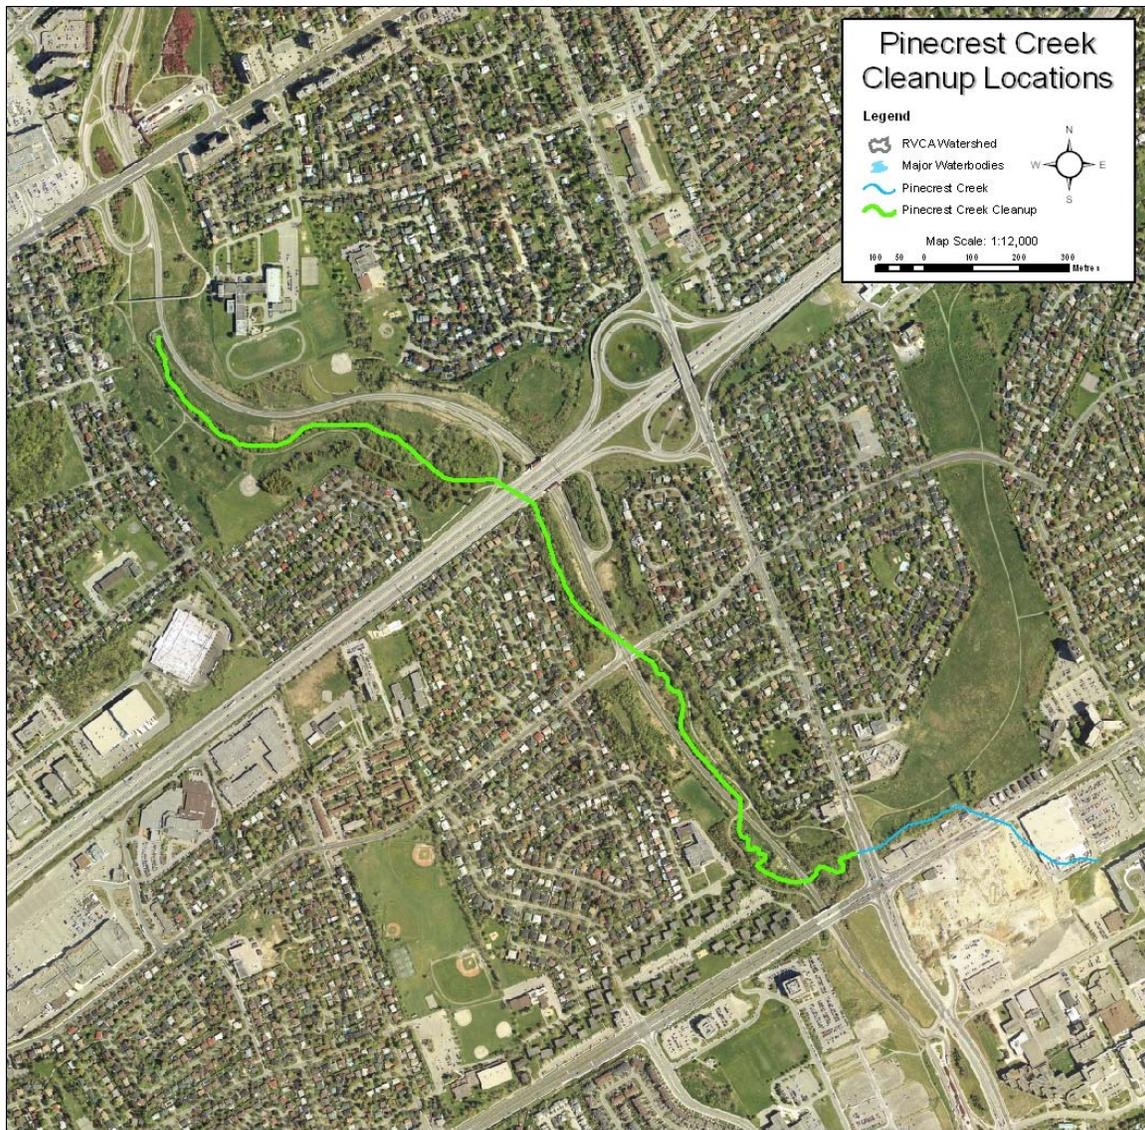
Figure 28. Pinecrest Creek Cleanup Site

The City Stream Watch program held a day long cleanup on Pinecrest Creek as part of World Oceans Day on June 10, 2006. The 2006 Oceans Day theme of "watersheds" celebrates watersheds in Canada, from upstream rivers through to the ocean environment into which they flow. This watershed wide cleanup marks the wrap up of a week of Oceans Day festivities (June 4 - June 10) as well as a day of festivities for National Rivers Day (June 11). City Stream Watch volunteers worked together cleaning 2.2km of Pinecrest Creek from south of Carling Rd to Woodroffe Ave. Figure 28 shows the stretches of creek that were cleaned by the volunteers

Pinecrest Creek flows from Baseline Road, just east of Woodroffe Ave, and empties into the Ottawa River at the Ottawa River Parkway, north of Lincoln Fields Shopping Centre. The stream flows through the NCC Greenbelt and follows the Pinecrest Creek recreational trail for its duration. Twenty-one volunteers participated despite the weather and cleaned up approximately 2 km of stream removing garbage and leaving it looking natural once again.

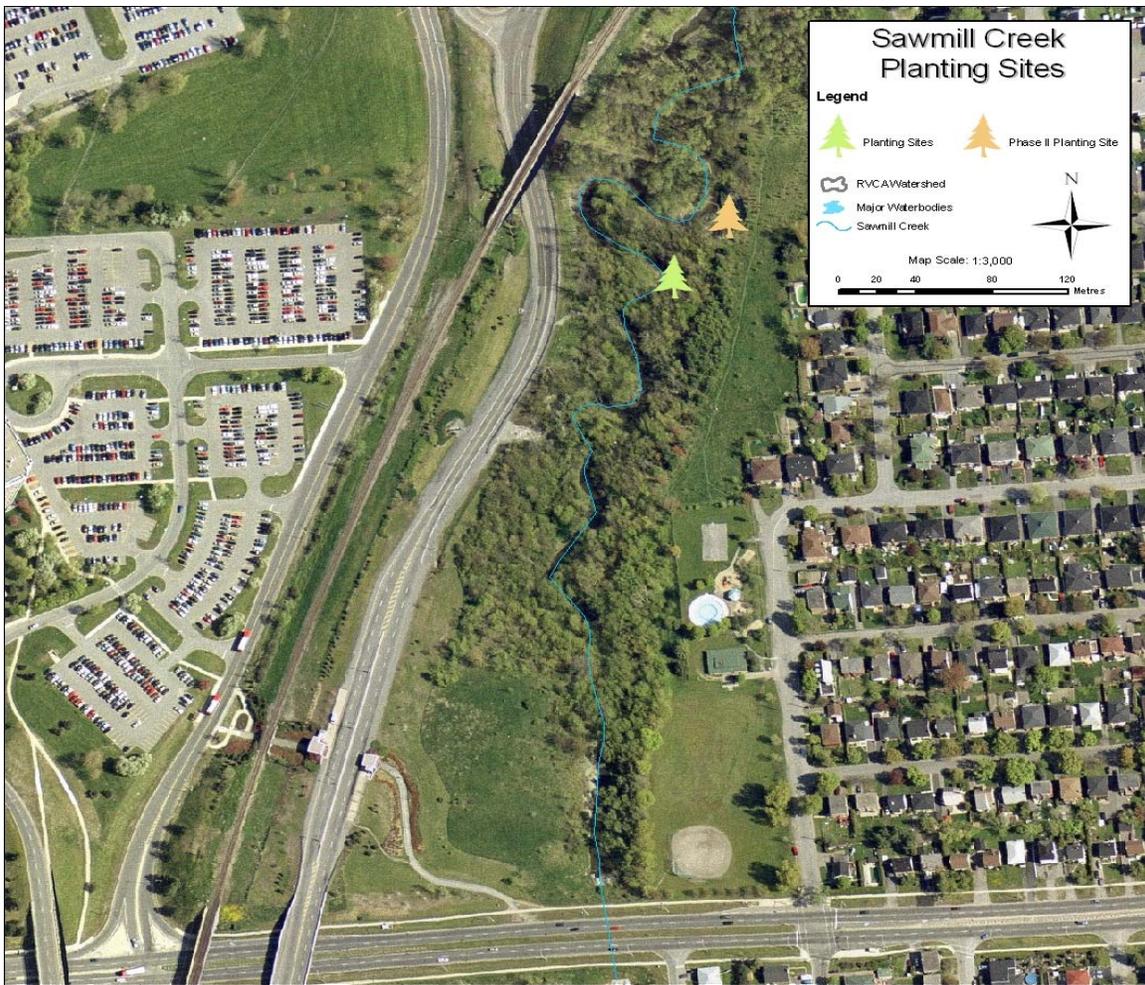
Figure 30. Sawmill Creek Planting Site in Heron Park

The City Stream Watch program in cooperation with Heron Park Community Association held a shoreline rehabilitation project on Sawmill Creek on May 6. This was Phase II of the Sawmill Creek Rehabilitation Project which started in 2005. The goal of this project is to restore a failed bank on the east side of the stream just north of Heron Road. In Phase I of this project the lower sections of bank, close to the stream, did well throughout the growing season although many trees were lost on the upper portion of the bank due to trampling and dry conditions. In Phase II, planting was to focus on the upper bank failure as well as filling in necessary sections that may have been washed away by spring flows. Figure 30 shows where the riparian rehab projects took place.

The riparian tree plant on Sawmill Creek at Heron Park was a successful event. Twelve volunteers successfully planted 600 trees in total (250 red osier, 200 nannyberry, 50 white spruce and 100 white cedar). Another site upstream, which had some bank erosion, was planted as well to help generate growth and prevent further erosion.

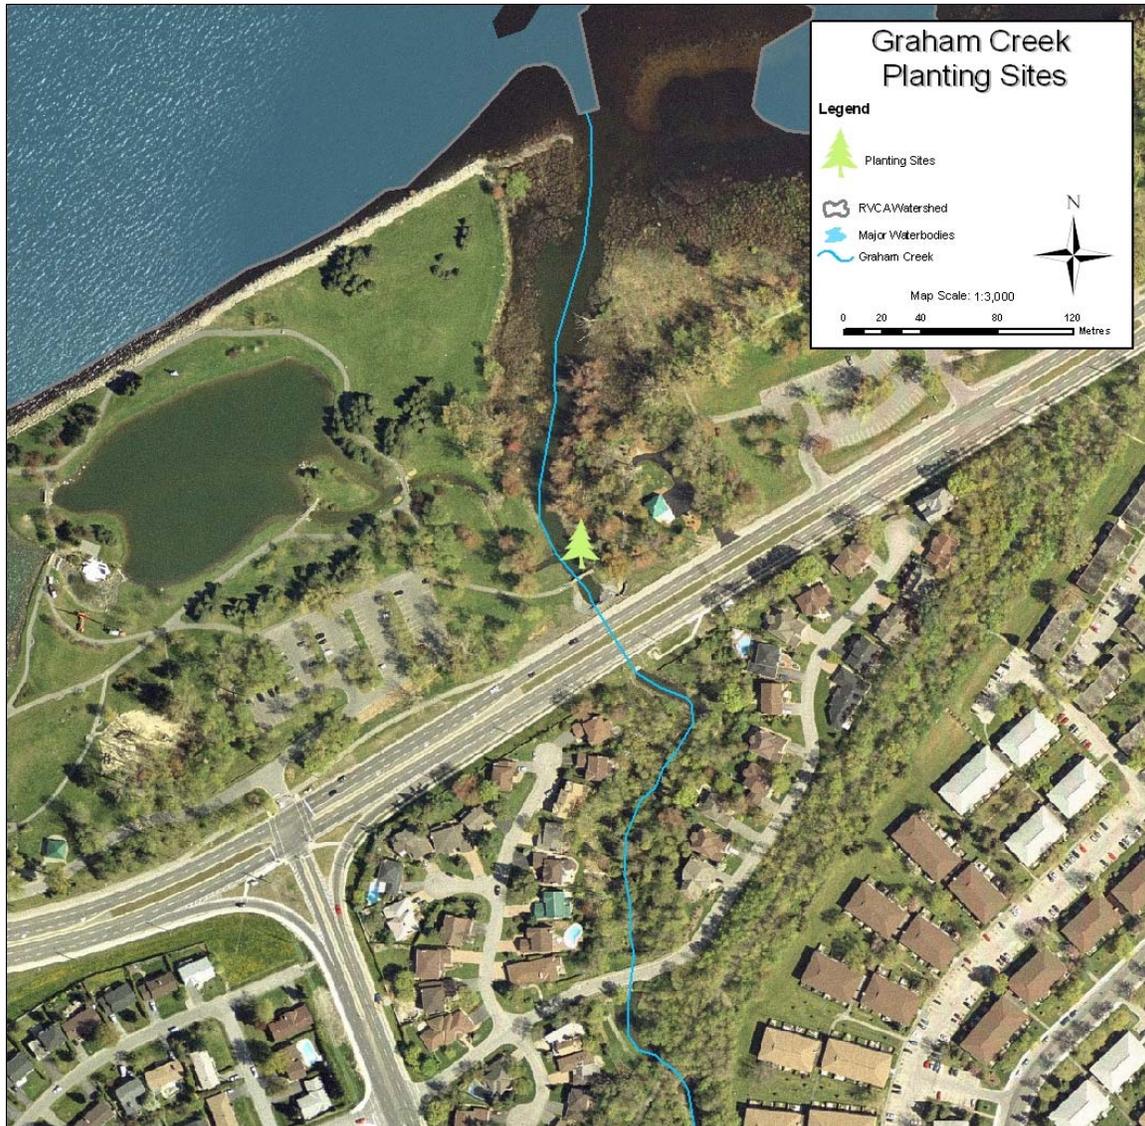
Figure 31. Graham Creek Planting Site in Andrew Haydon Park

Based on recommendations of the 2005 City Stream Watch Annual Report, a riparian planting project was carried out in the spring of 2006 on an eroded bank on Graham Creek. Figure 31 shows where Phase I of this planting project was carried out.

The riparian tree plant on Graham Creek took place in early June to help rehabilitate an eroded section along the stream in Andrew Haydon Park. Two volunteers from the program successfully planted 50 Red Osier along the bank on the east side of the stream.

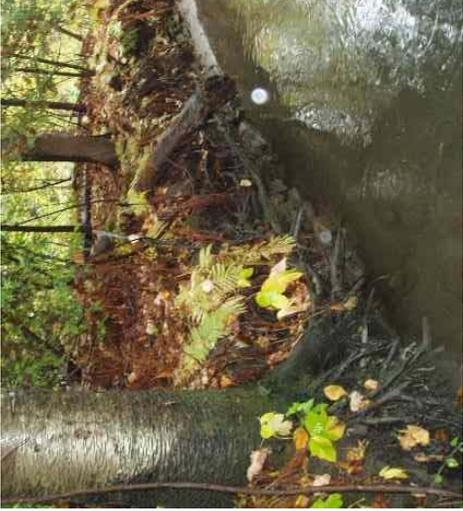
Location	Issue	Picture	Remediation Strategy	Expected Results
<p>Graham Creek - shoreline in between Acres Road and Carling Ave.</p>	<p>High water is eroding banks causing them to fail resulting in trees falling into stream. Landowners are worried that stream erosion may encroach on their land. Bioengineering work may take place in 2007. This could be a possible planting initiative after construction work is completed. Work would be best completed in spring of 2008.</p>

<p>Utilize existing volunteer base of the City Stream Watch program to participate in this rehabilitation effort. Plant shrubs and trees to stabilize banks and help stop erosion.</p>	<ul style="list-style-type: none"> • Community involvement • Enhancement of fish and wildlife habitat • Reduce erosion of banks • Eliminate possibility of bank failure causing tree collapse into stream
<p>Sawmill Creek - just North of Heron Park Community Centre (Heron Road.)</p>	<p>A bank failure just upstream of the Phase II planting site on Sawmill Creek is an area of concern. The bank failure has caused many trees to fall into the stream causing blockages as well as a considerable amount of siltation.</p>

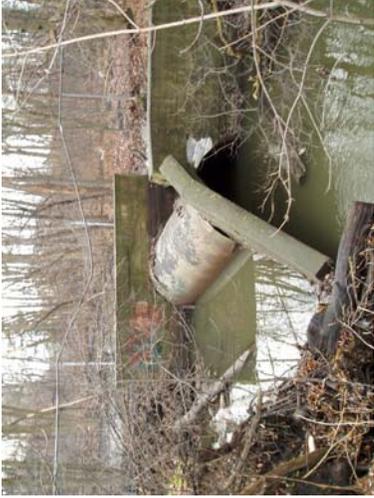
Location	Issue	Picture	Remediation Strategy	Expected Results
<p>Sawmill Creek - just north of Hunt Club Road.</p>	<p>Woody debris has accumulated at an abandoned culvert on Sawmill Creek. The wood has dammed up the stream pooling water above the abandoned culvert resulting in a channel restriction impacting flow. This has caused the stream to alter its course, creating an erosion and siltation problem. Secondly a cement wall has failed (as seen in the picture) creating a flow deflector, which is severely eroding the east bank.</p>

<p>Examine ways and obtain partners to remove the abandoned culvert.</p> <p>Utilize existing volunteer base of the City Stream Watch program to participate in this rehabilitation effort. Plant shrubs and trees to stabilize banks to help stop erosion.</p>	<ul style="list-style-type: none"> • Community involvement • Enhancement of fish and wildlife habitat • Reduce erosion of banks • Eliminate possibility of bank failure causing tree collapse into stream • Improve natural flow conditions • Remove potential fish barrier

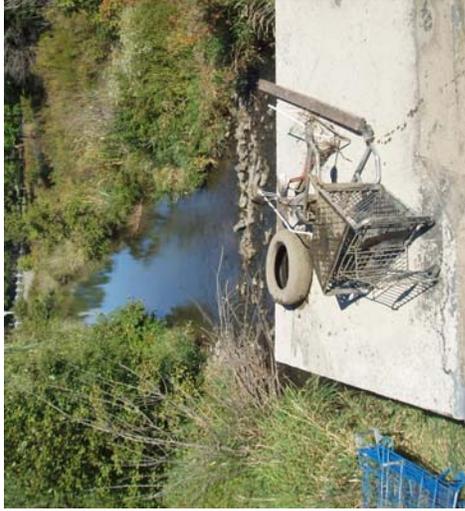
<p>Many sections of Sawmill Creek (South Keys Shopping Area of primary concern)</p>	<p>The accumulation of garbage and refuse along various stretches of Sawmill Creek is an ongoing problem. Not only does man made pollution take away from the aesthetic quality of the stream but it limits and degrades fish and wildlife habitat.</p>

<p>Utilize existing volunteer base of the City Stream Watch program to participate in this cleanup effort. Sawmill Creek cleanup days should be carried out in the summer and fall to properly remove garbage and rid the stream and riparian areas of pollution of human origin.</p>	<ul style="list-style-type: none"> • Community involvement • Enhancement of fish and wildlife habitat • Enhancement of the creek's aesthetic qualities

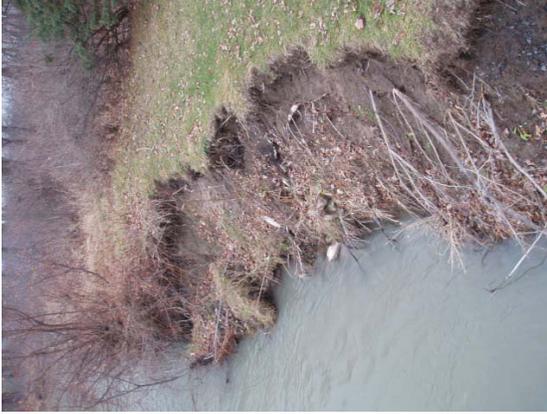
Location	Issue	Picture	Remediation Strategy	Expected Results
<p>Graham Creek at Andrew Haydon Park. On east bank just downstream from bridge.</p>	<p>PHASE II The phase II planting site on Graham Creek in Andrew Haydon Park hopes to further rehabilitate a highly eroded bank on the east side of the stream just north of Carling Rd. Phase I was carried out in early June of 2006 in hopes to stabilize the bank and prevent further erosion.</p>

<p>Utilize existing volunteer base of the City Stream Watch program and recruit volunteers from neighbouring communities to participate in this rehabilitation effort.</p>	<ul style="list-style-type: none"> • Community involvement • Effective stream bank protection • Reduce siltation of fish spawning habitat • The enhancement of conditions for natural colonization of existing plant community • Produce streamside wildlife habitat • Enhancement of the creek's aesthetic qualities

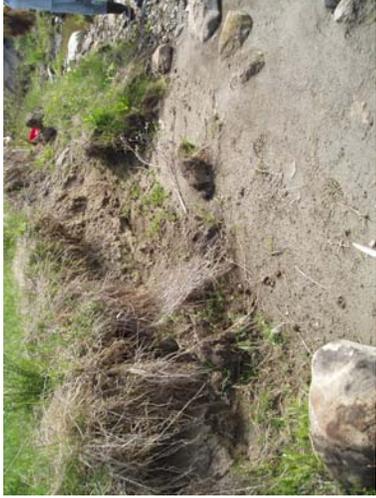
<p>Mosquito Creek downstream of Spratt Road within the Riverside South community</p>	<p>PHASE II Erosion of stream banks along Mosquito Creek is an issue. Development along with creation of roads, bridges and residential properties has increased runoff and caused significant erosion along the stream.</p>

<p>Utilize existing volunteer base of the City Stream Watch program and recruit volunteers from neighbouring communities to participate in this rehabilitation effort.</p>	<ul style="list-style-type: none"> • Enhancement of fish and wildlife habitat • Enhancement of the creek's aesthetic qualities • Effective stream bank protection • Erosion control

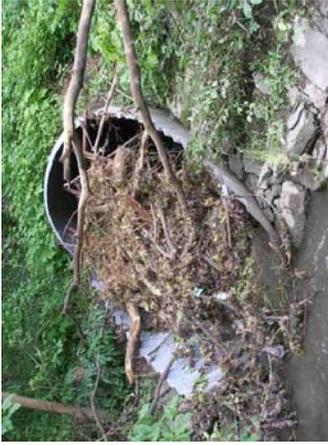
Location	Issue	Picture	Remediation Strategy	Expected Results
Pinecrest Creek	Frequency of litter on this system is high. Walk along cleanups involve members of the community walking certain stretches of stream with garbage bags and removing items such as styrofoam, lumber, bottles etc. to rid the stream of human oriented debris.

Utilize existing volunteer base of the City Stream Watch program and recruit volunteers from the communities around the streams to participate in this cleanup effort. The goal would be to facilitate the proper removal of garbage and to rid the stream and riparian areas of (man made) pollution.	<ul style="list-style-type: none"> • Community involvement • Enhancement of fish and wildlife habitat • Enhancement of the creek's aesthetic qualities
Pinecrest Creek	Erosion of stream banks along Pinecrest Creek is of major concern. The National Capital Commission (NCC) is leading an initiative to implement a to create a remediation strategy to eliminate erosion and help rehabilitate the stream.

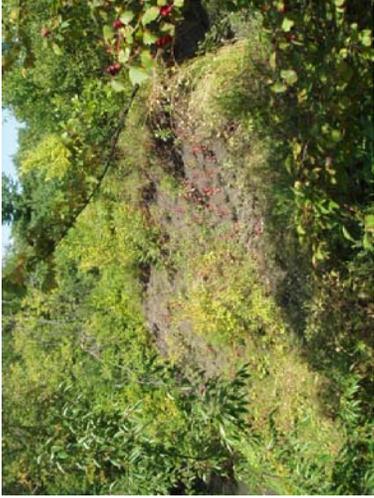
Location	Issue	Picture	Remediation Strategy	Expected Results
<p>Sawmill Creek just North of Heron Park Community Centre (Heron Rd.).</p>	<p>Phase I and Phase II planting took place on in 2005 and 2006 to help rehabilitate a failed bank on Sawmill Creek. Planting work has been successful although monitoring needs to be done often to ensure planting communities are successful. If trampling and further erosion are noticed, more planting may be needed.</p>

<p>Utilize existing volunteer base of the City Stream Watch program and residents from the Heron Park community to monitor success of planting site and report back to the coordinator with updates.</p>	<ul style="list-style-type: none"> • Promote community involvement in rehabilitation projects • Enhancement of fish and wildlife habitat • Enhancement of the creek's aesthetic qualities • Erosion control
