Mud Creek 2018 Catchment Report

Introduction

Mud Creek is approximately six kilometers long and is one of five major tributaries to Greens Creek in the east end of the City of Ottawa. The headwaters of Mud Creek begin in the Mer Bleue Wetland, which is a popular recreation destination as well as being recognized as a Wetland of International Importance by the Ramsar convention, an Area of Natural and Scientific Interest (ANSI) and a Provincially Significant Wetland. From its headwaters Mud Creek flows through property owned by the National Capital Commission, crossing Renaud road three times and Innes road once before it empties into Greens Creek north of Innes road.

In 2018, the City Stream Watch program surveyed sixty four 100 meter sections of the main channel of Mud Creek and twenty five 100 meter sections of a tributary of Mud Creek that originates East of Pagé Road. Three sites were sampled for fish community composition.

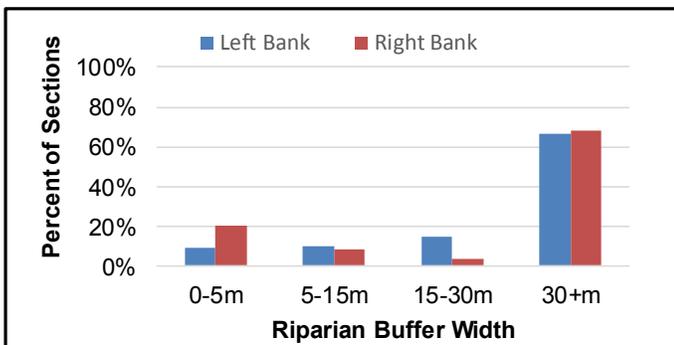
Figure 2 Vegetated buffer width along Mud Creek

Figure 2 demonstrates buffer conditions along the left and right banks of Mud Creek. Buffers greater than 30 meters were present along 67 percent of the left bank and 68 percent of the right bank. A five meter buffer or less was present along 9 percent of the left banks and 20 percent of the right bank. A fifteen to thirty meter buffer was present along 15 percent of the left banks and four percent of the right bank. A five to fifteen meter buffer was present along nine percent of the left bank and eight percent of the right banks.

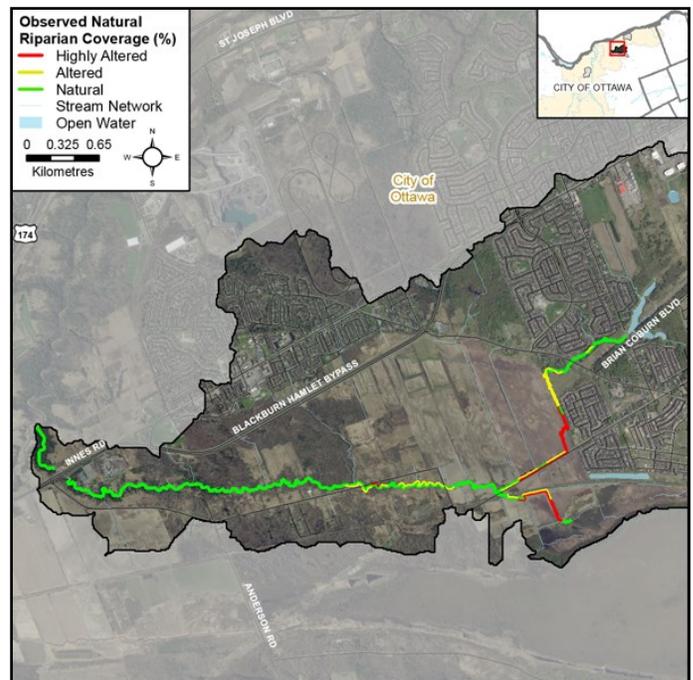
Figure 3 Riparian buffer alterations in Mud Creek

Alterations within the riparian buffer were assessed within three distinct shoreline zones (0-5 m, 5-15 m, 15-30 m), and evaluated based on the dominant vegetative community and/or land cover type. The percentage of anthropogenic alterations to the natural riparian cover are shown in Figure 3.

Mud Creek riparian zones have primarily natural vegetative communities; however there are areas with alterations that are associated with channel straightening and infrastructure such as roadways. Reduced buffers were also observed in residential and agricultural areas.

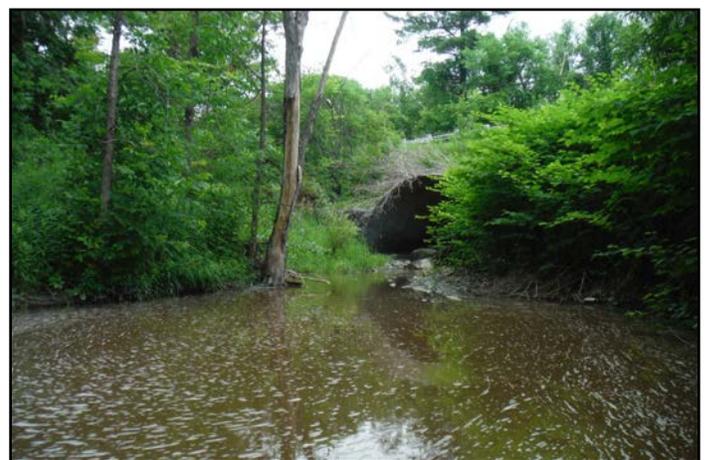
Infrastructure along Mud Creek at Renaud Road

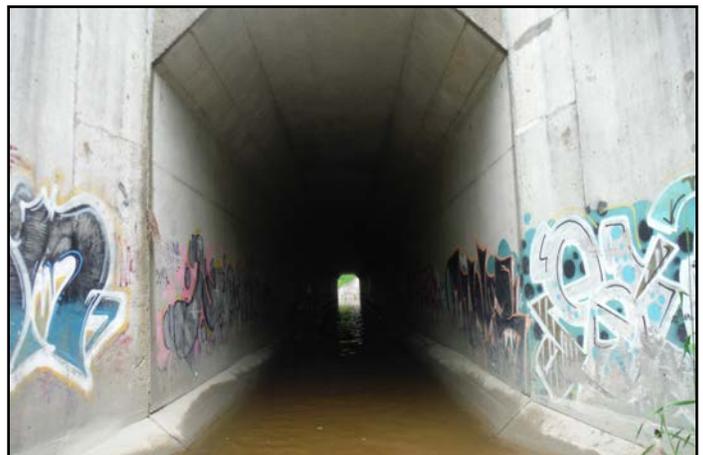
A highly altered section of Mud Creek at Innes Road

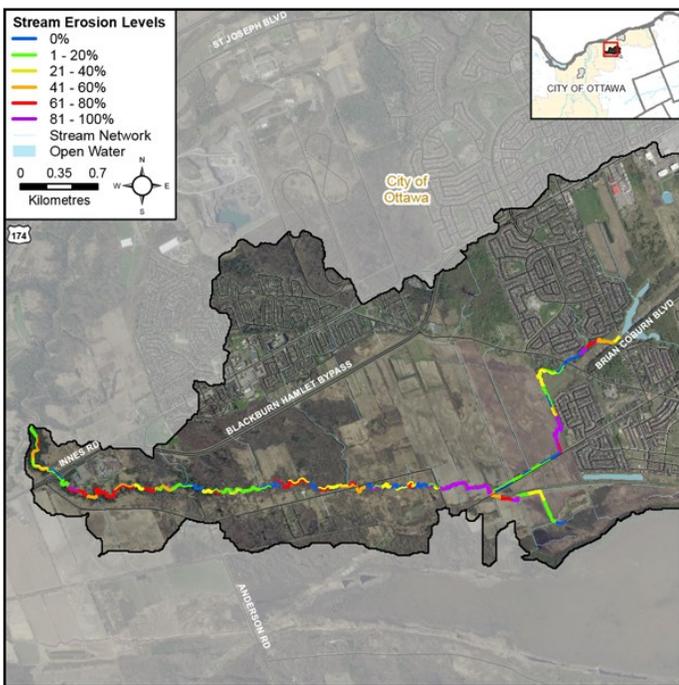
Figure 6 Erosion levels along Mud Creek

Figure 6 shows the levels of stream erosion observed across the surveyed portions of Mud Creek.

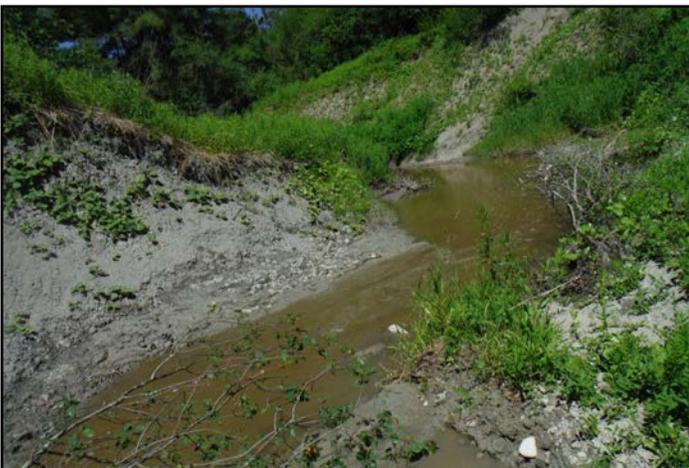
Bank erosion observations along Mud Creek

There was erosion present along the majority of the creek which ranged from low to high levels of erosion. There were many areas where CSW staff and volunteers noted highly unstable banks and evidence of recent slope failures.

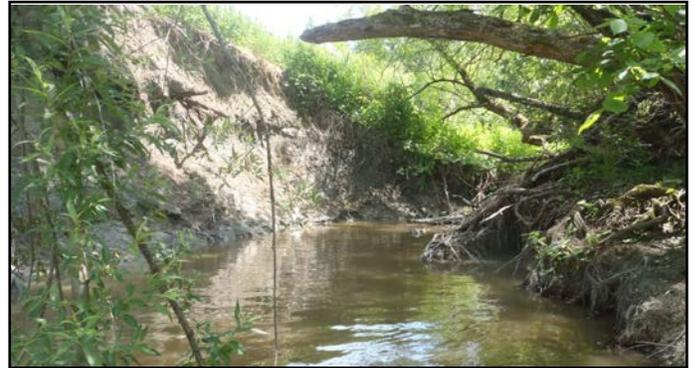
Unstable banks along Mud Creek

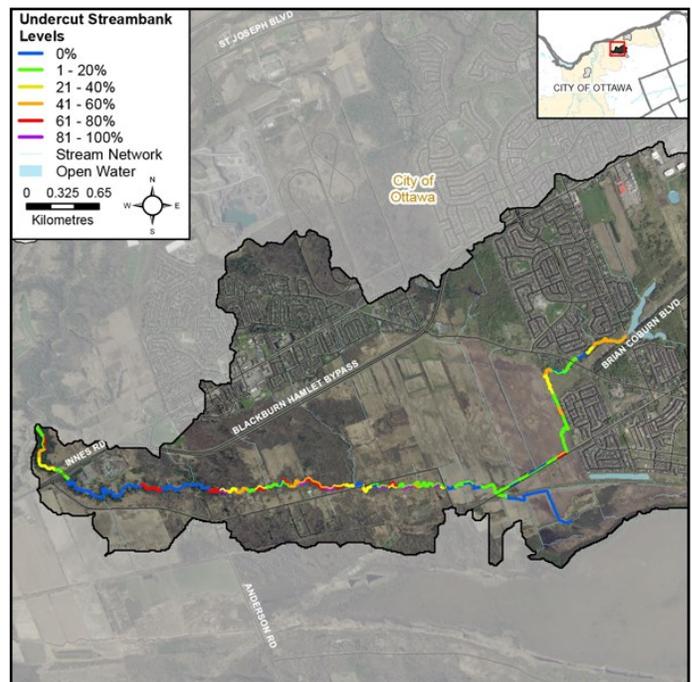
Figure 7 Undercut stream banks along Mud Creek

Figure 7 shows that undercut banks were present in over half of the sections surveyed in Mud Creek. Sixty-six percent of the sections had undercutting in the left bank and 67 percent of the right bank.

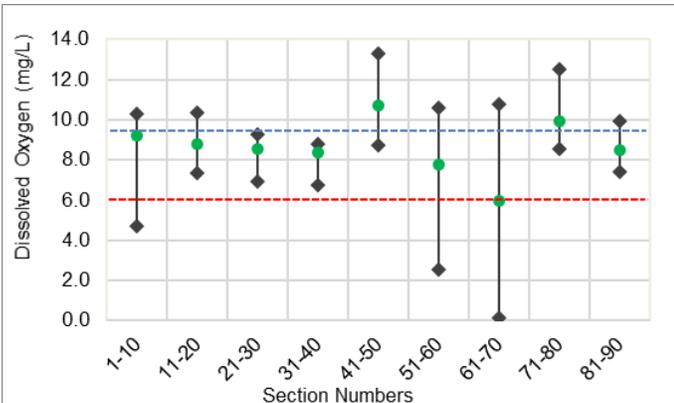
Figure 22 Dissolved oxygen ranges along Mud Creek

Figure 22 shows the concentration levels found in Mud Creek. The two dashed lines depicted represent the Canadian water quality guidelines. All of the surveyed portions had average oxygen levels adequate to support warm-water aquatic life, with two sections having oxygen levels adequate to support cold-water biota. Average levels across the system were 8.6 milligrams per liter.

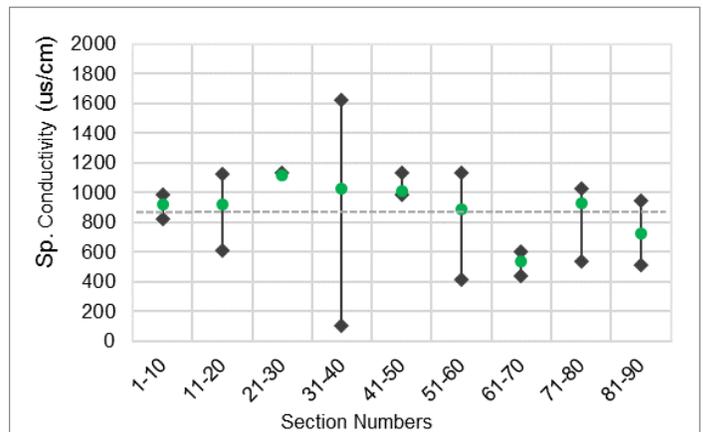
Figure 23 Conductivity ranges along sections of Mud Creek pH

Figure 23 shows specific conductivity levels in Mud Creek, the average level is depicted by the dashed line (899.3 $\mu\text{S/cm}$).

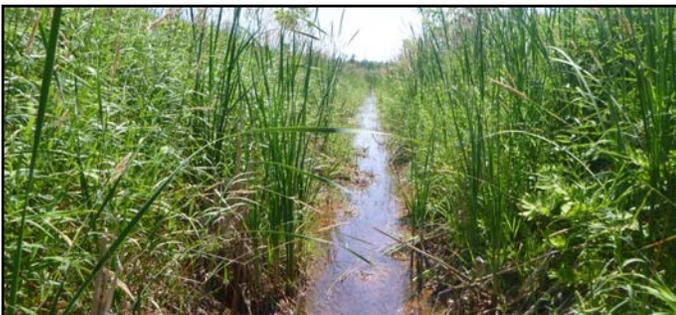
Site on Mud Creek with **impaired** oxygen conditions (Dissolved oxygen levels of 1.96 mg/L and 22.7% saturation)

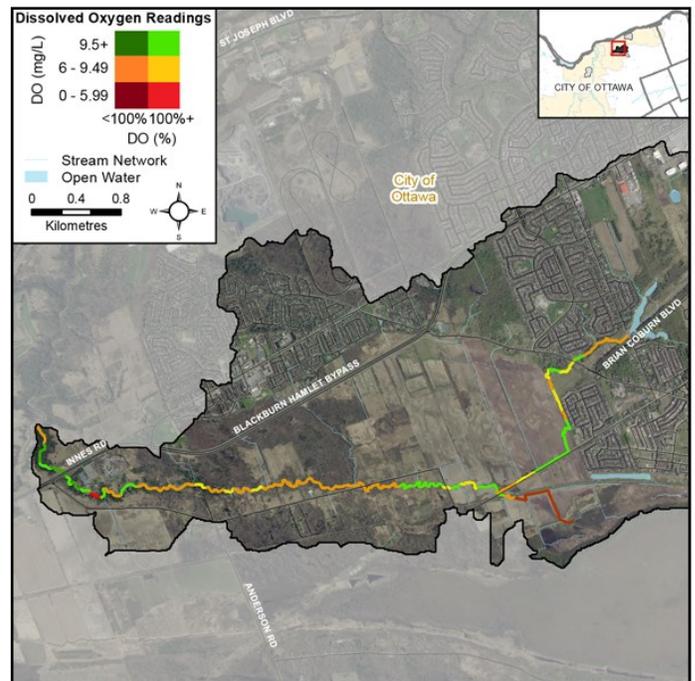
Figure 25 Bivariate assessment of dissolved oxygen concentration (mg/L) and saturation (%) along Mud Creek

Figure 25 shows the oxygen conditions across the areas that were surveyed in 2018. Overall dissolved oxygen conditions in Mud Creek are sufficient to sustain warm-water biota. Sections downstream of the final crossing of Renaud Road, shown in dark red and orange in Figure 25, have significant levels of impairment both in concentration and percent saturation. These areas have wetland features that have naturally lower oxygen levels, however these can be further limited by extensive vegetation growth of invasive species, and anthropogenic nutrient input.

Areas in the lower reaches near the confluence with Greens Creek and in the upper reaches near Renaud Road showed optimal conditions for cold-water biota. These areas are shaded and contain riffle habitat that is conducive to oxygenation.

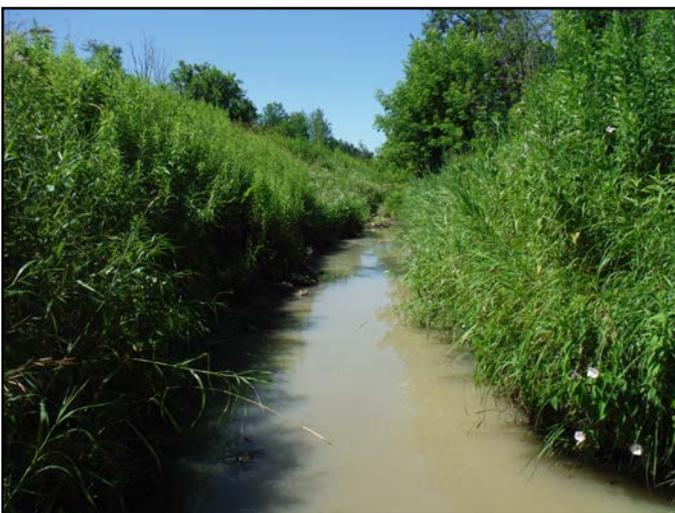
Section of Mud Creek along Renaud Road with moderately elevated levels of specific conductivity

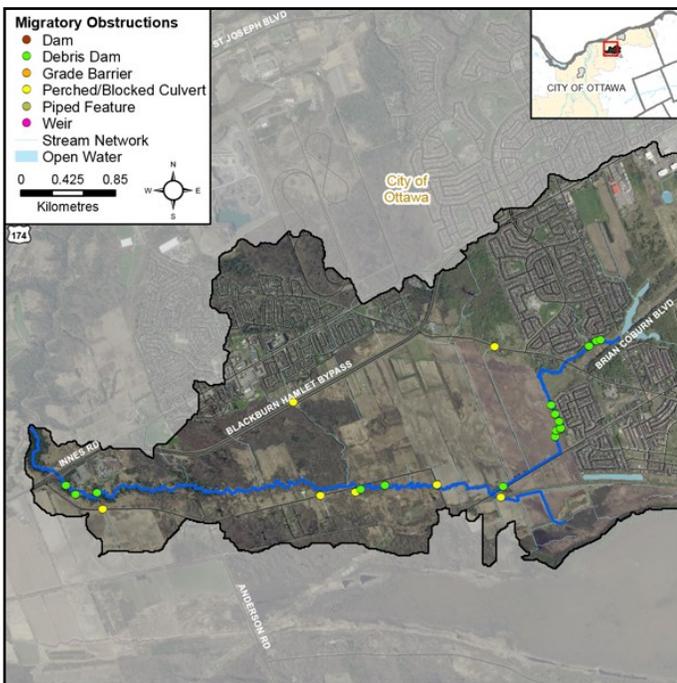
Figure 31 Locations of migratory obstructions along Mud-Creek

The majority of migratory obstructions observed on Mud Creek were debris dams. This debris accumulated from naturally fallen trees and branches. There were also seven perched culverts observed. The locations of migratory obstructions observed during headwater drainage feature assessment and stream surveys in 2018 are shown in Figure 31.

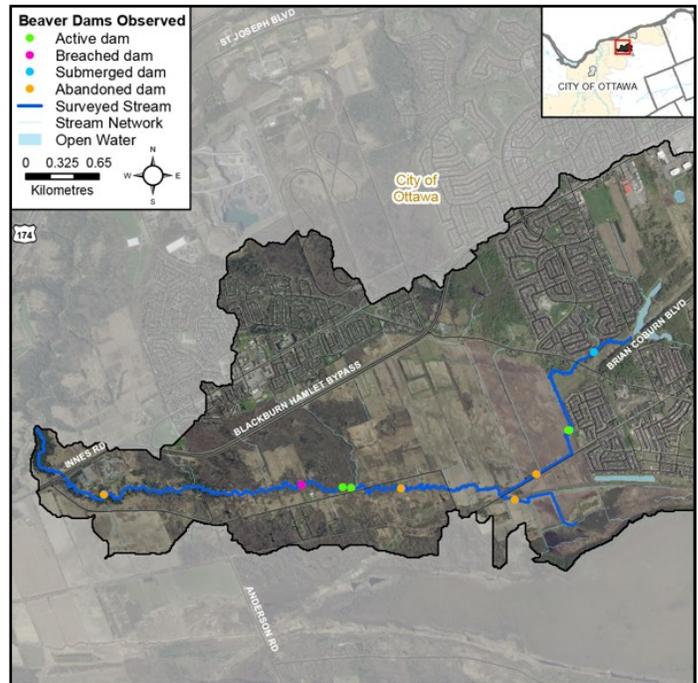
Figure 32 Locations of beaver dams along Mud Creek

Nine beaver dams were observed along Mud Creek. This included four abandoned dams, one breached dam, one submerged dam and three active dams. The locations of beaver dams observed during stream surveys in 2018 are shown in Figure 32.

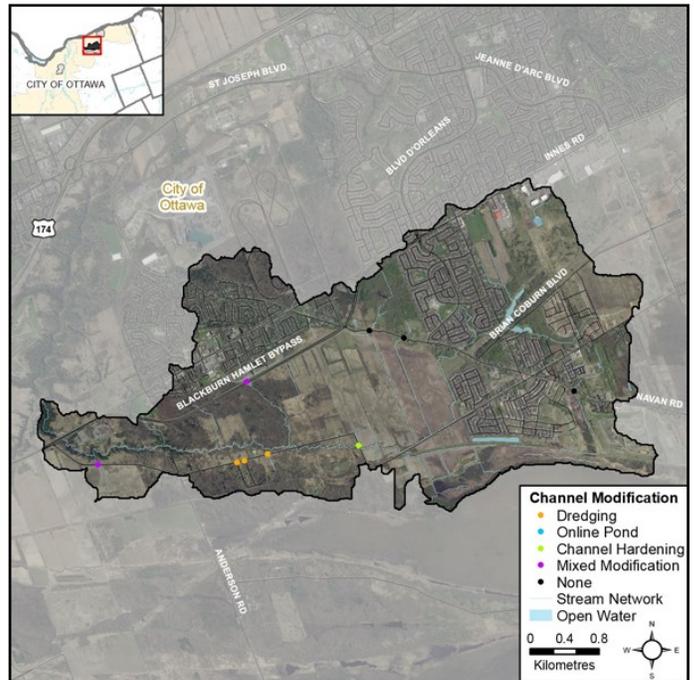
Figure 36 Headwater feature channel modifications in the

Figure 36 shows channel modifications observed in Mud Creek headwater drainage features. Most modifications observed in this catchment for headwater drainage features are dredging and channel hardening.

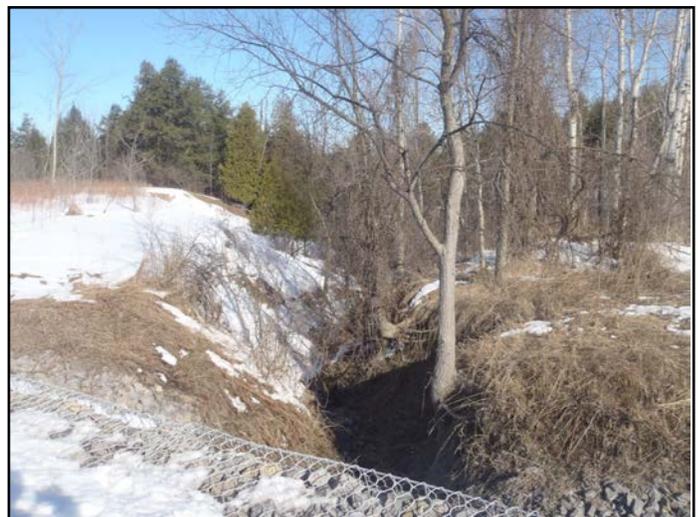
Channel hardening with gabion baskets along Renaud Road

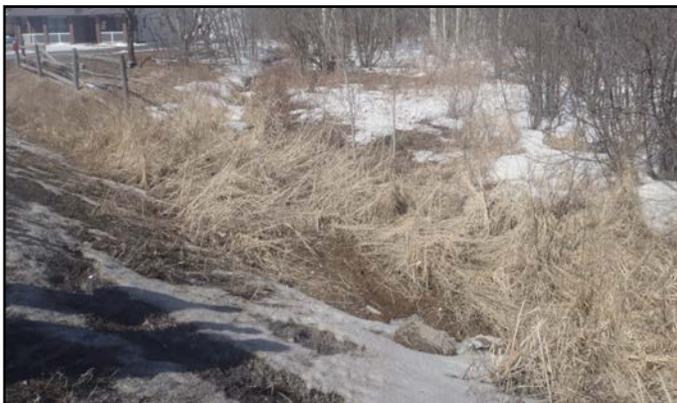
Substantial sediment deposition observed on Navan Road

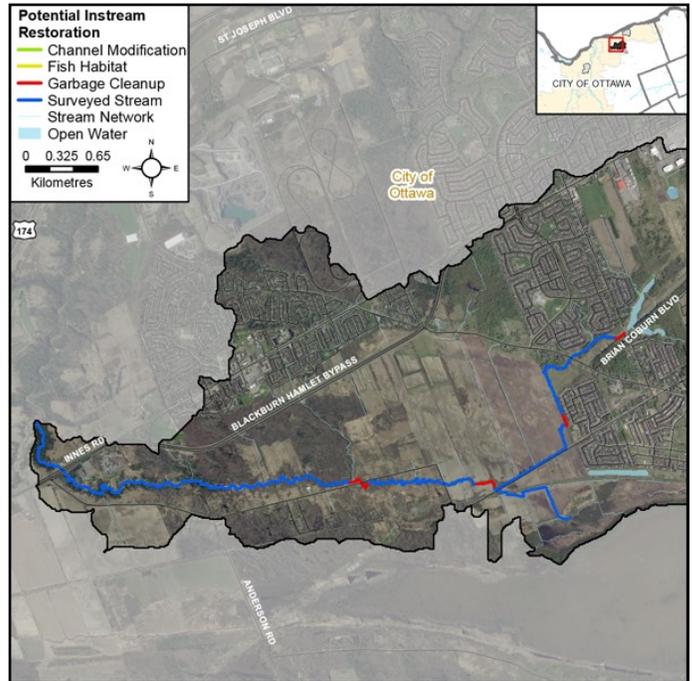
Figure 42 Potential instream restoration opportunities in Mud Creek

Pollution was observed in many sections surveyed along Mud Creek. In particular, garbage was more concentrated near both crossings at Renaud Road, in an area where the creek runs behind a residential neighborhood, and downstream of a stormwater management pond. Mud Creek would benefit from clean ups in any of the areas shown in Figure 42.

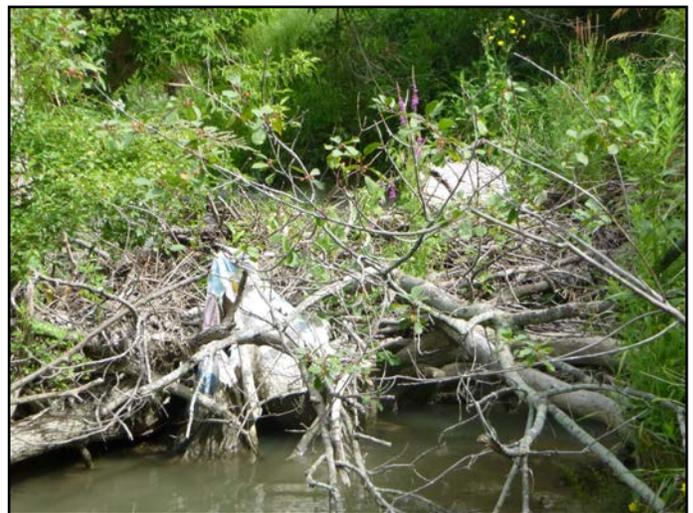
Area with accumulation of garbage that could benefit from a stream clean up.
