Ramsay Creek 2013 Summary Report

Introduction

As part of the City Stream Watch monitoring activities in 2013, 101 sections of Ramsay Creek were surveyed by staff and volunteers.

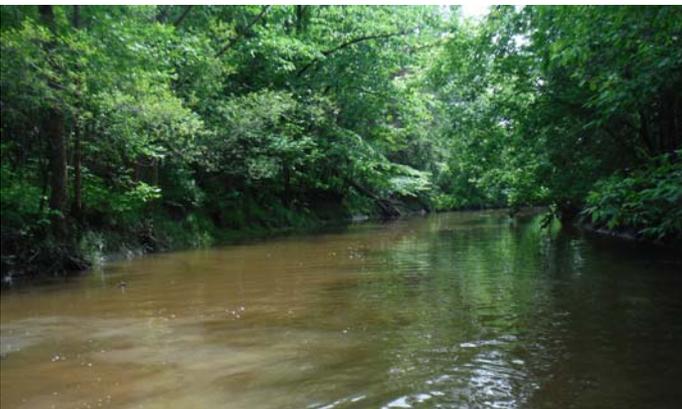
Well vegetated buffer along Ramsay Creek

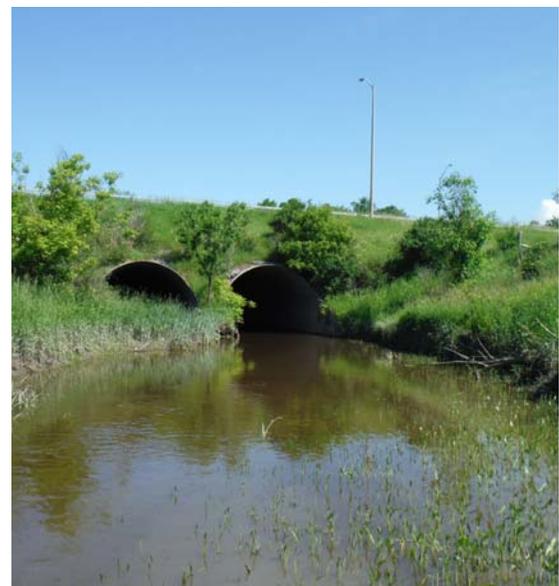
Infrastructure along Ramsay Creek where it crosses Walkley Road

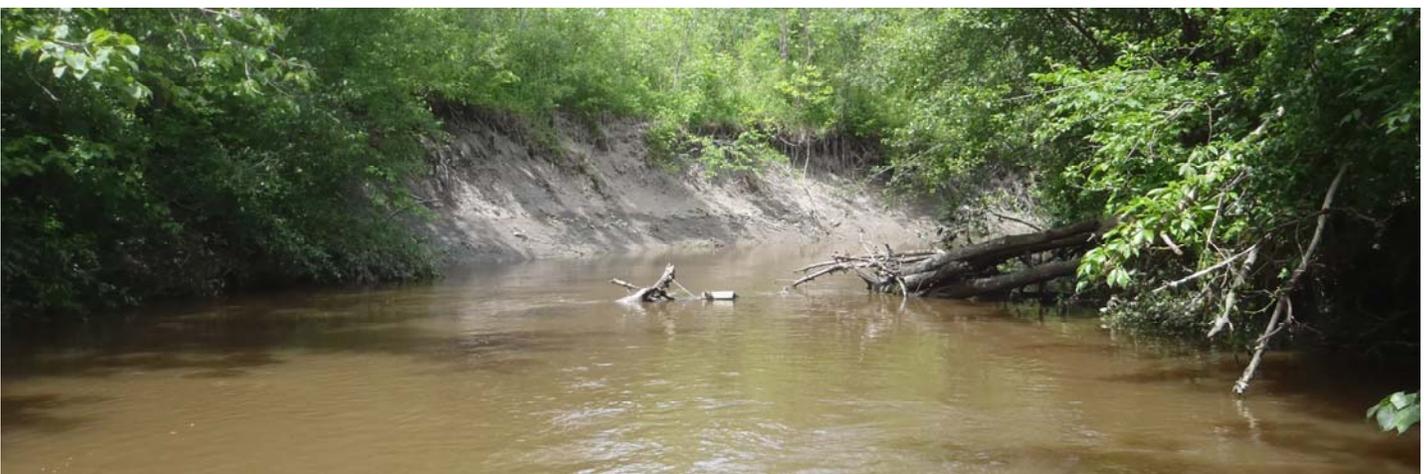
Stream bank erosion along Ramsay Creek

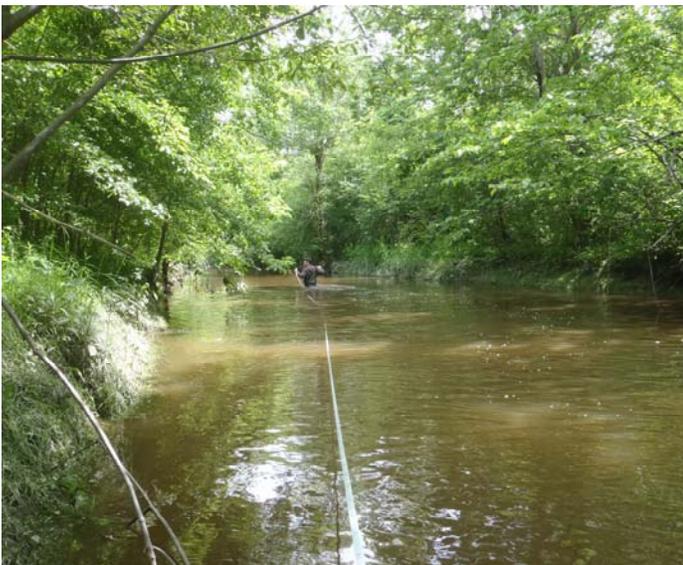
Stream shade along Ramsay Creek

Grasses, shrubs and trees all contribute towards shading a stream. Shade is important in moderating stream temperature, contributing to food supply and helping with nutrient reduction within a stream. Figure 6 shows stream shading along Ramsay Creek. Low to moderate levels were seen along most of the creek. High levels of shading were observed in forested pockets near the mouth of the creek as well as in the upper reaches where the creek narrowed and overhanging grasses provided shade.

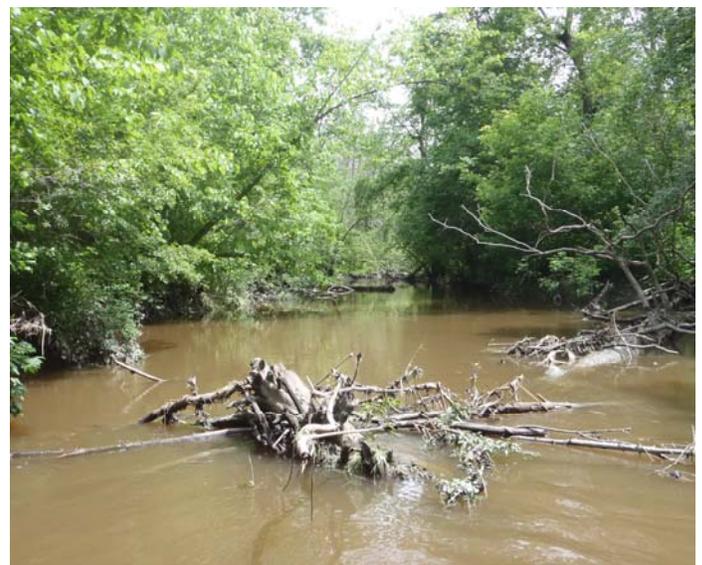
Instream woody debris on Ramsay Creek

Figure 7 shows that many sections along Ramsay Creek had low levels of instream woody debris in the form of branches and trees. Instream woody debris is important for fish and benthic habitat, providing refuge and feeding areas.

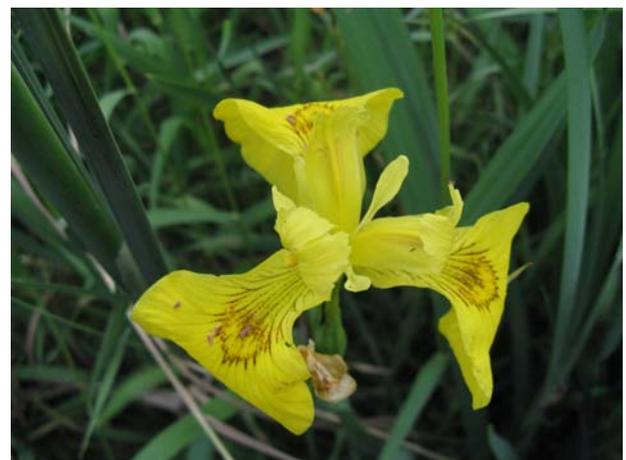
Yellow iris, an invasive species found on Ramsay Creek

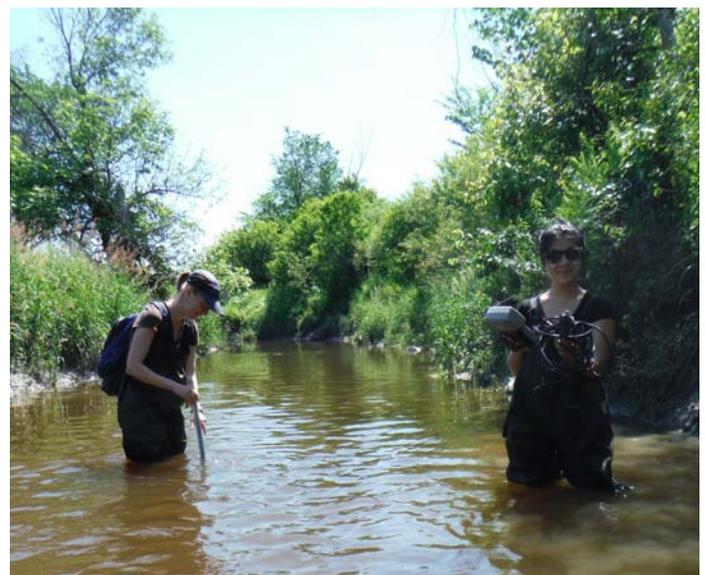
Volunteers measuring water chemistry parameters

Month	Range	DO (mg/L)	DO(%)	Conductivity (µs/cm)	pH
June 2013	Low	7.18	75.31	482.00	7.07
	High	10.91	114.43	1164.00	8.15
July 2013	Low	0.25	2.69	460.00	6.68
	High	11.61	124.71	773.00	8.96

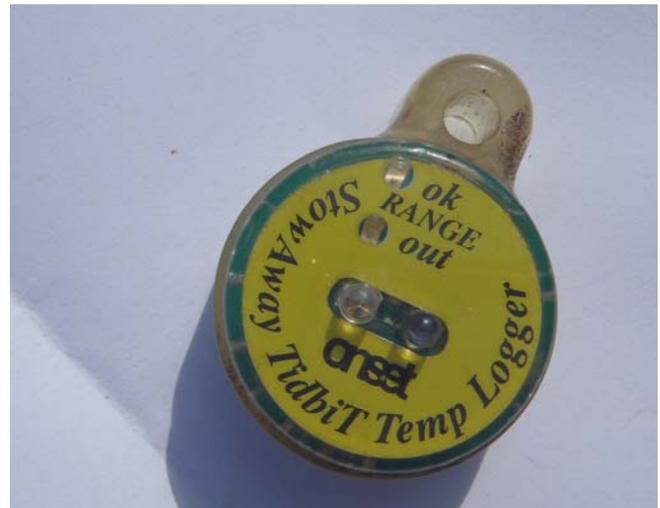
Temperature logger

There were four temperature loggers installed on Ramsay Creek from April until September. Logger 1 was installed at Walkley Road, logger 2 was installed at Ramsayville Road, logger 3 was installed at Russell Road and logger 4 was installed at Leitrim Road. Analysis of the data collected indicates that Ramsay Creek is classified as a warm water system with cool water reaches. The cool water reaches were recorded by logger 4 located in the upper reaches of the creek close to Leitrim Road. There was no evidence of groundwater inputs observed during surveys.

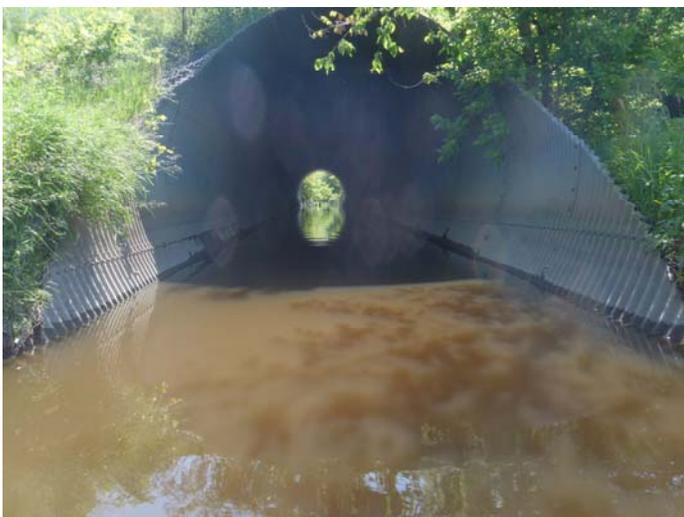
A stream section considered highly altered in 2013

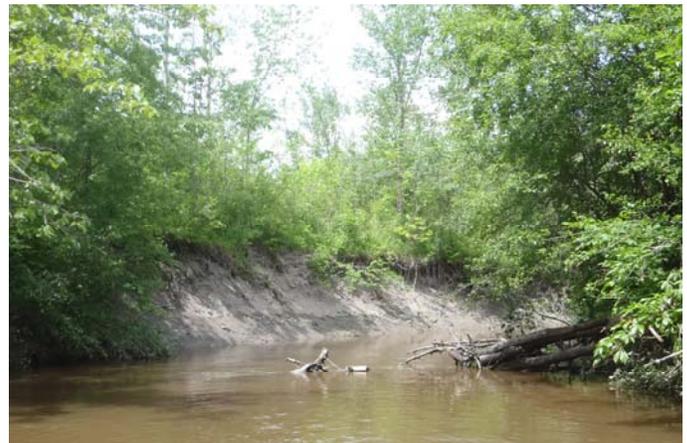
An unstable stream section recorded in 2013

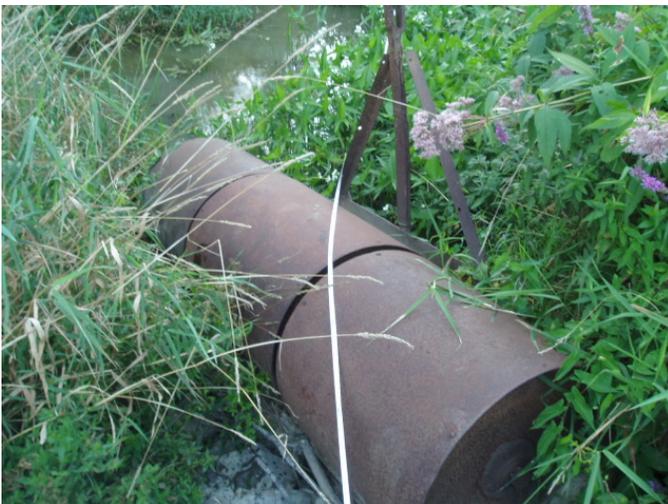
A pavement roller that was found on Ramsay Creek in 2007 and 2013
