Cranberry Creek 2013 Summary Report

Cranberry Creek is approximately 19 kilometres long and runs through areas dominated by naturally occurring woodlands and wetlands as well as agricultural lands. The watershed supports a provincially significant wetland called Cranberry Creek wetland. The headwaters of Cranberry Creek begin west of Malakoff Road and it crosses many roads including Highway 416 before it empties into the Rideau River south of Kars.

In 2013 permission was granted to survey 43 sections of Cranberry Creek. The following is a summary of the observations made along those 43 sections.

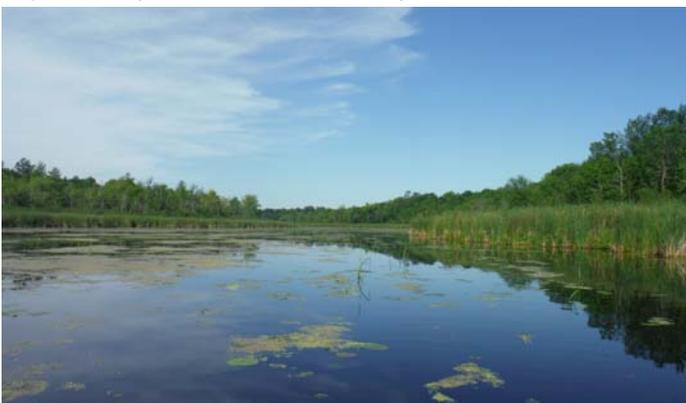
Vegetated buffer along Cranberry Creek

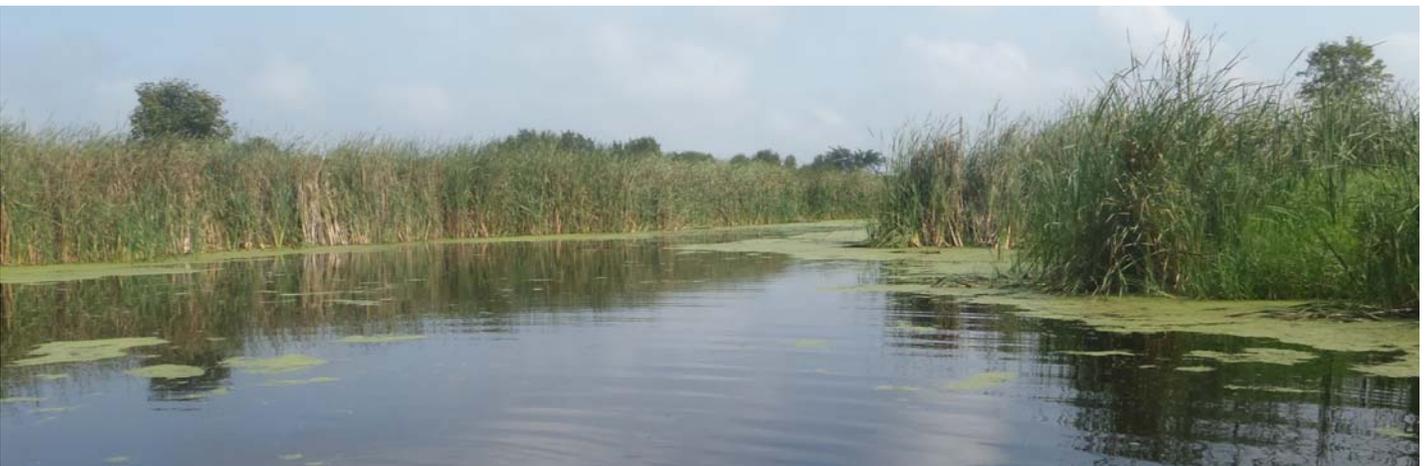
Wetland plants buffering stream banks on Cranberry Creek

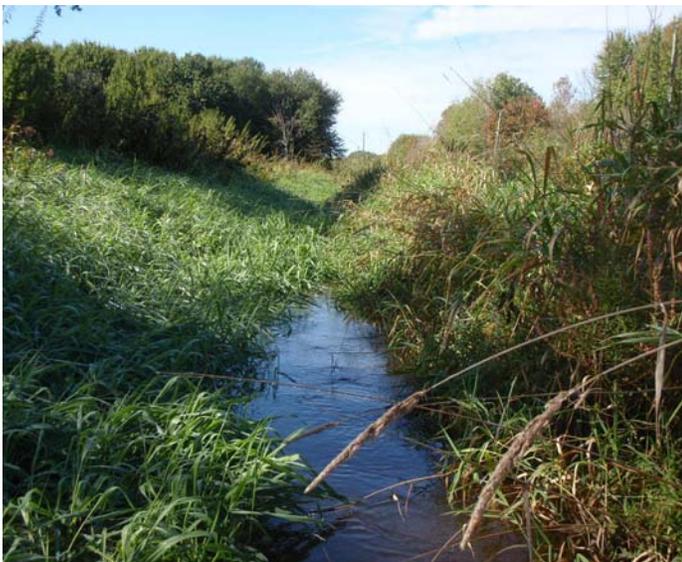
Stream shading from emergent grasses along Cranberry Creek

Grasses, shrubs and trees all contribute towards shading a stream. Shade is important in moderating stream temperature, contributing to food supply and helping with nutrient reduction within a stream. Figure 6 shows stream shading along Cranberry Creek. Low to moderate levels were seen along most of the surveyed sections of the creek. The creek is extremely wide in the lower reaches which is a reason why stream shading is low in those areas.

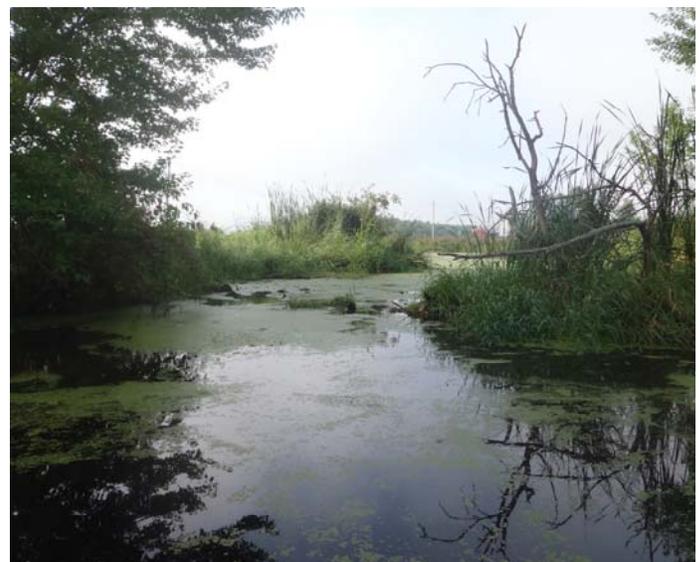
Low levels of Instream woody debris on Cranberry Creek

Instream woody debris is important for fish and benthic habitat, providing refuge and feeding areas. Figure 7 shows that many sections along Cranberry Creek had low levels of instream woody debris in the form of branches and trees. Low levels are predominant because the surveyed sections of the creek are dominated by wetland habitat with little woody vegetation nearby.

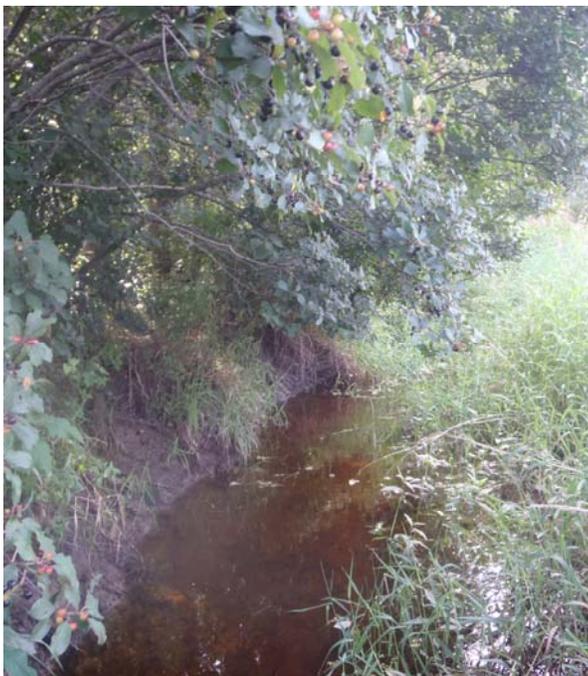
Overhanging trees and branches on Cranberry Creek

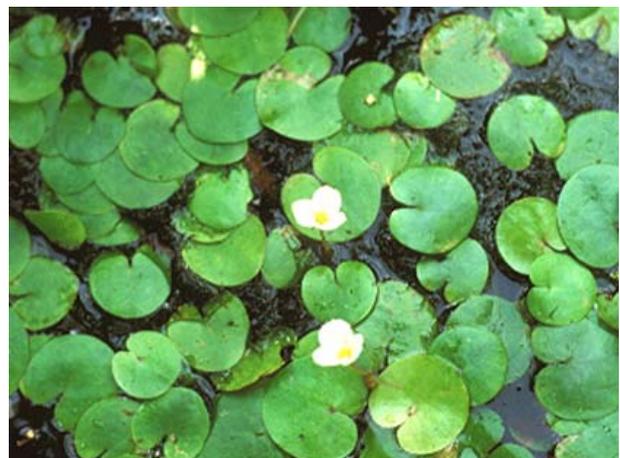
European frogbit, an invasive species found on Cranberry Creek

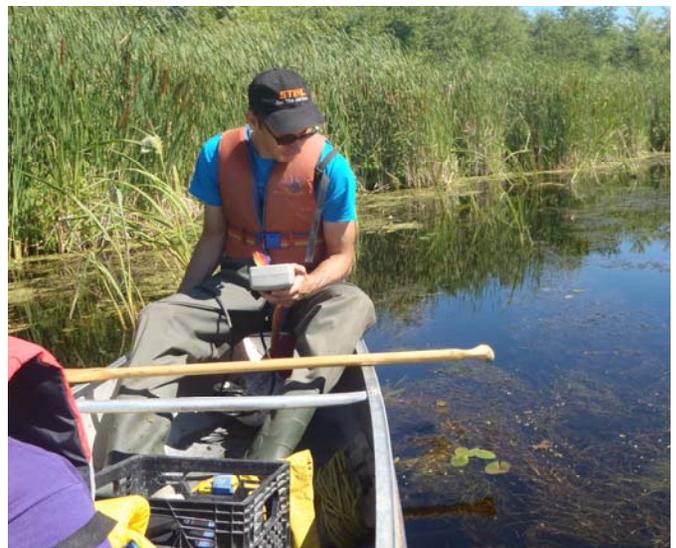
A volunteer measuring water chemistry parameters

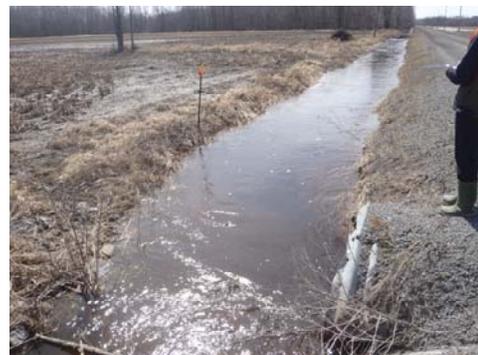
Spring HDF sampling at a site along Dilworth Road

The Headwater Drainage Feature sampling protocol is a rapid assessment method characterizing the amount of water, sediment transport, and storage capacity within headwater drainage features (HDF). An HDF is a depression in the land that conveys surface flow. As a result of their importance and a lack of information for headwater drainage features City Stream Watch has incorporated monitoring of these systems at 19 sites in the Cranberry Creek catchment (Figure 21).

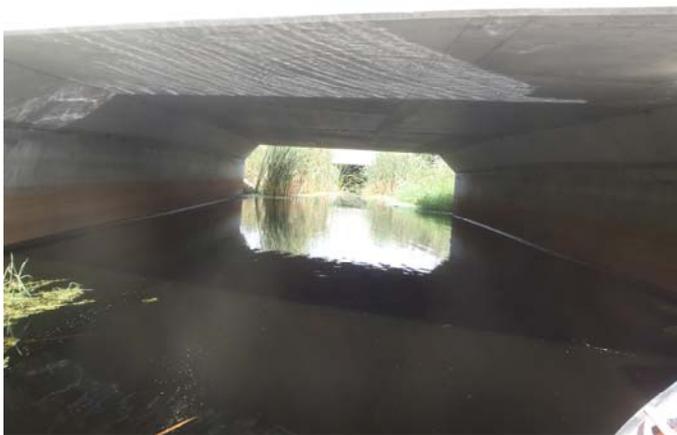
A highly altered section of Cranberry Creek that runs through a culvert under highway 416

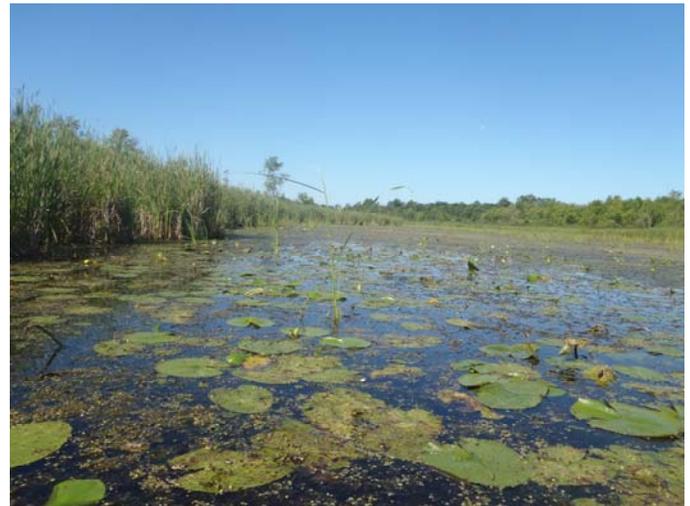
The banks of Cranberry Creek are dominated by wetland plants making them very stable

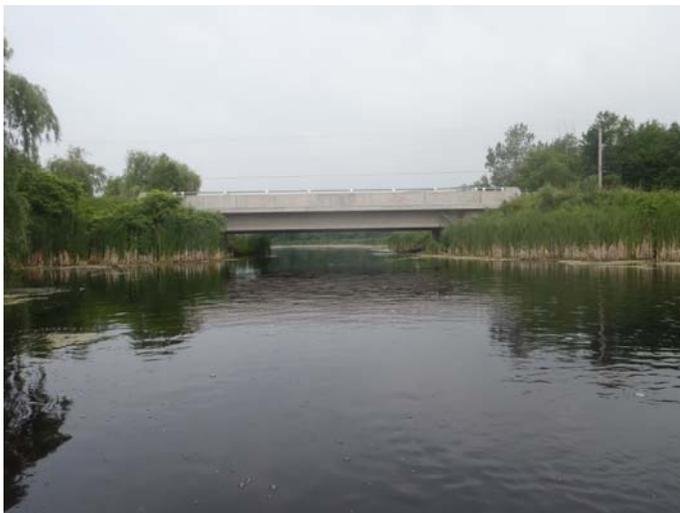
Cranberry Creek crossing at Rideau Valley Drive—one of the sites where people are accessing the creek and floating garbage was found
