Cranberry Creek 2019 Catchment Report

Introduction

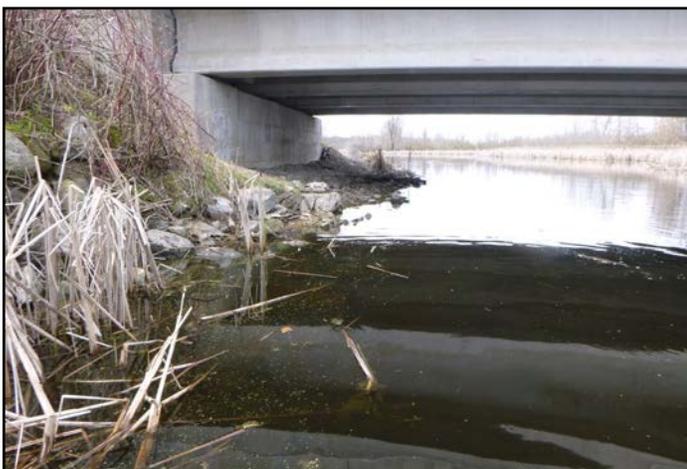
Rip rap used as an control measure at a road crossing in Kars along Cranberry Creek

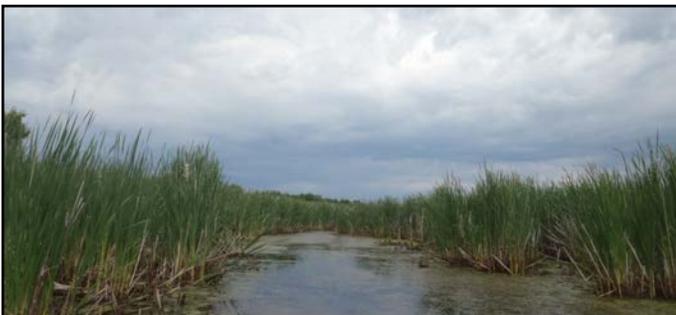
Site on Cranberry Creek near the Highway 416 with **impaired** oxygen conditions (Dissolved oxygen levels of 1.03 mg/L and 12.0 % saturation)

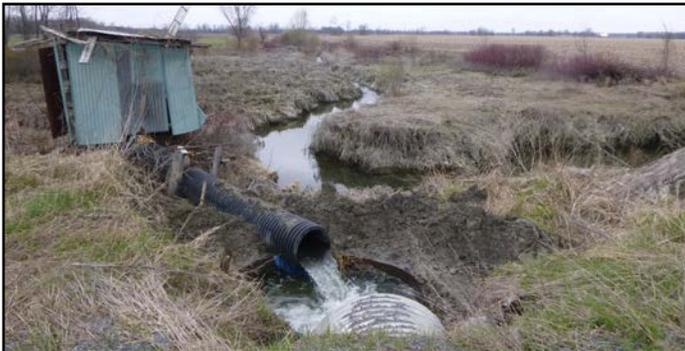
Tiling and modifications of headwater drainage features create fish migratory obstructions, loss of aquatic habitat and spawning areas for fish species

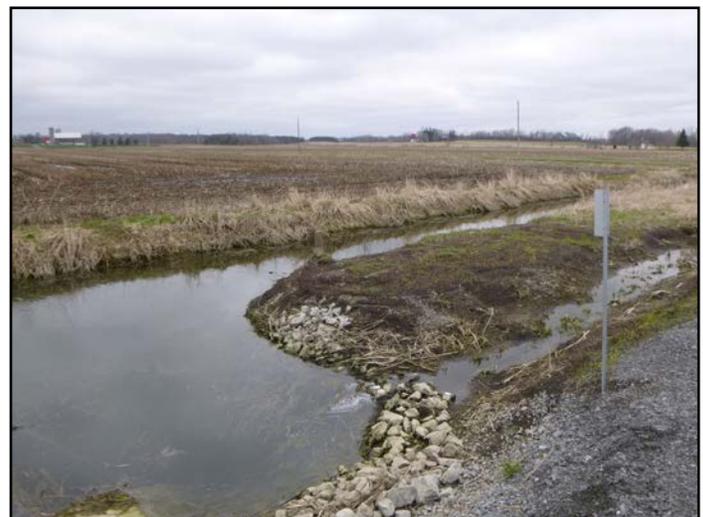
An example of mixed modifications on a headwater drainage feature: dredging and channel hardening with rip rap on Fourth Line Road

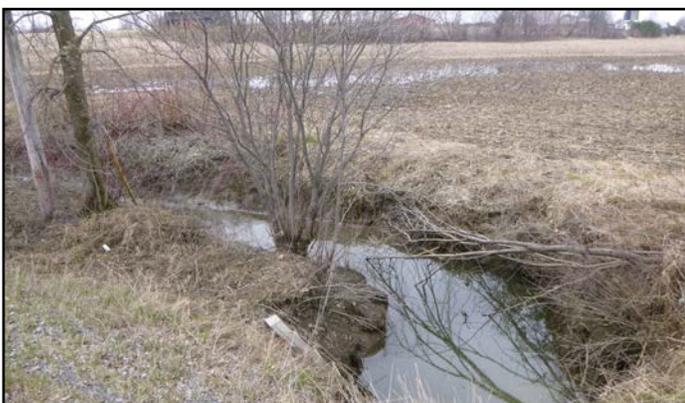
Substantial sediment deposition observed in a headwater drainage feature on Lockhead Road
