# Black Rapids Creek 2022 Catchment Report

## Catchment Features

## Introduction

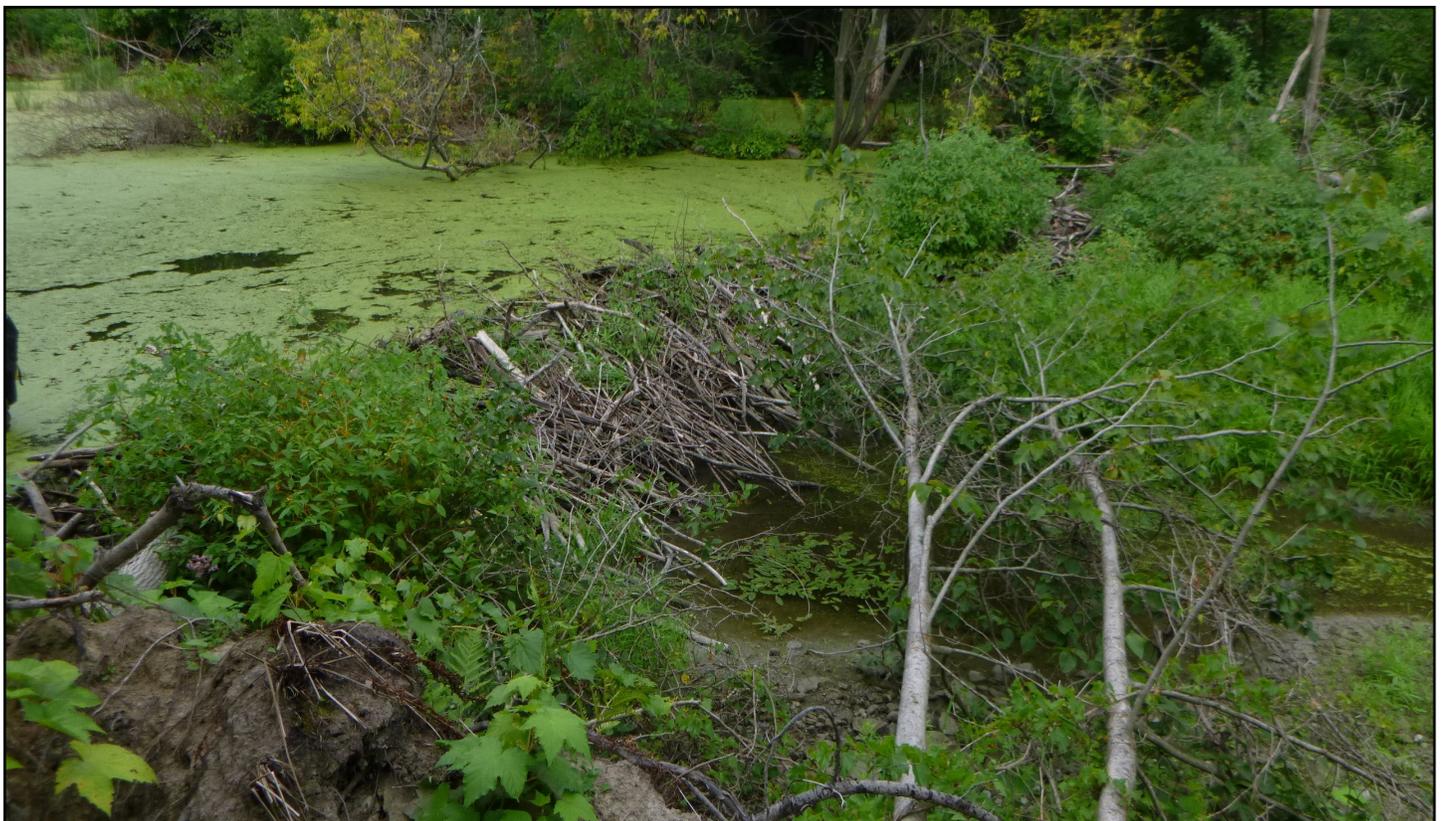
Beaver dam activity observed along Black Rapids Creek.

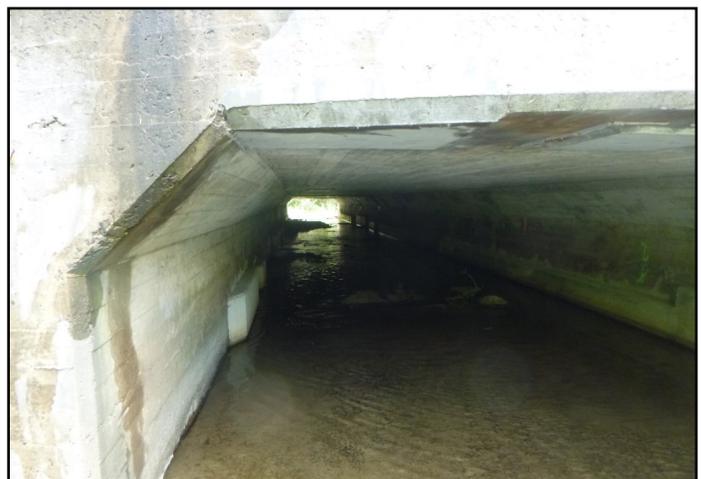
Roadway infrastructure on Prince of Wales along Black Rapids Creek.

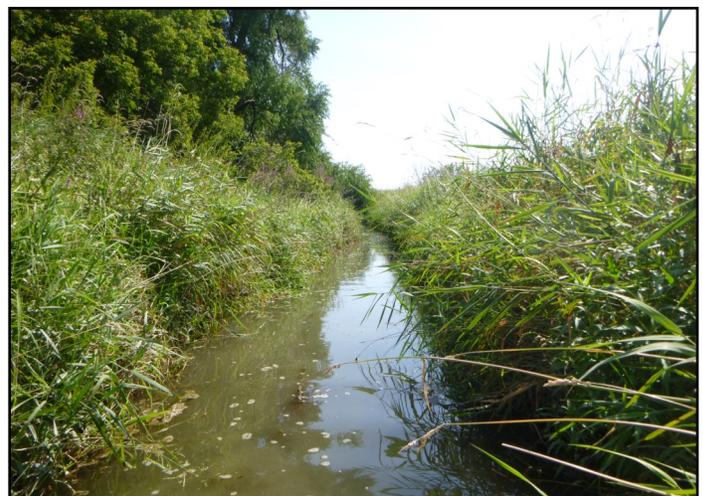
Channelized section of Black Rapids Creek in the headwaters near Woodroffe Road with increased turbidity.

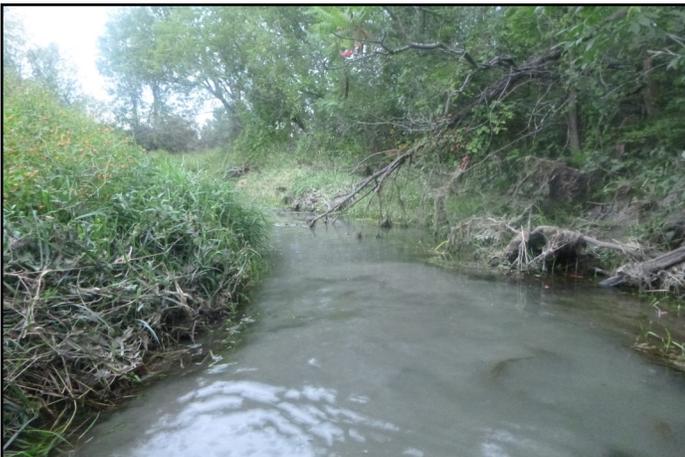
Minor bank erosion along Black Rapids Creek.

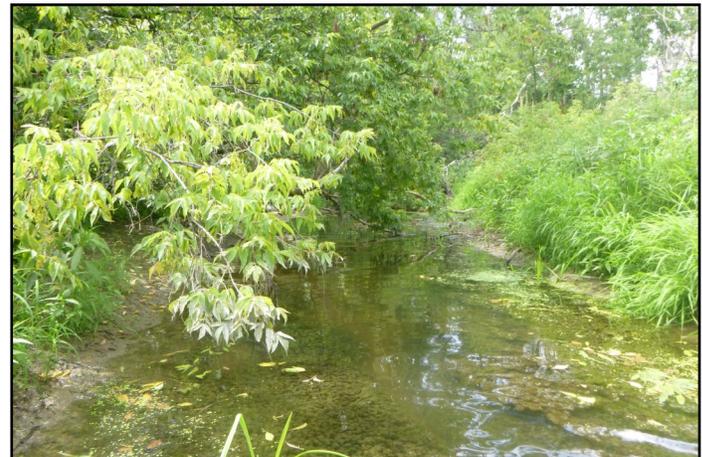
Undercut banks west of Prince of Wales Drive along Black Rapids Creek.

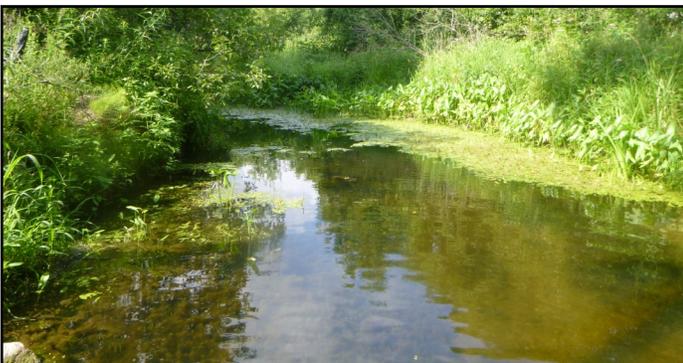
Section on Black Rapids Creek west of Prince of Wales Drive with **impaired** oxygen conditions (Dissolved oxygen levels of 4.86 mg/L and 55.8% saturation).

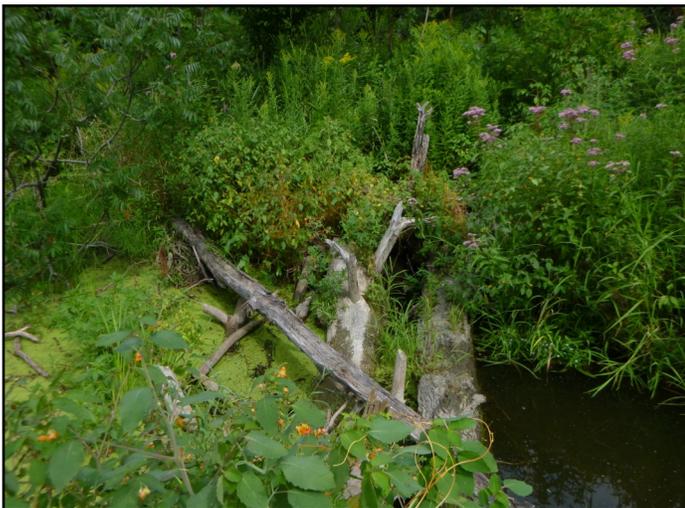
Debris dams, such as the one above, seen along Black Rapids Creek create seasonal migratory obstructions for many fish species.

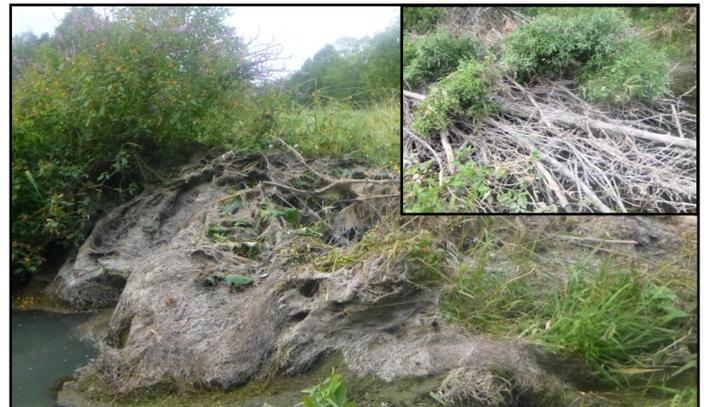
An active beaver dam and a lodge along Black Rapids Creek upstream of Merivale Road.

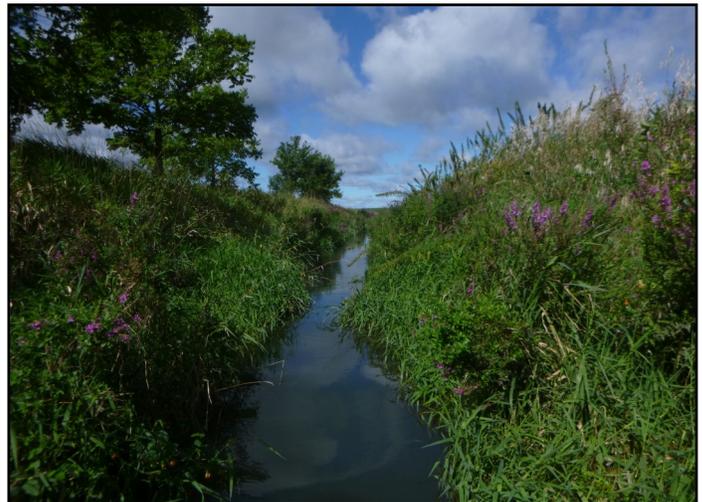
Area of Black Rapids Creek in the headwaters that would benefit from riparian planting.

Certain riparian areas of Black Rapids Creek can benefit from planting to increase plant diversity. Many sections had riparian buffers of low plant diversity. Additional planting would increase shading, enhance wildlife habitat, prevent soil erosion and mitigate negative impacts from runoff and anthropogenic input.
