# Stillwater Creek 2015 Summary Report

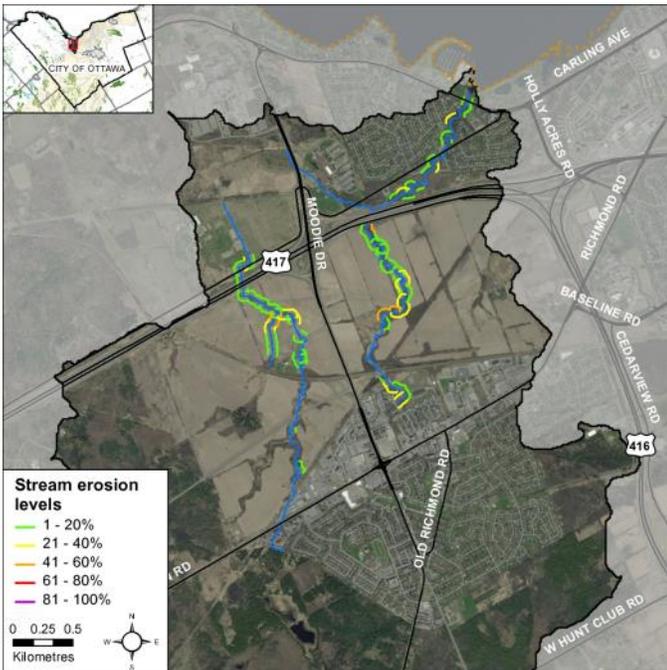
Figure 4 Erosion along Stillwater Creek

Erosion is a normal, important stream process and may not affect actual bank stability; however, excessive erosion and deposition of sediment within a stream can have a detrimental effect on important fish and wildlife habitat. Poor bank stability can greatly contribute to the amount of sediment carried in a waterbody as well as loss of bank vegetation due to bank failure, resulting in trees falling into the stream and the potential to impact instream migration. Figure 4 shows low to moderate levels of bank erosion were observed along many sections of Stillwater Creek. Most of the areas where erosion was observed were in the agricultural lands south of Highway 417 on the main channel of the creek and its tributary. Shoreline stability in this area could be improved by increasing the vegetated buffer width along the creek.

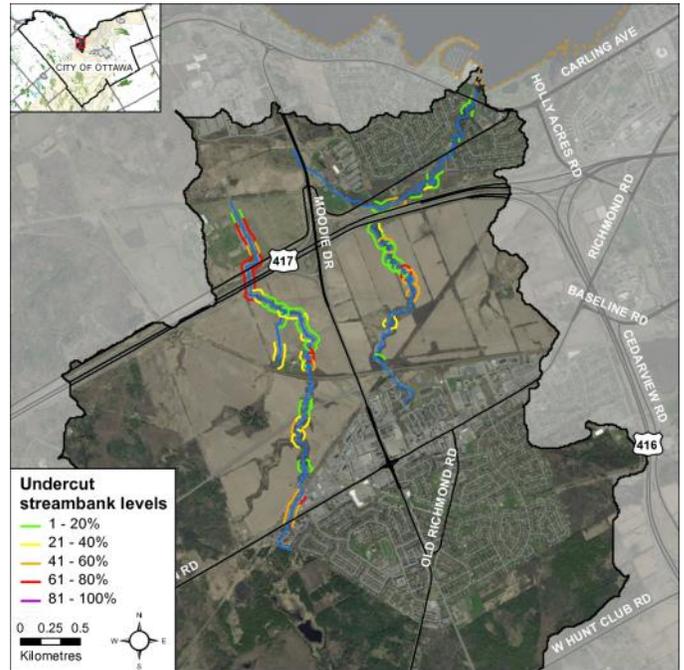
Figure 5 Undercut stream banks along Stillwater Creek

Undercut banks are a normal and natural part of stream function and can provide excellent refuge areas for fish. Figure 5 shows that the bank undercutting on Stillwater Creek varied considerably. Much of the creek had low levels of bank undercutting but these were interspersed with areas of moderate to high level undercutting. The highest levels of undercutting were observed where highway 417 crosses Stillwater Creek. The bank and substrate composition in this area is dominated by clay and the riparian vegetation is predominantly grasses so there is a possibility that the bank undercutting in section of the creek may lead to bank failure over time.

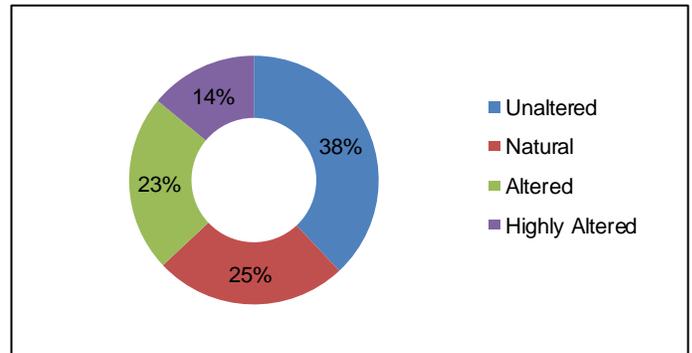
**Figure 9** Anthropogenic alterations along Stillwater Creek

Figure 9 demonstrates that 63 percent of the sections on Stillwater Creek remain “unaltered” or “natural”. Sections considered “altered” account for 23 percent of the stream, while 14 percent of the sections sampled were considered “highly altered”. The highly altered sections of Stillwater Creek refer to those that are channelized as well as those that run through a culvert or road crossing with associated instream and shoreline modifications.

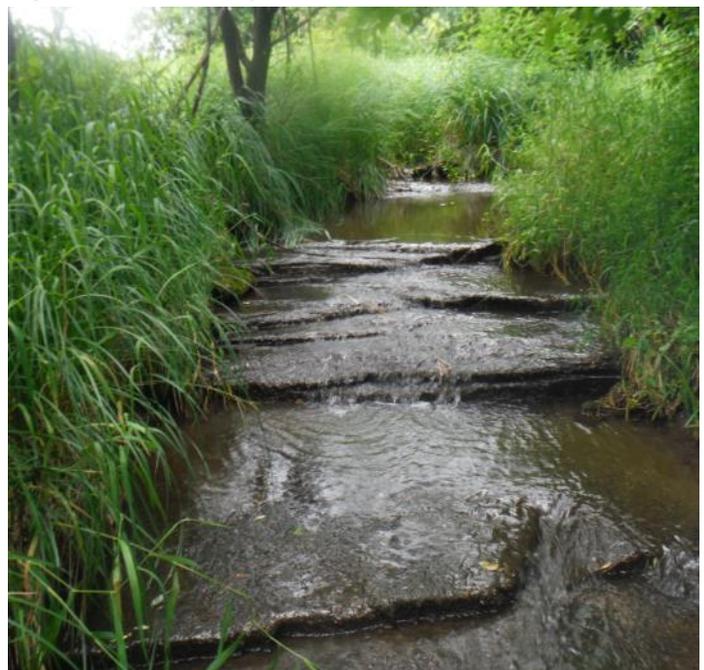
Bedrock substrate with instream low vegetation abundance

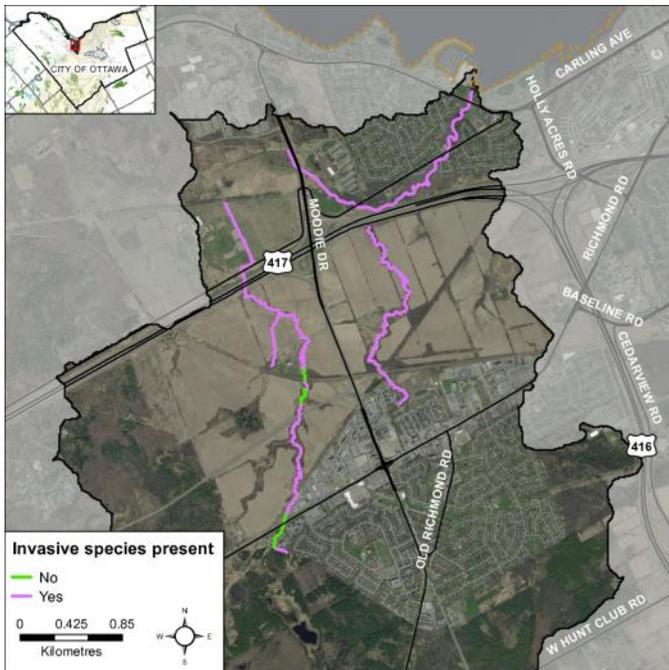
Figure 19 Presence of invasive species along Stillwater Creek

Invasive species can have major implications on streams and species diversity. Invasive species are one of the largest threats to ecosystems throughout Ontario and can outcompete native species, having negative effects on local wildlife, fish and plant populations. Invasive species were observed along 94 percent of the sections surveyed along Stillwater Creek (Figure 19). Figure 20 shows the variety of invasive species observed along Stillwater Creek. The invasive species that were observed most often were purple loosestrife (*Lythrum salicaria*), common buckthorn (*Rhamnus cathartica*), and Manitoba maple (*Acer negundo*). Most of the sections where invasive species were present had more than one invasive species recorded.

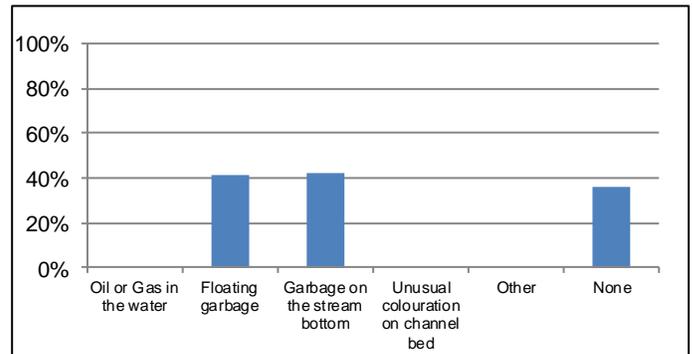
Figure 21 Pollution observed along Stillwater Creek

Figure 21 demonstrates the incidence of pollution/garbage in Stillwater Creek. Thirty six percent of the sections surveyed did not have any observable garbage. Forty two percent had garbage on the stream bottom and 41 percent had floating garbage. Many of the sections had both garbage on the stream bottom and floating garbage. These areas were located near road crossings or in the developed areas near Robertson Road and Corkstown Road.

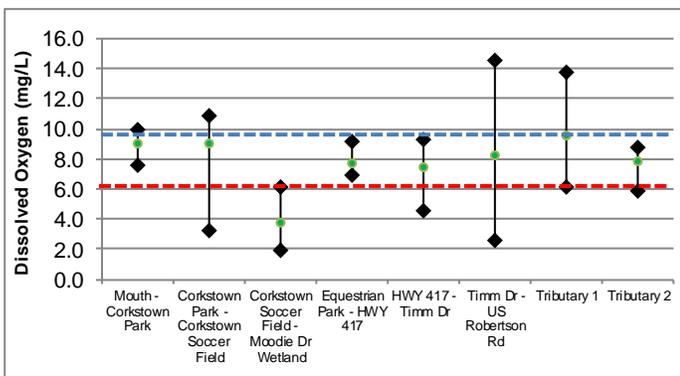
Figure 22 Dissolved oxygen ranges in Stillwater Creek

Dissolved oxygen is a measure of the amount of oxygen dissolved in water. The Canadian Environmental Quality Guidelines of the Canadian Council of Ministers of the Environment (CCME) suggest that for the protection of aquatic life the lowest acceptable dissolved oxygen concentration should be 6 mg/L for warmwater biota (red line in Figure 22) and 9.5 mg/L for coldwater biota (blue line in Figure 22) (CCME, 1999). Figure 22 shows that most of the stretches of Stillwater Creek meet the standard for warmwater biota. With an average dissolved oxygen level of 3.8 mg/L, the stretch of creek between Corkstown Road and Moodie Drive had much lower average dissolved oxygen compared to other stretches of the creek. This section is influenced by a weir and doesn't meet standard of 6 mg/L for warmwater biota.

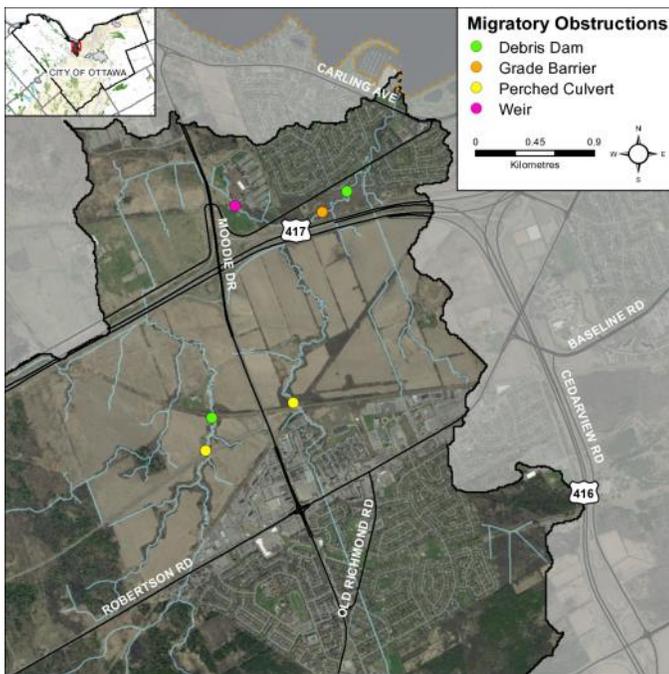
**Figure 29** Stillwater Creek migratory obstructions

It is important to know locations of migratory obstructions because these can prevent fish from accessing important spawning and rearing habitat. Migratory obstructions can be natural or manmade, and they can be permanent or seasonal. Figure 29 shows that along Stillwater Creek, two perched culverts, two debris dams, one grade barrier and one weir were observed. Fish migration is currently being impacted by the weir near Moodie Drive and the perched culverts identified on the main channel of the creek at Timm Drive and the tributary east of Moodie Drive at the old railway line.

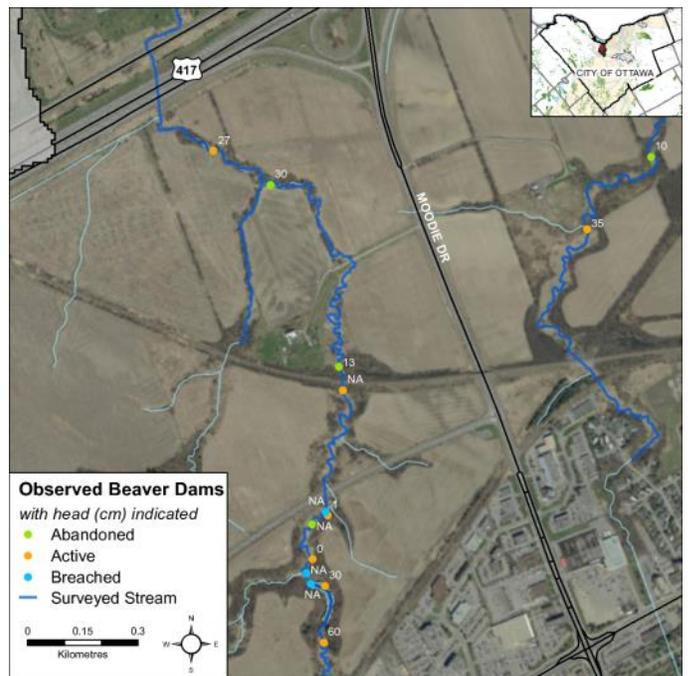
**Figure 30** Beaver dams observed on Stillwater Creek

Beaver dams can also act as obstructions to fish migration. Figure 30 shows that a number of active, abandoned and breached beaver dams were observed on Stillwater Creek. Most of the beaver activity was observed between Highway 417 and Robertson Road as well as on the tributary east of Moodie Drive. The head, or difference between the water level up and down stream, of the beaver dams ranged from 0 cm to 60 cm.

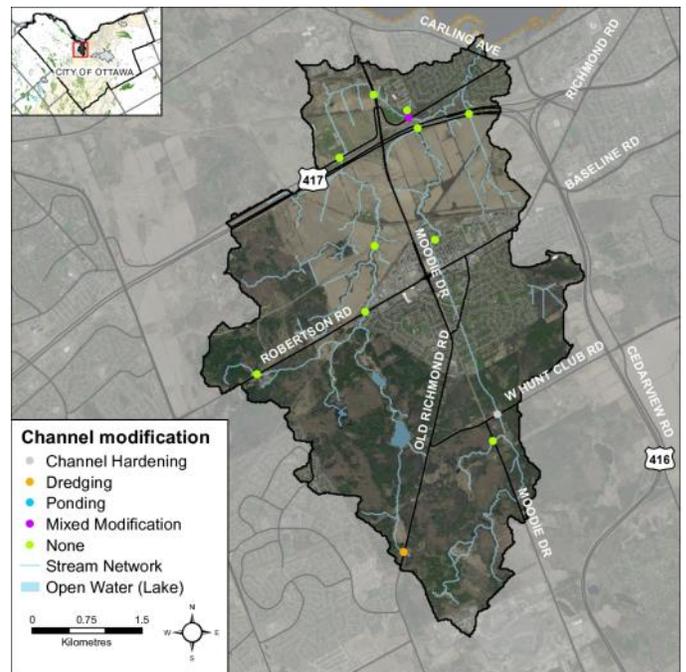
Figure 34 Mosquito Creek HDF channel modifications

Channel modifications were assessed at each headwater drainage feature sampling location. Modifications include channelization, dredging, hardening and realignments. Land use in the Stillwater Creek catchment varies widely from developed land to agriculture and natural forested and wetland areas. The majority of the sampling locations for the Stillwater Creek catchment area had no channel modifications but one site had mixed modifications, one site had channel hardening and one site had dredging. Figure 34 shows the channel modifications observed at the sampling locations for Stillwater Creek.

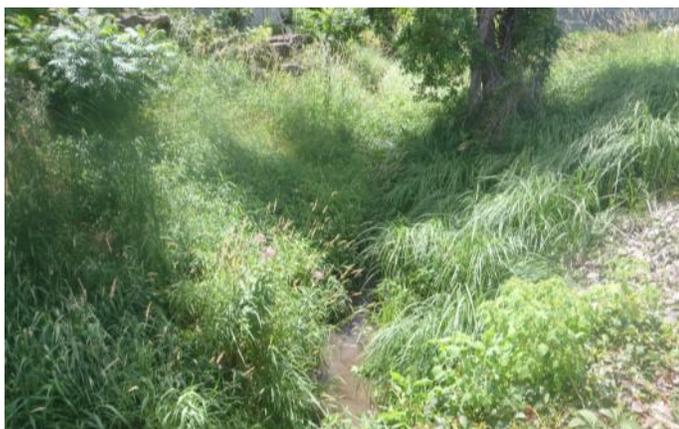
Permanent HDF sampling site along Robertson Road

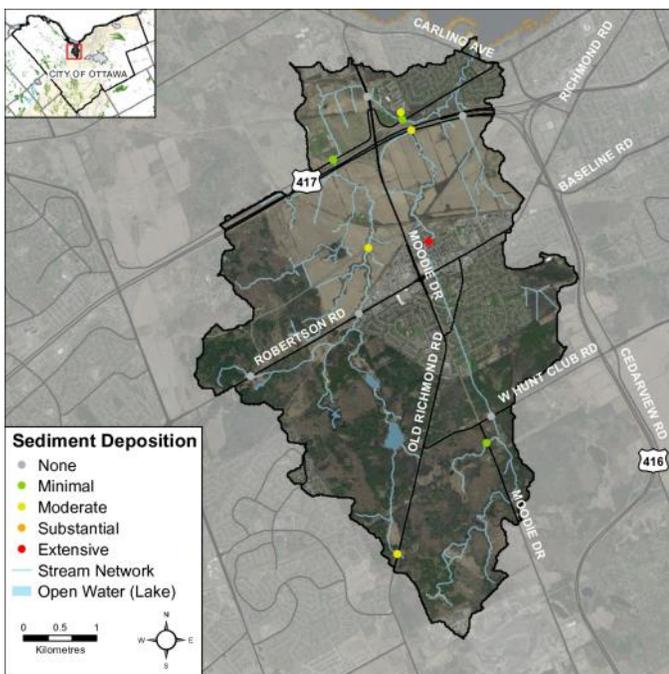
**Figure 37** Stillwater Creek HDF sediment deposition

Assessing the amount of recent sediment deposited in a channel provides an index of the degree to which the feature could be transporting sediment to downstream reaches (OSAP, 2013). Evidence of excessive sediment deposition might indicate the requirement to follow up with more detailed targeted assessments upstream of the site location to identify potential best management practices to be implemented. Conditions ranged from no deposition observed to moderate levels of sediment deposition observed. Overall, most sites had minimal or moderate levels of sediment deposition. Figure 37 depicts the degree of sediment deposition observed at the sampled headwater sites in the Stillwater Creek catchment.

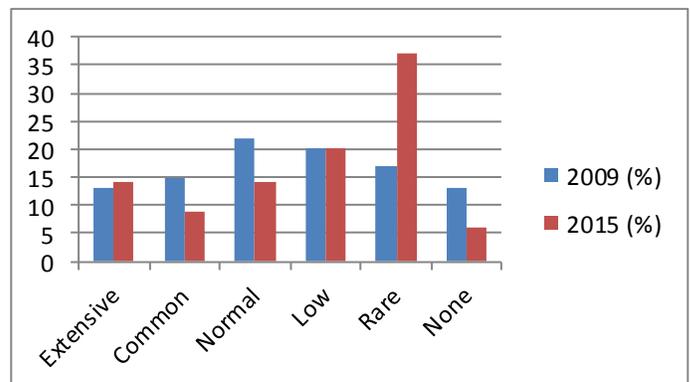
**Figure 39** Comparison of instream vegetation levels between 2009 and 2015

Figure 39 shows that there has been a decrease in instream vegetation in Stillwater Creek since 2009. The amount of areas with no vegetation and rare levels of vegetation totaled 30 percent in 2009, and that number has increased to 43 percent in 2015. Low levels have remained the same at 20 percent in both 2009 and 2015. Normal levels of vegetation have decreased from 22 percent in 2009 to 14 percent in 2015. Finally, the number of areas classified as having common and extensive levels of vegetation has decreased from 28 percent in 2009 to 23 percent in 2015. The decrease in instream vegetation may be in part attributed to increased sedimentation in the system but vegetation growth is also dependent on climatic variables as well as the stage of the growing season when observations took place.

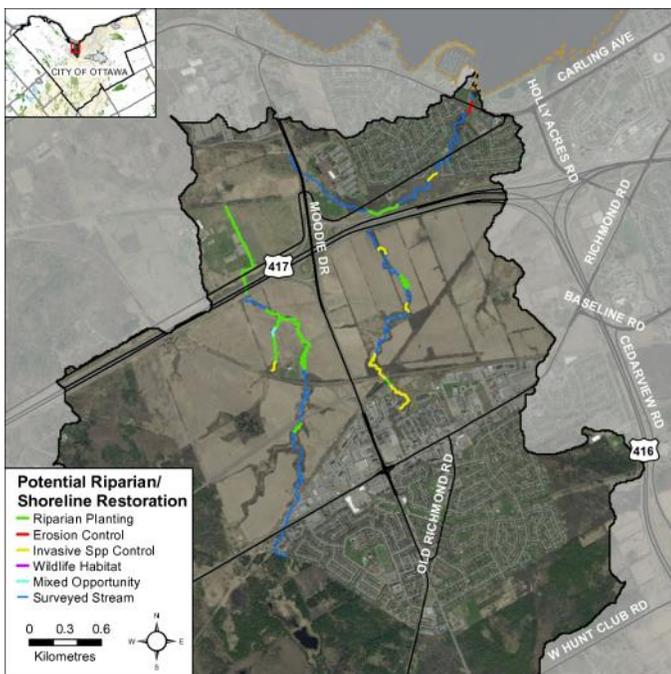
**Figure 40** Potential riparian/shoreline restoration opportunities

Figure 40 depicts the locations where City Stream Watch staff and volunteers observed areas where the riparian zone could be restored or enhanced using one or more of the following techniques: riparian planting, erosion control, invasive species control and wildlife habitat creation.

The majority of the opportunities listed were riparian planting and invasive species control. Himalayan balsam is prolific along the tributary east of Moodie Drive and numerous riparian planting opportunities were observed along the main channel of the creek and the tributaries surveyed.

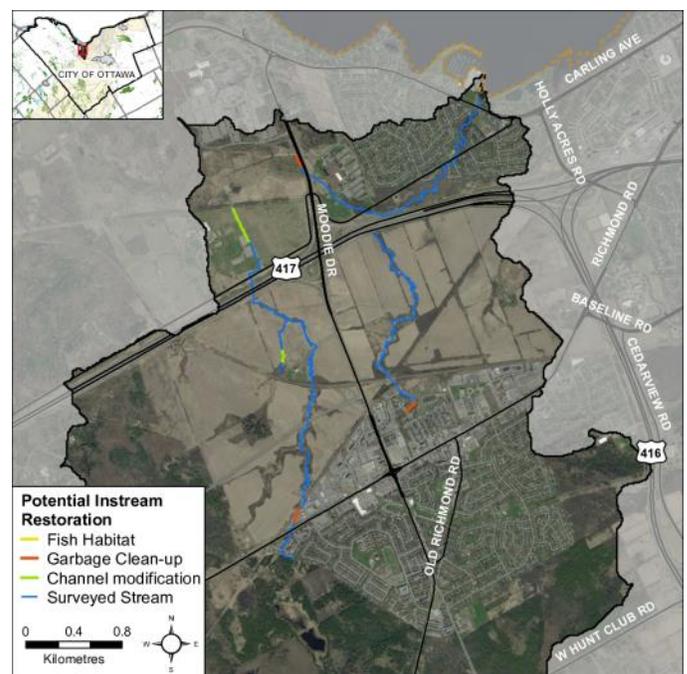
**Figure 41** Potential instream restoration opportunities

Figure 41 depicts the locations where City Stream Watch staff and volunteers made note of areas where there were one or more of the following instream restoration opportunities: fish habitat enhancement, garbage cleanup and channel modification.

Three areas were identified for stream cleanups, all near road crossings in the developed areas of Stillwater Creek. In addition, two locations where stream channelization had occurred were identified for channel modifications. An additional opportunity exists to remove the weir located downstream of Moodie Drive.
