## **Rideau Valley Conservation Authority**

### **Technical Memorandum**

**Subject:** **Analysis of Regulatory Flood Level on the Shoreline of Otter Lake, for the purposes of administering Ontario Regulation 174/06**

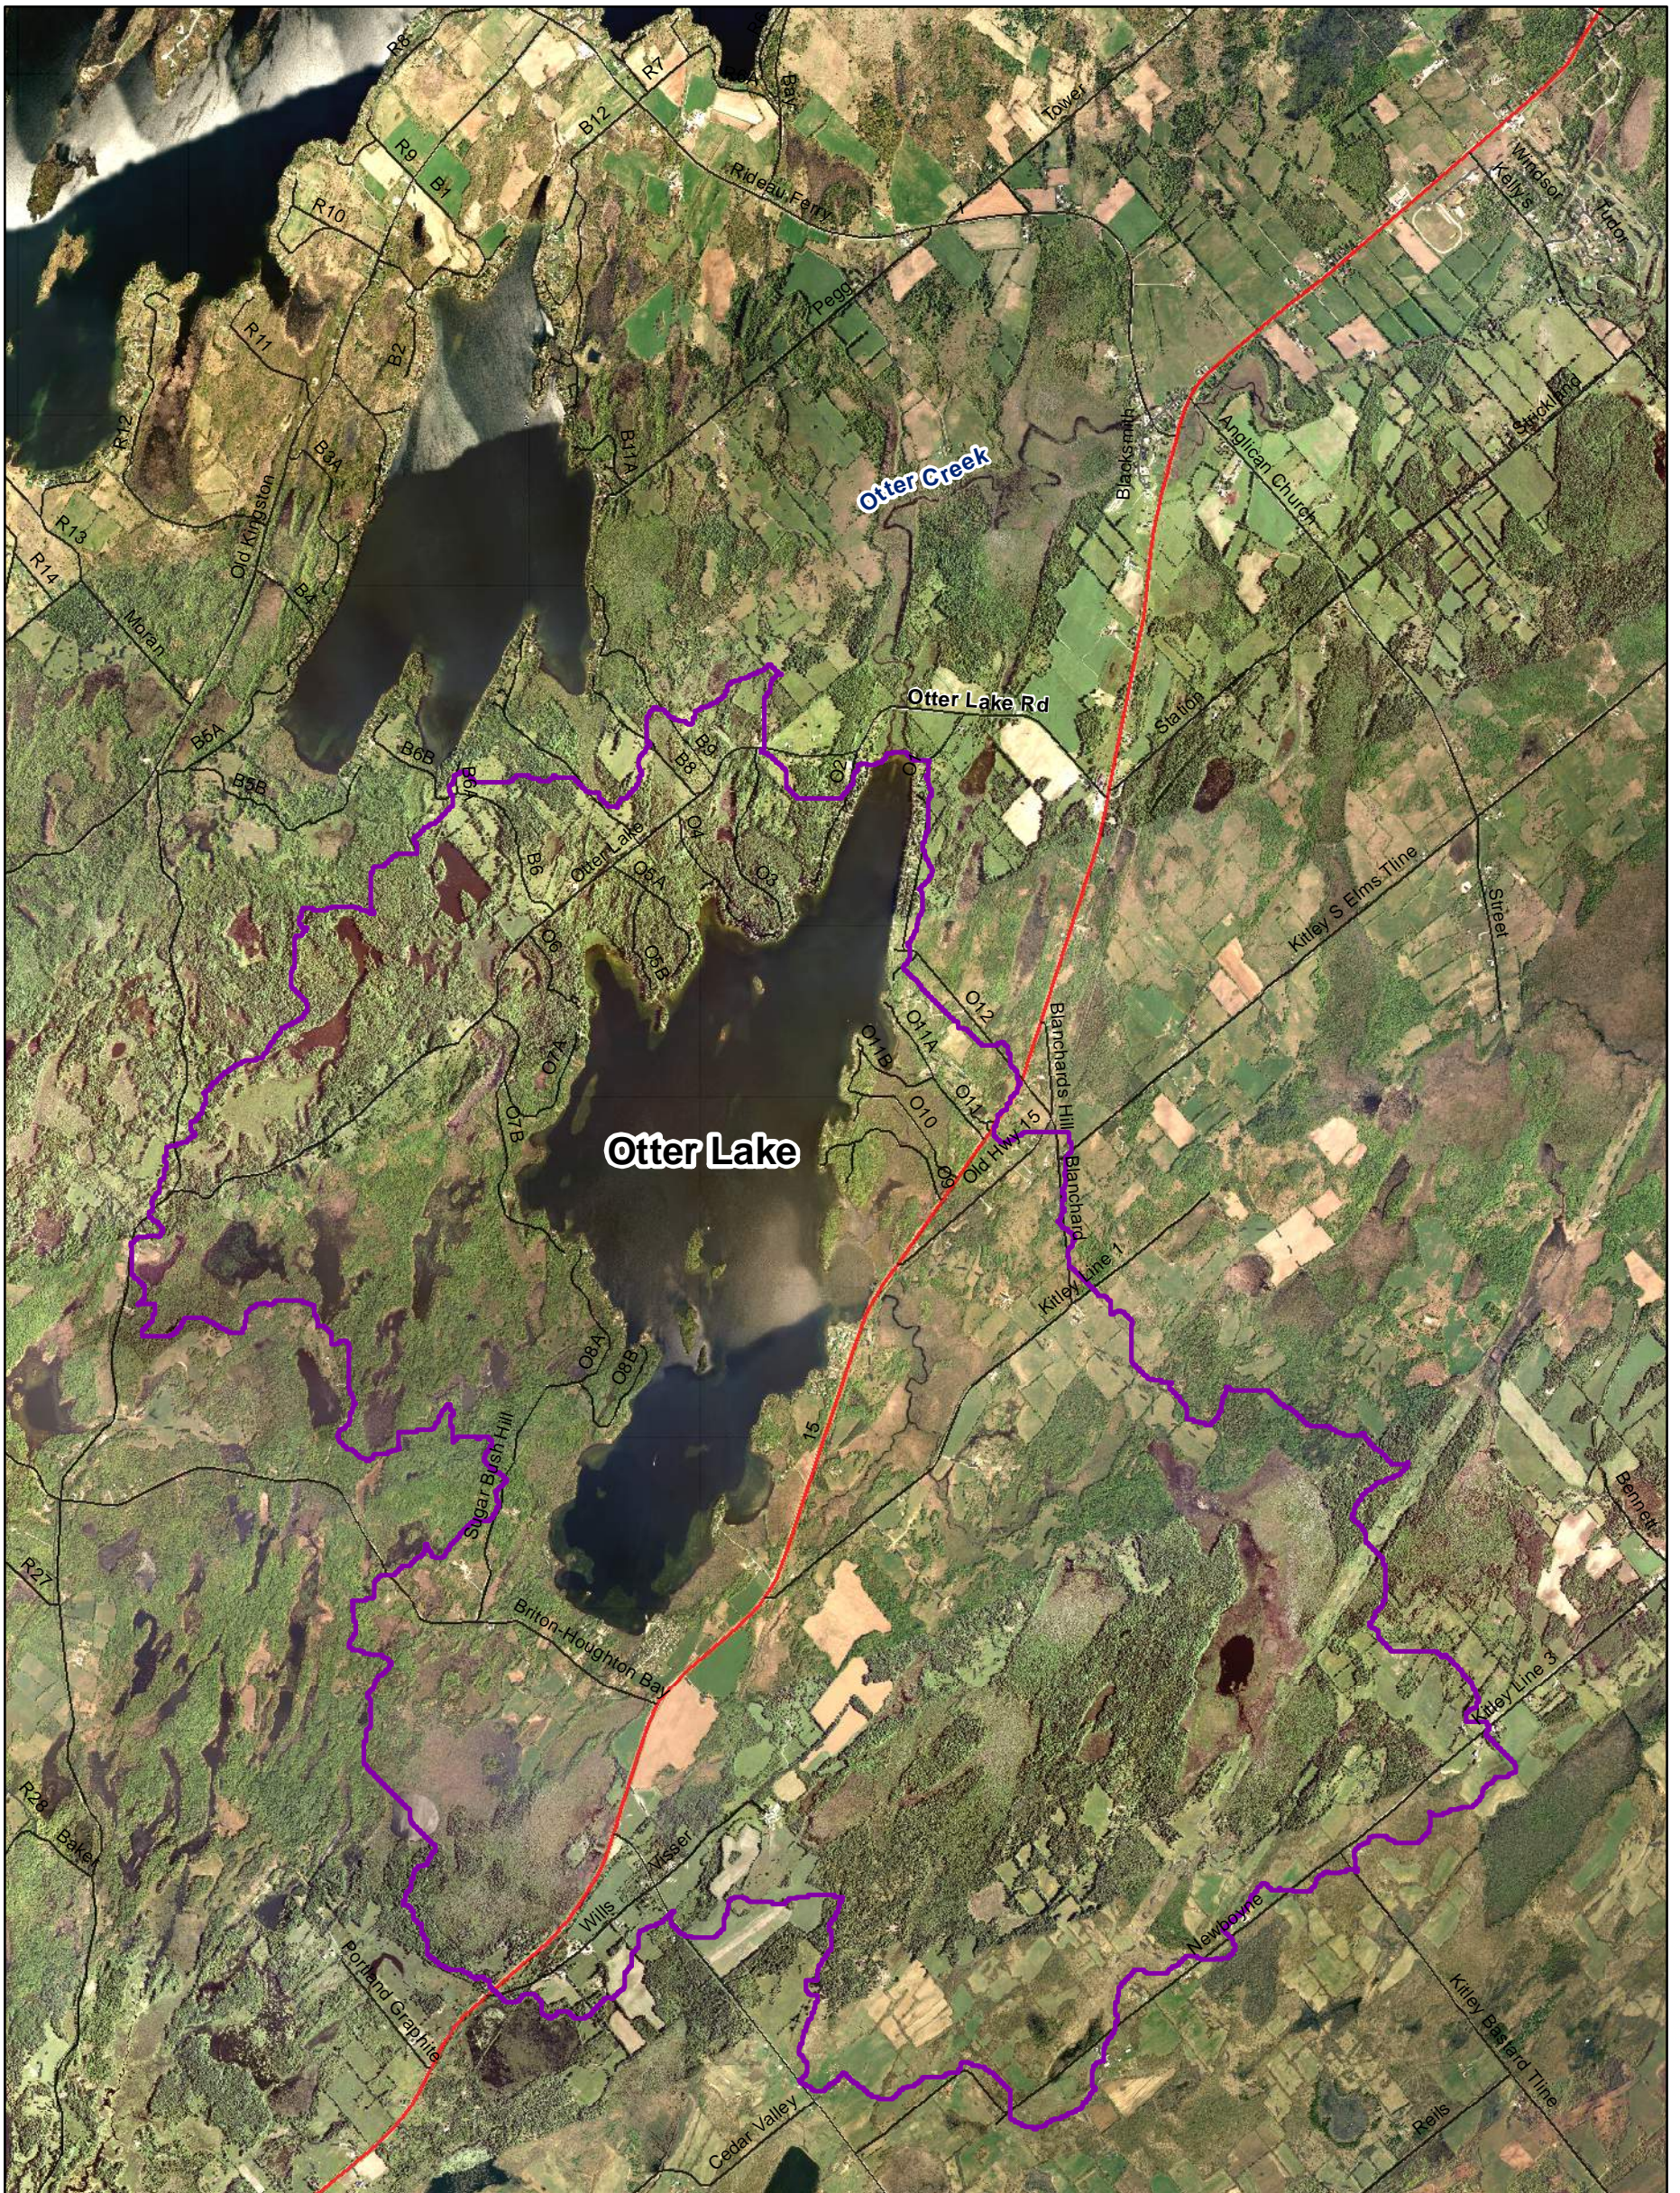
**Figure 1: Location Map**

Aerial Photo: The available DRAPE aerial photo was collected in May and June of 2008 for the entire RVCA area of jurisdiction. This high quality colored photo (Figure 1) clearly shows the rivers, creeks, land use, houses, buildings, roads, infrastructure, vegetation and other details.

The study area includes the watershed of Otter Lake as shown in Figures 1 (aerial photo base) and Figure 2 (DEM base). Ideally, regulation limits are to be produced for the entire shoreline of Otter Lake and adjacent low-lying areas based on the estimated flood lines for the 1:100 year water surface elevation. Otter Lake Road was assumed to

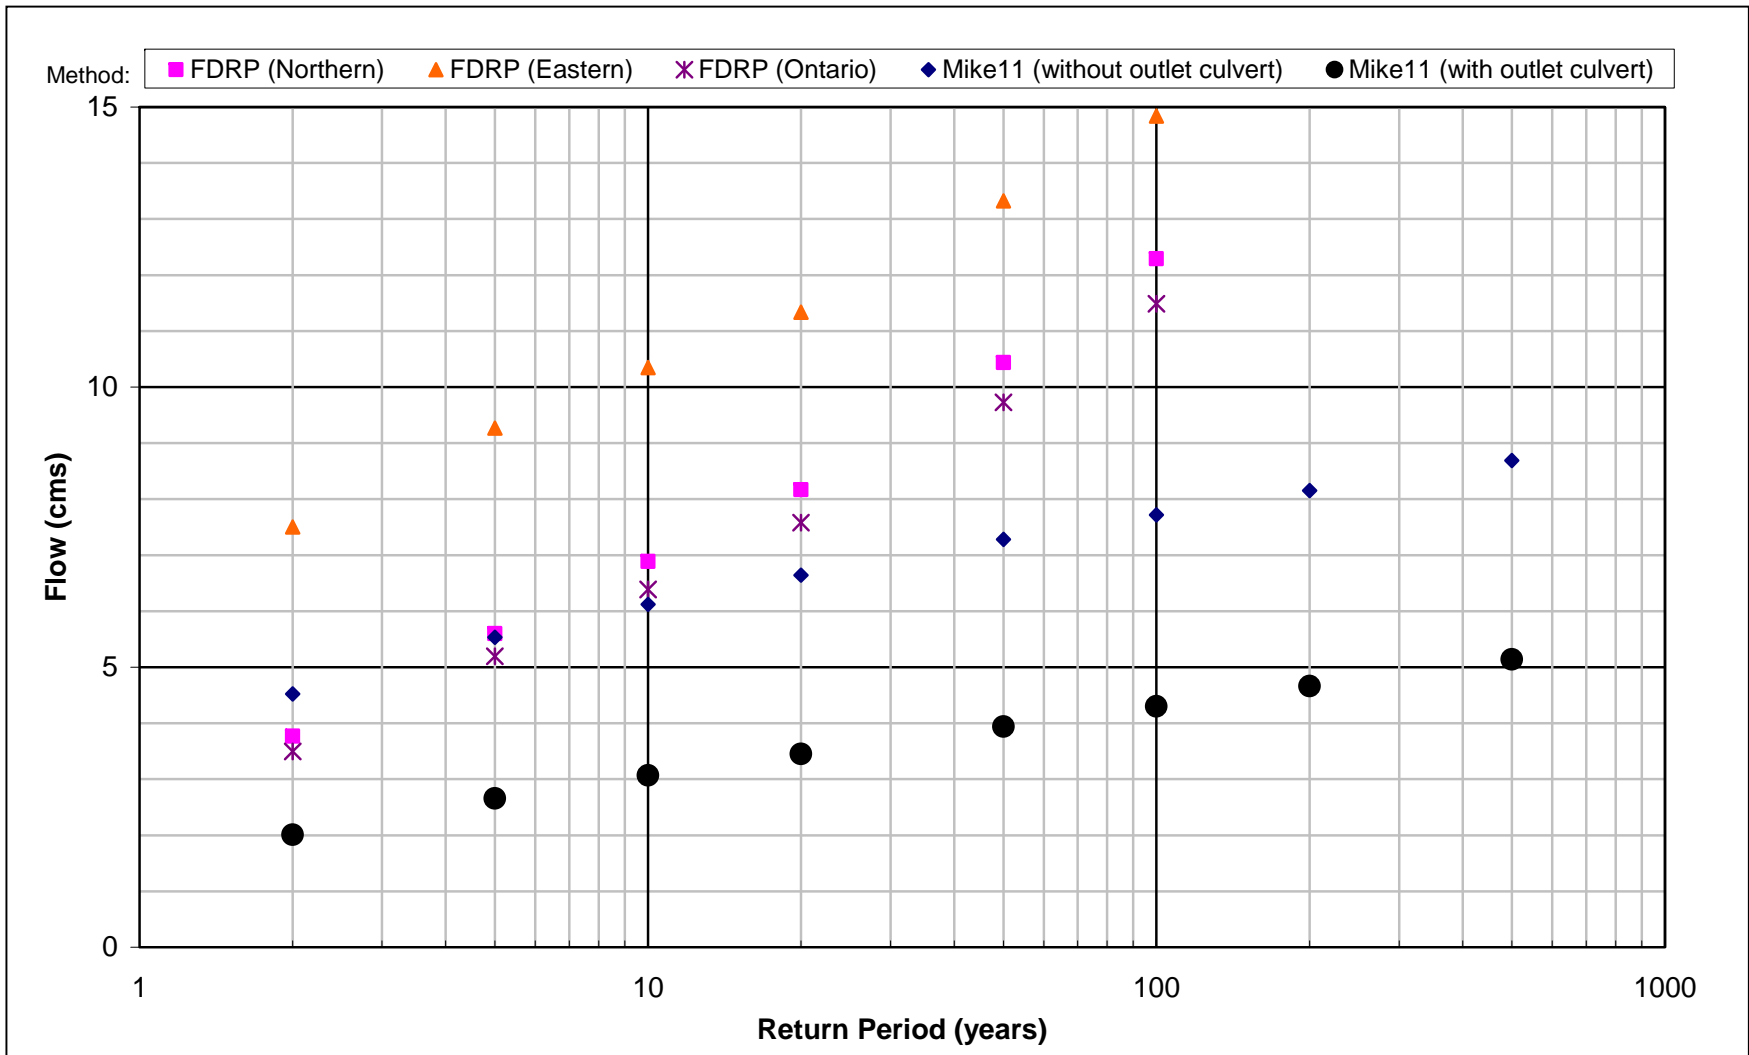
**Figure 3:** Estimated Flood Flows

As described in RVCA (2010), flood flows for the Otter Lake outlet were previously computed using a number of methods, as follows (Table 1, Figure 3):

The original Mike11 model, encompassing the whole Middle Rideau subwatershed, was done at a regional scale and did not account for the Otter Lake outlet (the existing CSPA culvert under the Otter Lake Road). As a part of this study, a new local-scale model for the Otter-Hutton system was built which included the lake outlet (Figure 15). This system was simulated from 1940 to 2007. Ignoring the first three years to avoid effects of initial condition, the remaining 65 years of simulated flow data (1943 to 2007) at the outlet of Otter Lake was used for flood frequency analysis using the CFA program of Environment Canada (Pilon and Harvey, 1993). The flood quintiles derived from this analysis are listed in Table 1 and plotted in Figure 3.

selected from amongst the range of values derived from the three “FDRP” regression equations, based on local considerations. In this examination of the Otter Lake situation, the 1:100 year flood discharge derived from long term hydrologic simulation using RVCA’s MIKE 11 model was also considered (see Figure 3).

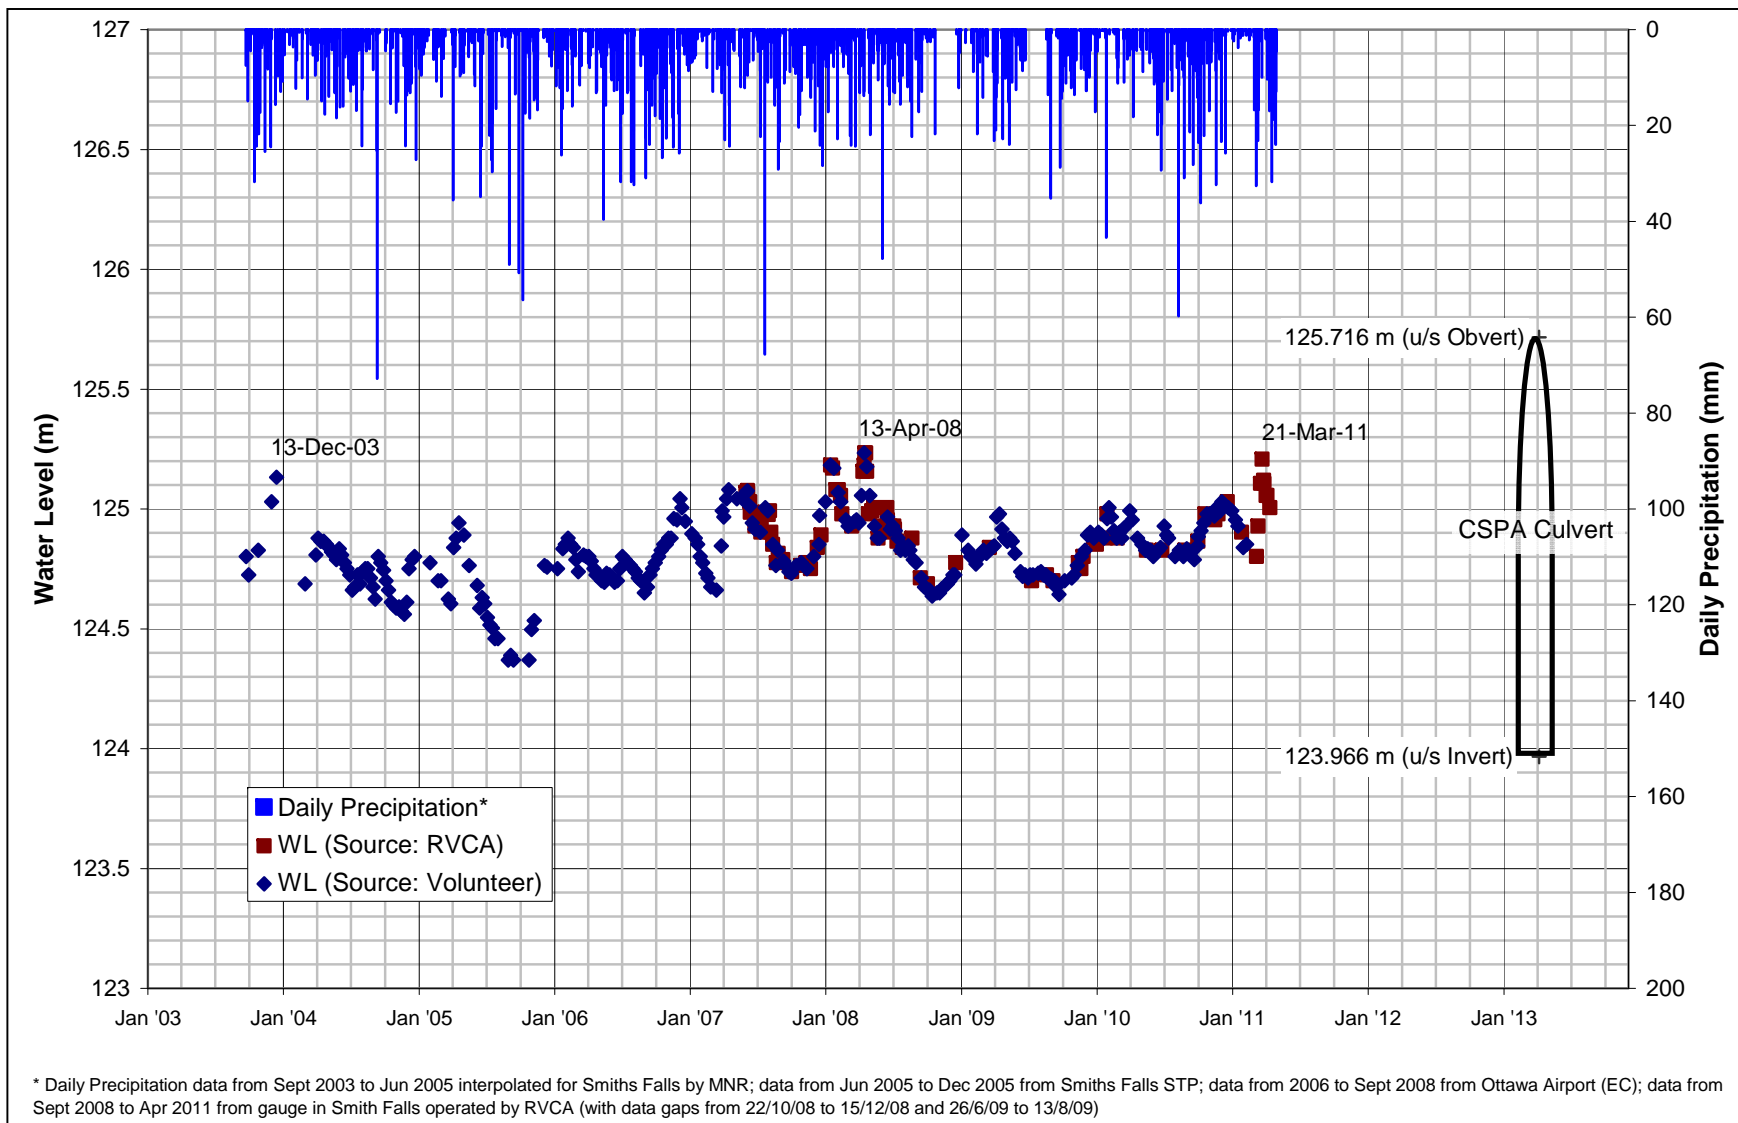
**Figure 4:** Water Level Measurements Near Otter Lake Outlet and Recorded Precipitation

Measured Water Level: Since 2003, periodic water level measurements of the lake water level near the outlet of Otter Lake have been taken by both RVCA and local residents. This information (Figure 4) has been utilized in the present study.

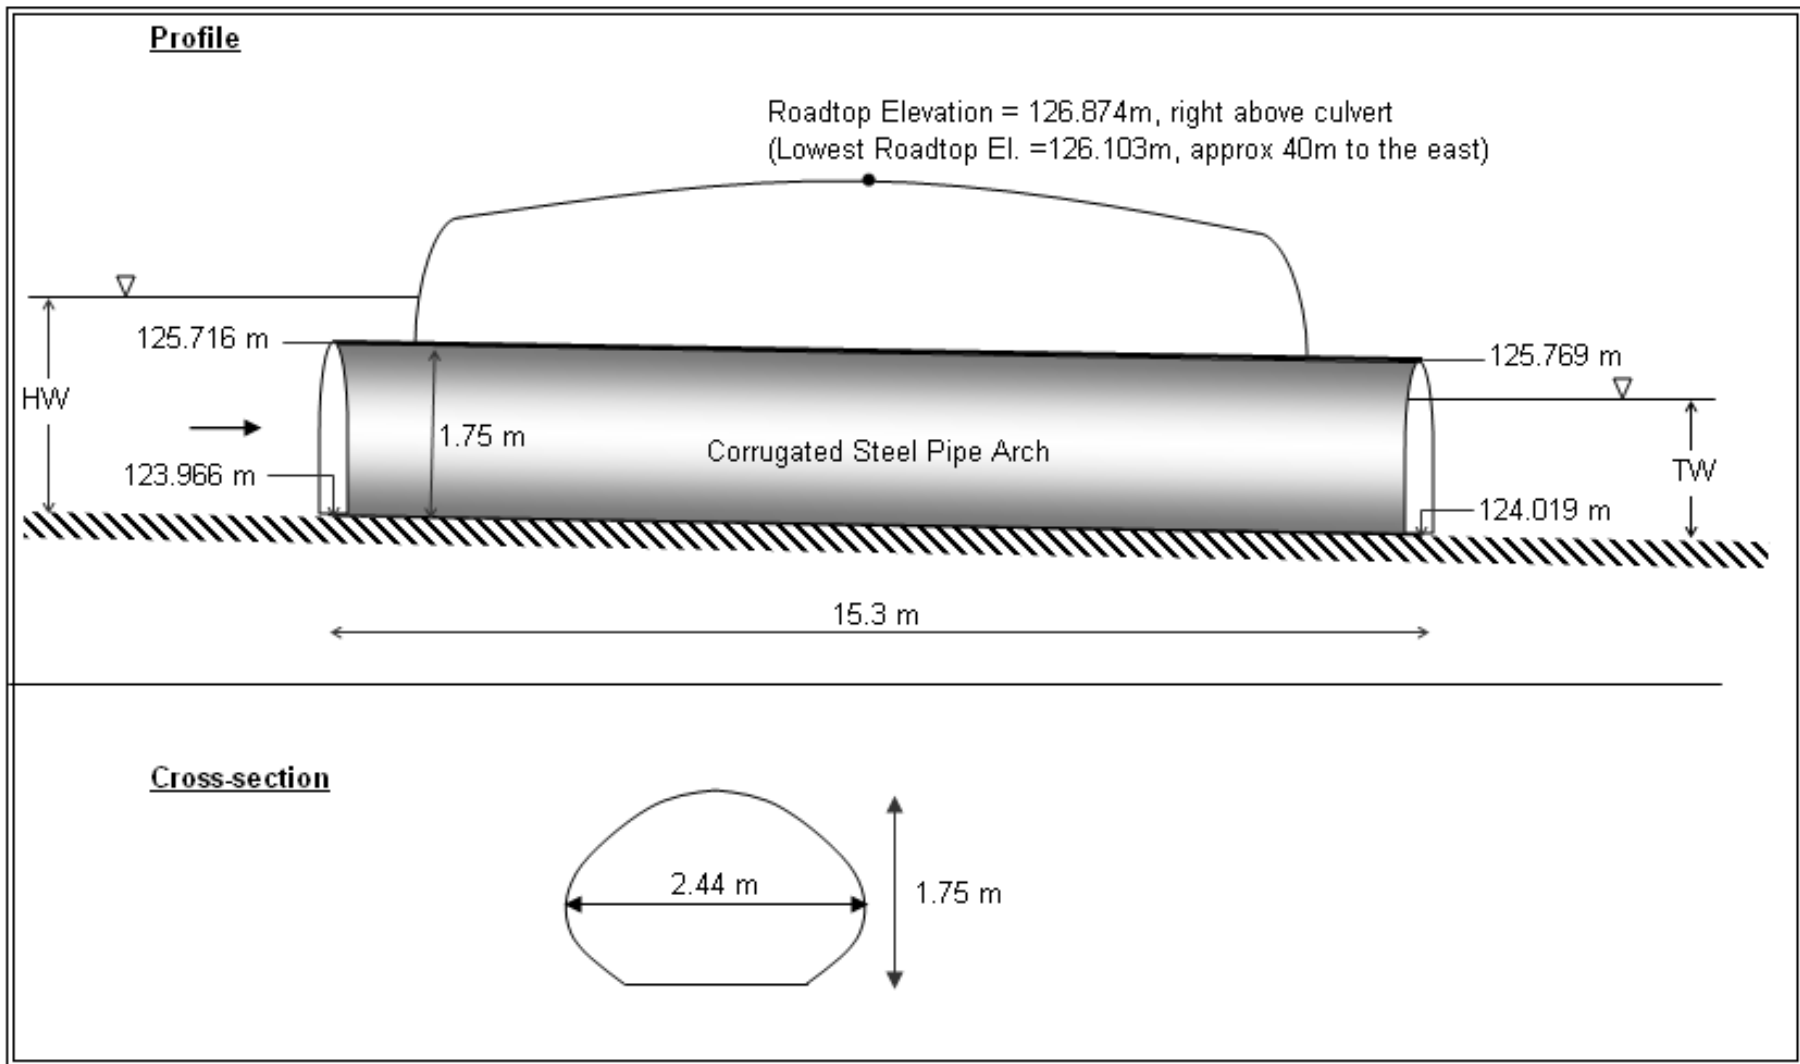
**Figure 6:** Culvert under Otter Lake Road

Outlet Culvert: The 15.3 m long, 2.44 m wide and 1.75 m high corrugated steel pipe arch (CSPA) culvert under the Otter Lake Road acts as the outlet control of the lake under high flow conditions (Figures 6, 7 and 8). Information on the culvert and the associated road profile is not available from as-built drawings, and was obtained by field surveys undertaken by RVCA technologists.

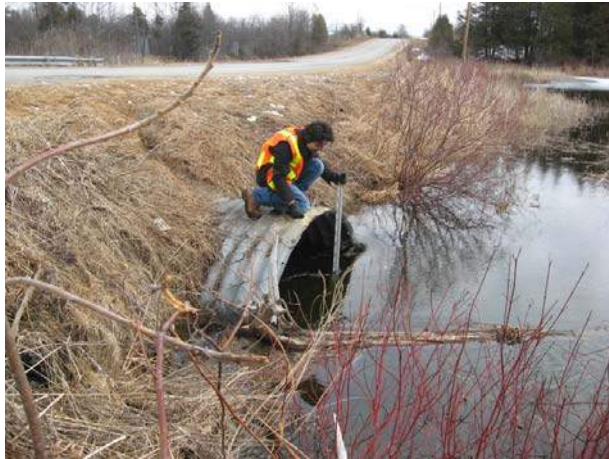
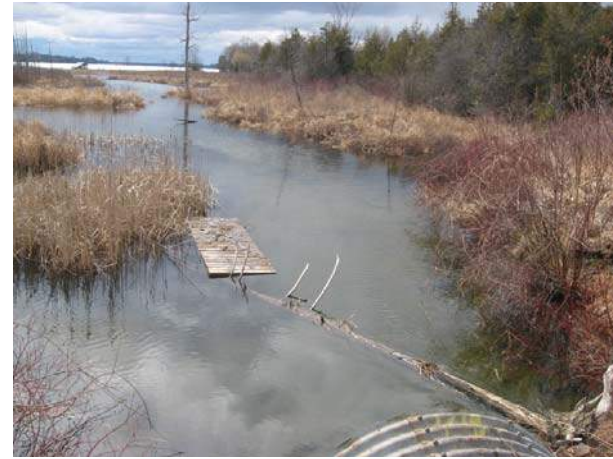
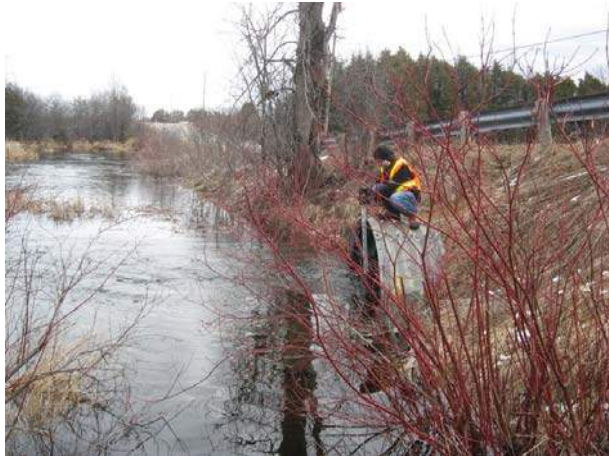
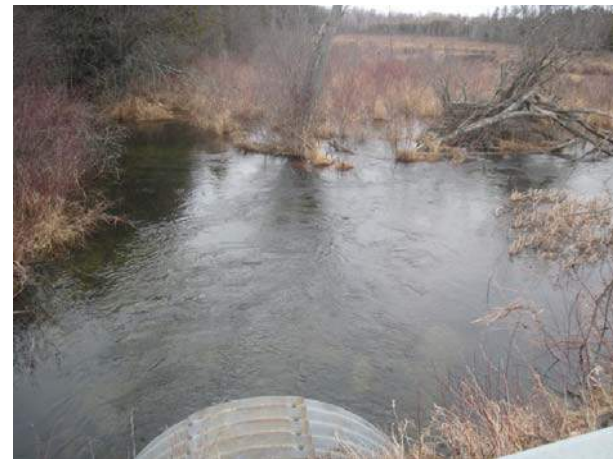
**Figure 8:** Photos of Otter Lake Outlet (taken March 22, 2011)

Otter Lake Inlet

Looking upstream towards Otter Lake

Otter Lake Outlet

Looking downstream along Otter Creek

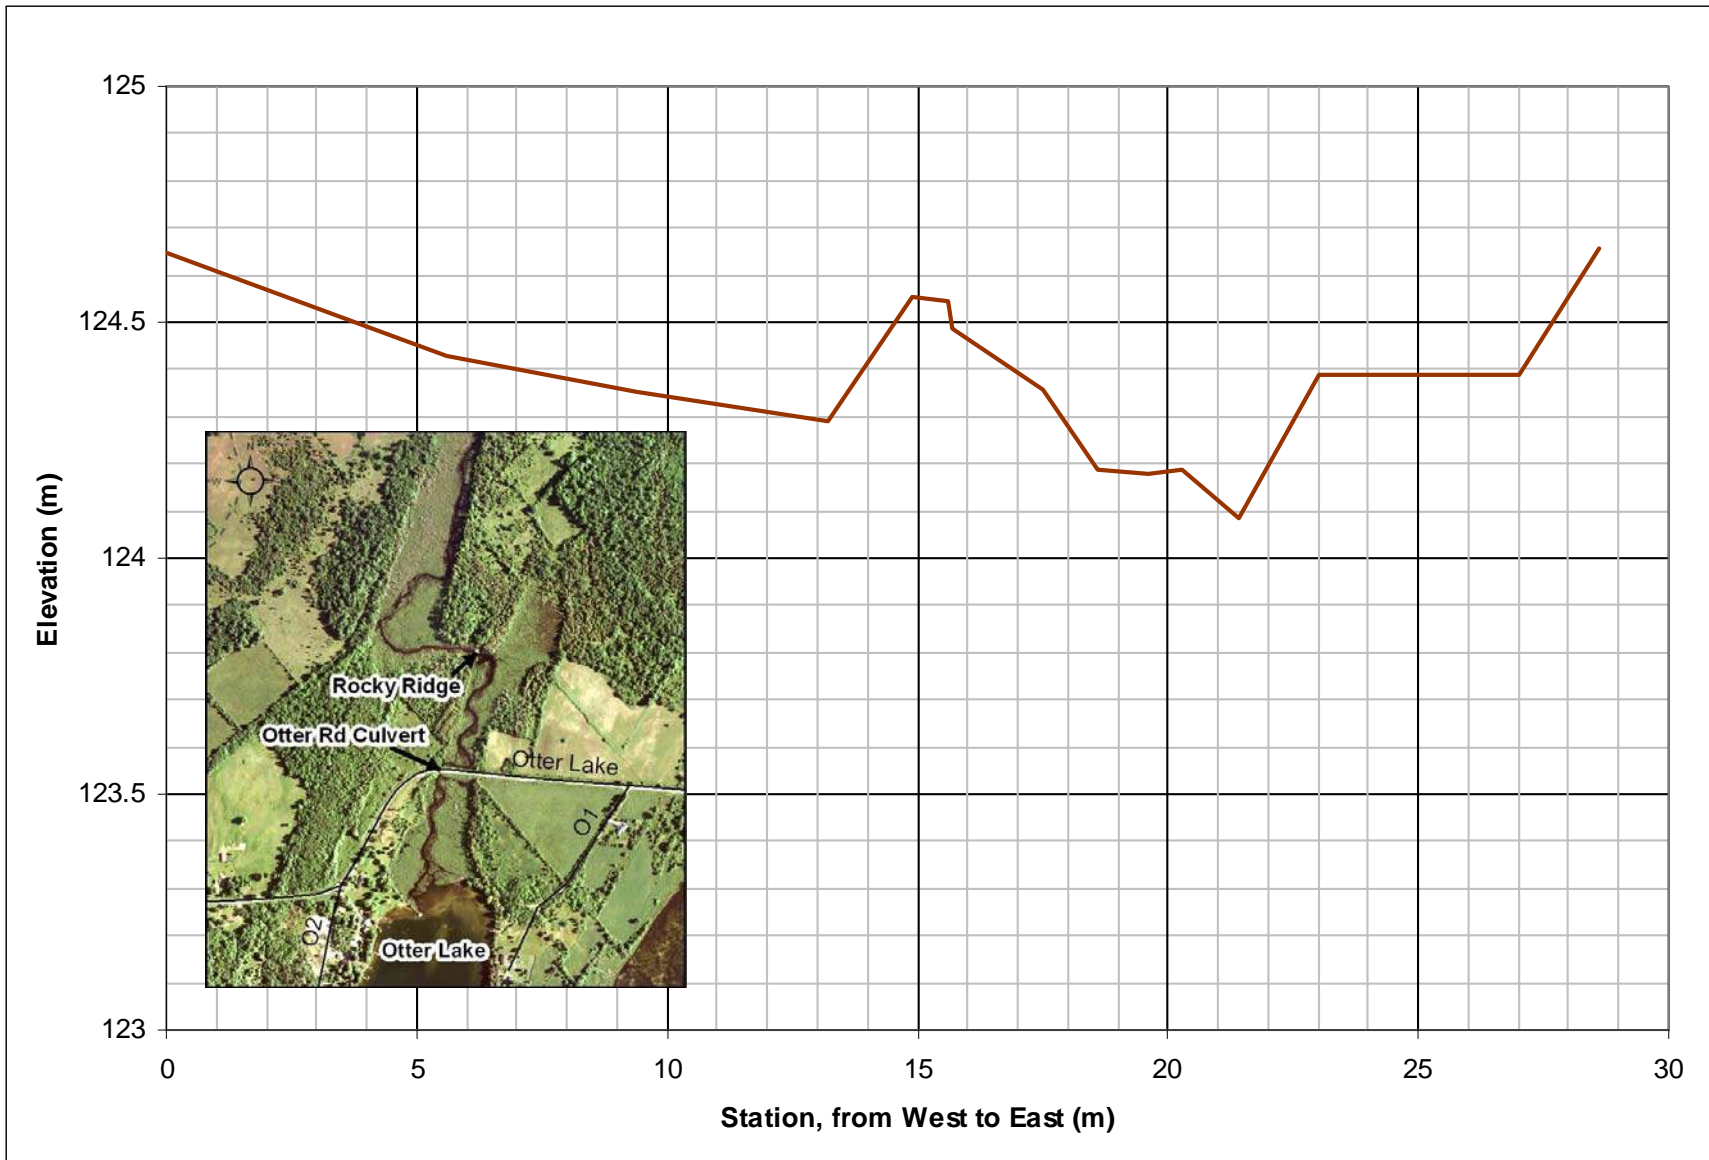
**Figure 9:** Rock Ledge Cross-section (d/s of Otter Lake Rd culvert)

Rock Ledge: An elevated rock ledge located about 250 m downstream of the Otter Lake Road culvert, controls the tailwater condition at the culvert and the lake level during low flows and frequently occurring runoff events. The cross-section at this location was surveyed (Figure 9).

In the case of Otter Lake, the rock ledge about 250 m downstream of the culvert (Figure 9), sets up a tailwater level at the culvert under low flow conditions at an elevation of at least 124.2 m (about 0.2 m above the culvert invert) plus the depth of flow at the rock ledge cross-section itself. (This assumes the channel is free of obstructions such as beaver dams or debris blockages). During extreme events, the rock ledge is expected to have less of a controlling effect on the culvert tailwater level, since overbank flow on the flood plain overbanks will occur and/or the ledge could be submerged by a further downstream control. Using the MTO approach (Figure 11), the assumed tailwater level for upstream flood level estimation purposes and the 1:100 year flow of 4.3 cms is 125.26 metres above sea level.

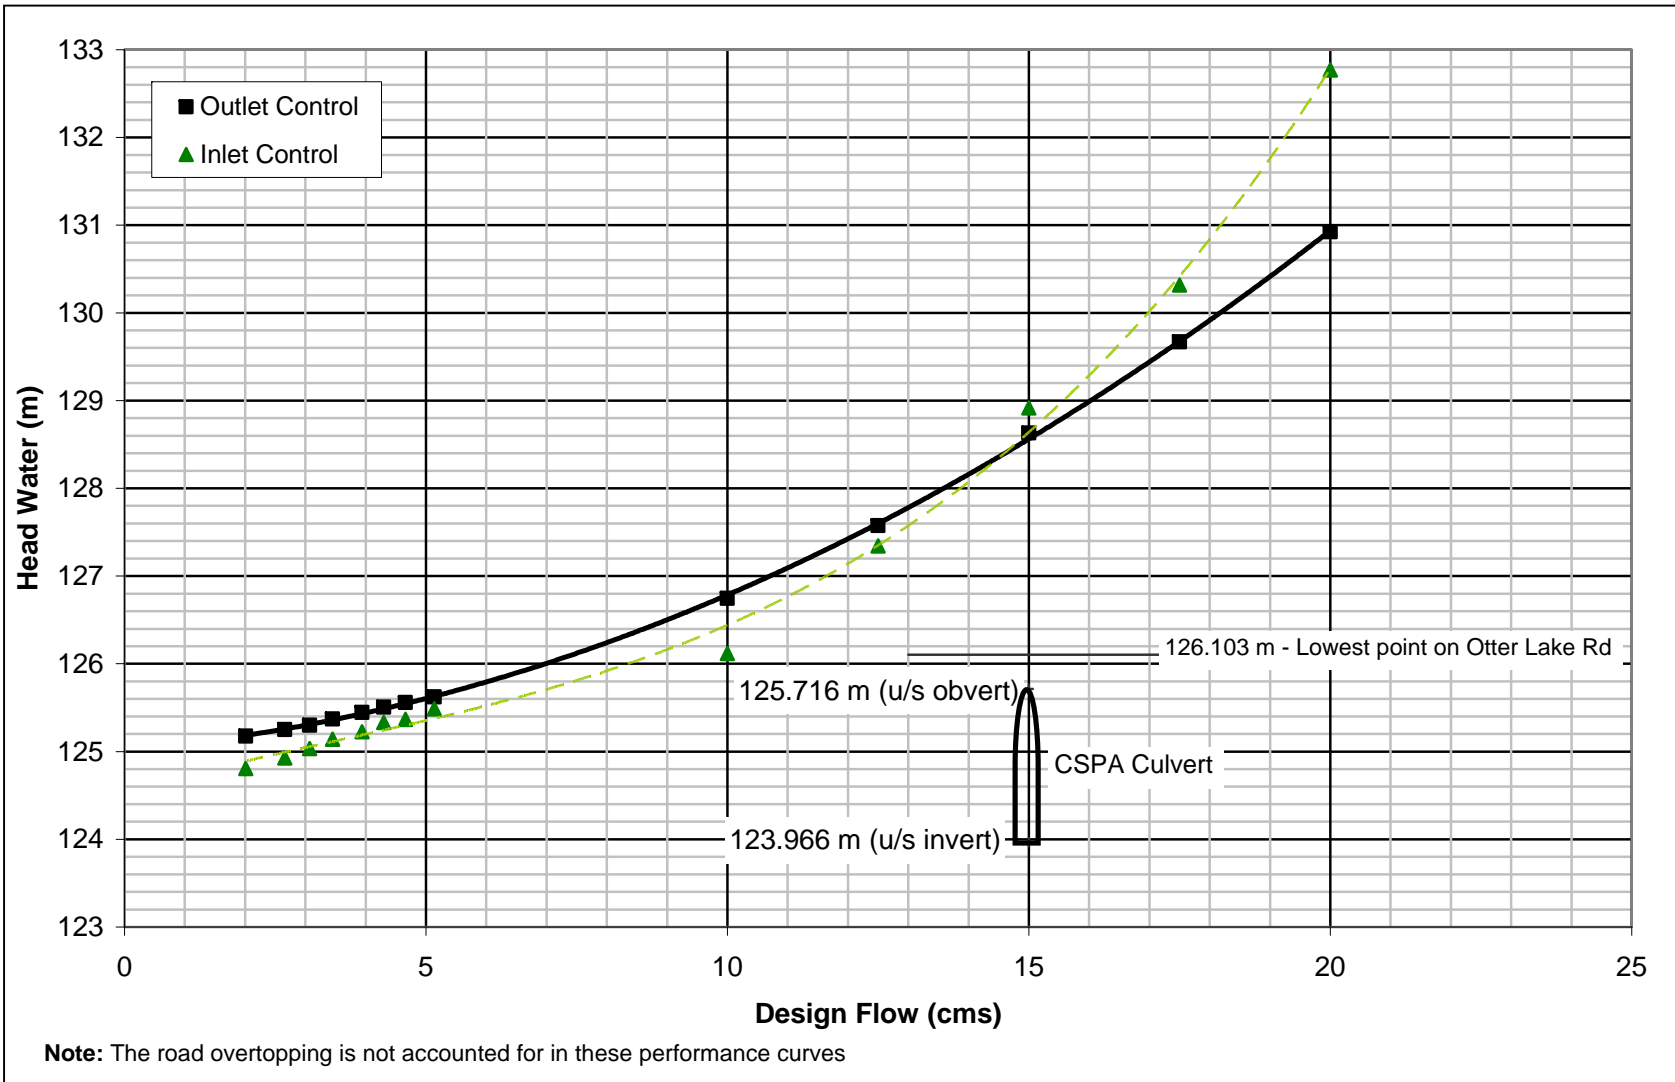
Figure 13: Performance Curve of Otter Lake Road Culvert

resulting culvert rating performance curve (upstream water surface elevation vs. discharge) is shown in Figure 13.
